APPENDIX L
FACILITIES REPORTS – TRANSIT STOPS

City of Carson City
ADA Self-Evaluation and Transition Plan Update
Transit Stop Projection Summary
2/13/2015

Route: No Route Listed on Sign GPS ID: 1
 Project Name: Hot Springs Rd - South (East of Roop St)
 City: Carson City

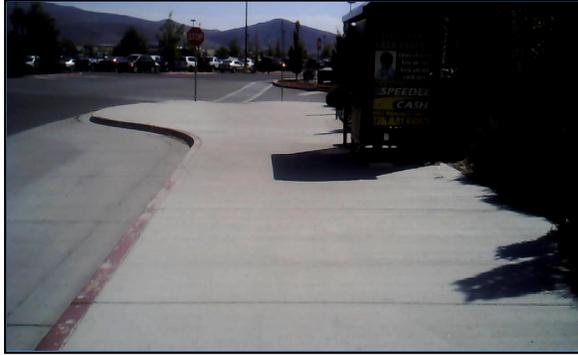
Boarding/Alighting Area

Boarding Area Issues	Issue Exists	Recommendations
Boarding area does not exist		
Boarding area length is less than 96"		
Boarding area width is less than 60"		
Boarding area running slope is greater than 2%		
Boarding area cross slope is greater than adjacent street grade		
Heaving/Sinking/Cracking present in the boarding area		
Ponding present in the boarding area		
Permanent obstruction (>0.25") in boarding area		
Temporary obstruction (>0.25") in boarding area		
Transition at connection to the curb is greater than 0.25"	X	Fix connection transition
Boarding area is missing a connection to the street or sidewalk network		
Adjacent Sidewalk Network Issues	Issue Exists	Recommendations
Sidewalk network width is less than 48"		
Sidewalk network cross slope is greater than 2%		
Heaving/Sinking/Cracking present in the sidewalk network		
Ponding present in the sidewalk network		
Permanent obstruction (>0.25") in sidewalk network

Temporary obstruction (>0.25") in sidewalk network		
Transition at connection to boarding area is greater than 0.25"		
Transit Stop Sidewalk Issues	Issue Exists	Recommendations
Transit stop sidewalk cross slope is greater than 2%		
Heaving/Sinking/Cracking present in the transit stop sidewalk		
Ponding present in the transit stop sidewalk		
Permanent obstruction (>0.25") in transit stop sidewalk		
Temporary obstruction (>0.25") in transit stop sidewalk		
Transition at connection to sidewalk network is greater than 0.25"		
Transit Stop Amenity Issues	Issue Exists	Recommendations
No transit stop signage		
Transit stop signage is non-compliant	X	Remove and replace transit stop signage
No clear space adjacent to stand-alone bench		
Stand-alone bench clear space length is less than 48"		
Stand-alone bench clear space width is less than 30"		
Stand-alone bench clear space cross slope is greater than 2%		
Stand-alone bench clear space running slope is greater than 2%

No clear space under shelter		
Shelter clear space length is less than 48"		
Shelter clear space width is less than 30"		
Shelter clear space cross slope is greater than 2%		
Shelter clear space running slope is greater than 2%		
Shelter opening clear width is less than 32"

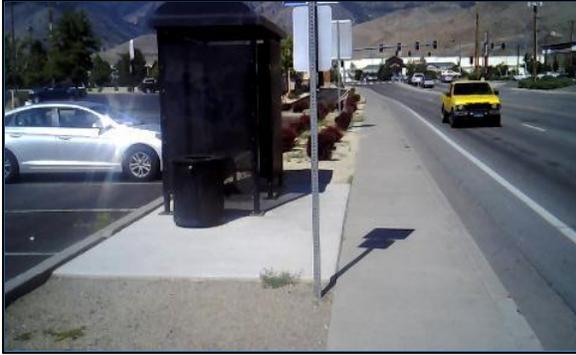
Boarding/Alighting Area

Boarding Area Issues	Issue Exists	Recommendations
Boarding area does not exist		
Boarding area length is less than 96"		
Boarding area width is less than 60"		
Boarding area running slope is greater than 2%		
Boarding area cross slope is greater than adjacent street grade		
Heaving/Sinking/Cracking present in the boarding area		
Ponding present in the boarding area		
Permanent obstruction (>0.25") in boarding area		
Temporary obstruction (>0.25") in boarding area		
Transition at connection to the curb is greater than 0.25"		
Boarding area is missing a connection to the street or sidewalk network		
Adjacent Sidewalk Network Issues	Issue Exists	Recommendations
Sidewalk network width is less than 48"		
Sidewalk network cross slope is greater than 2%		
Heaving/Sinking/Cracking present in the sidewalk network		
Ponding present in the sidewalk network		
Permanent obstruction (>0.25") in sidewalk network		
Temporary obstruction (>0.25") in sidewalk network

Transition at connection to boarding area is greater than 0.25"		
Transit Stop Sidewalk Issues	Issue Exists	Recommendations
Transit stop sidewalk cross slope is greater than 2%		
Heaving/Sinking/Cracking present in the transit stop sidewalk		
Ponding present in the transit stop sidewalk		
Permanent obstruction (>0.25") in transit stop sidewalk		
Temporary obstruction (>0.25") in transit stop sidewalk		
Transition at connection to sidewalk network is greater than 0.25"		
Transit Stop Amenity Issues	Issue Exists	Recommendations
No transit stop signage		
Transit stop signage is non-compliant	X	Remove and replace transit stop signage
No clear space adjacent to stand-alone bench		
Stand-alone bench clear space length is less than 48"		
Stand-alone bench clear space width is less than 30"		
Stand-alone bench clear space cross slope is greater than 2%		
Stand-alone bench clear space running slope is greater than 2%

No clear space under shelter		
Shelter clear space length is less than 48"		
Shelter clear space width is less than 30"		
Shelter clear space cross slope is greater than 2%		
Shelter clear space running slope is greater than 2%		
Shelter opening clear width is less than 32"

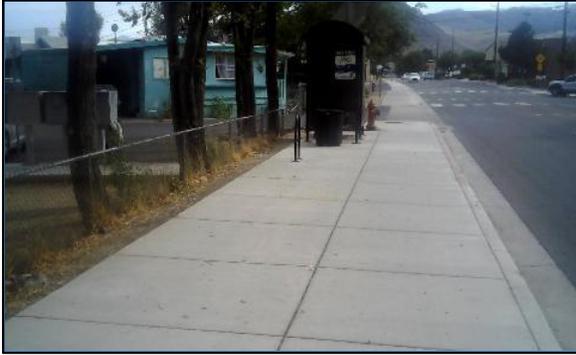
Boarding/Alighting Area

Boarding Area Issues	Issue Exists	Recommendations
Boarding area does not exist		
Boarding area length is less than 96"		
Boarding area width is less than 60"		
Boarding area running slope is greater than 2%		
Boarding area cross slope is greater than adjacent street grade		
Heaving/Sinking/Cracking present in the boarding area		
Ponding present in the boarding area		
Permanent obstruction (>0.25") in boarding area		
Temporary obstruction (>0.25") in boarding area		
Transition at connection to the curb is greater than 0.25"		
Boarding area is missing a connection to the street or sidewalk network		
Adjacent Sidewalk Network Issues	Issue Exists	Recommendations
Sidewalk network width is less than 48"		
Sidewalk network cross slope is greater than 2%		
Heaving/Sinking/Cracking present in the sidewalk network		
Ponding present in the sidewalk network		
Permanent obstruction (>0.25") in sidewalk network		
Temporary obstruction (>0.25") in sidewalk network

Transition at connection to boarding area is greater than 0.25"		
Transit Stop Sidewalk Issues	Issue Exists	Recommendations
Transit stop sidewalk cross slope is greater than 2%		
Heaving/Sinking/Cracking present in the transit stop sidewalk		
Ponding present in the transit stop sidewalk		
Permanent obstruction (>0.25") in transit stop sidewalk		
Temporary obstruction (>0.25") in transit stop sidewalk		
Transition at connection to sidewalk network is greater than 0.25"		
Transit Stop Amenity Issues	Issue Exists	Recommendations
No transit stop signage		
Transit stop signage is non-compliant	X	Remove and replace transit stop signage
No clear space adjacent to stand-alone bench		
Stand-alone bench clear space length is less than 48"		
Stand-alone bench clear space width is less than 30"		
Stand-alone bench clear space cross slope is greater than 2%		
Stand-alone bench clear space running slope is greater than 2%

No clear space under shelter		
Shelter clear space length is less than 48"		
Shelter clear space width is less than 30"		
Shelter clear space cross slope is greater than 2%		
Shelter clear space running slope is greater than 2%		
Shelter opening clear width is less than 32"

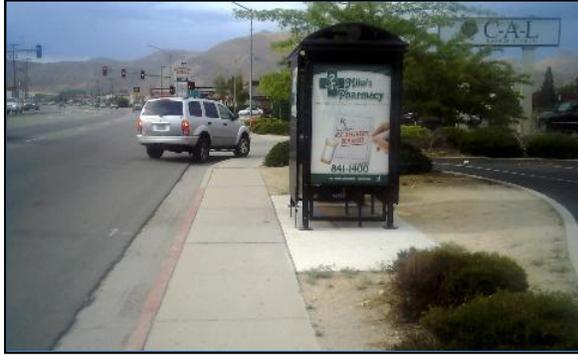
Boarding/Alighting Area

Boarding Area Issues	Issue Exists	Recommendations
Boarding area does not exist		
Boarding area length is less than 96"		
Boarding area width is less than 60"		
Boarding area running slope is greater than 2%		
Boarding area cross slope is greater than adjacent street grade		
Heaving/Sinking/Cracking present in the boarding area	X	Remove and replace boarding area
Ponding present in the boarding area		
Permanent obstruction (>0.25") in boarding area		
Temporary obstruction (>0.25") in boarding area		
Transition at connection to the curb is greater than 0.25"	X	Fix connection transition
Boarding area is missing a connection to the street or sidewalk network		
Adjacent Sidewalk Network Issues	Issue Exists	Recommendations
Sidewalk network width is less than 48"		
Sidewalk network cross slope is greater than 2%		
Heaving/Sinking/Cracking present in the sidewalk network		
Ponding present in the sidewalk network

Permanent obstruction (>0.25") in sidewalk network		
Temporary obstruction (>0.25") in sidewalk network		
Transition at connection to boarding area is greater than 0.25"		
Transit Stop Sidewalk Issues	Issue Exists	Recommendations
Transit stop sidewalk cross slope is greater than 2%		
Heaving/Sinking/Cracking present in the transit stop sidewalk		
Ponding present in the transit stop sidewalk		
Permanent obstruction (>0.25") in transit stop sidewalk		
Temporary obstruction (>0.25") in transit stop sidewalk		
Transition at connection to sidewalk network is greater than 0.25"		
Transit Stop Amenity Issues	Issue Exists	Recommendations
No transit stop signage		
Transit stop signage is non-compliant	X	Remove and replace transit stop signage
No clear space adjacent to stand-alone bench		
Stand-alone bench clear space length is less than 48"		
Stand-alone bench clear space width is less than 30"		
Stand-alone bench clear space cross slope is greater than 2%

Stand-alone bench clear space running slope is greater than 2%		
No clear space under shelter		
Shelter clear space length is less than 48"		
Shelter clear space width is less than 30"		
Shelter clear space cross slope is greater than 2%		
Shelter clear space running slope is greater than 2%	X	
Shelter opening clear width is less than 32"

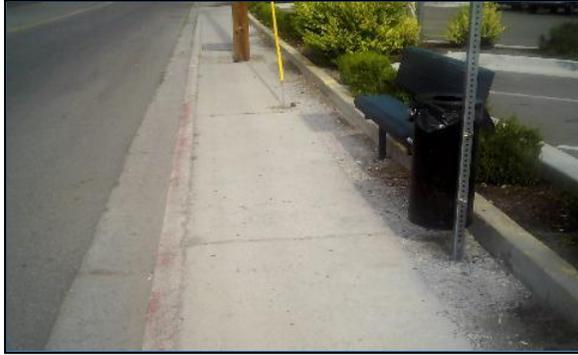
Boarding/Alighting Area

Boarding Area Issues	Issue Exists	Recommendations
Boarding area does not exist		
Boarding area length is less than 96"	X	Increase boarding area size
Boarding area width is less than 60"		
Boarding area running slope is greater than 2%	X	
Boarding area cross slope is greater than adjacent street grade		
Heaving/Sinking/Cracking present in the boarding area	X	Remove and replace boarding area
Ponding present in the boarding area		
Permanent obstruction (>0.25") in boarding area		
Temporary obstruction (>0.25") in boarding area		
Transition at connection to the curb is greater than 0.25"	X	Fix connection transition
Boarding area is missing a connection to the street or sidewalk network		
Adjacent Sidewalk Network Issues	Issue Exists	Recommendations
Sidewalk network width is less than 48"		
Sidewalk network cross slope is greater than 2%		
Heaving/Sinking/Cracking present in the sidewalk network		
Ponding present in the sidewalk network

Permanent obstruction (>0.25") in sidewalk network		
Temporary obstruction (>0.25") in sidewalk network		
Transition at connection to boarding area is greater than 0.25"		
Transit Stop Sidewalk Issues	Issue Exists	Recommendations
Transit stop sidewalk cross slope is greater than 2%		
Heaving/Sinking/Cracking present in the transit stop sidewalk		
Ponding present in the transit stop sidewalk		
Permanent obstruction (>0.25") in transit stop sidewalk		
Temporary obstruction (>0.25") in transit stop sidewalk		
Transition at connection to sidewalk network is greater than 0.25"		
Transit Stop Amenity Issues	Issue Exists	Recommendations
No transit stop signage		
Transit stop signage is non-compliant	X	Remove and replace transit stop signage
No clear space adjacent to stand-alone bench		
Stand-alone bench clear space length is less than 48"		
Stand-alone bench clear space width is less than 30"		
Stand-alone bench clear space cross slope is greater than 2%

Stand-alone bench clear space running slope is greater than 2%		
No clear space under shelter		
Shelter clear space length is less than 48"		
Shelter clear space width is less than 30"		
Shelter clear space cross slope is greater than 2%		
Shelter clear space running slope is greater than 2%		
Shelter opening clear width is less than 32"

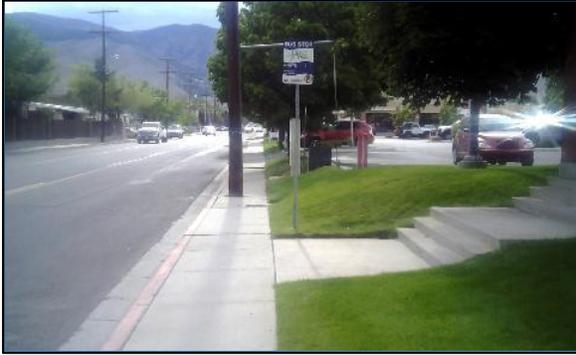
Boarding/Alighting Area

Boarding Area Issues	Issue Exists	Recommendations
Boarding area does not exist		
Boarding area length is less than 96"		
Boarding area width is less than 60"		
Boarding area running slope is greater than 2%		
Boarding area cross slope is greater than adjacent street grade		
Heaving/Sinking/Cracking present in the boarding area	X	Remove and replace boarding area
Ponding present in the boarding area		
Permanent obstruction (>0.25") in boarding area		
Temporary obstruction (>0.25") in boarding area		
Transition at connection to the curb is greater than 0.25"	X	Fix connection transition
Boarding area is missing a connection to the street or sidewalk network		
Adjacent Sidewalk Network Issues		
Sidewalk network width is less than 48"		
Sidewalk network cross slope is greater than 2%		
Heaving/Sinking/Cracking present in the sidewalk network		
Ponding present in the sidewalk network		
Permanent obstruction (>0.25") in sidewalk network

Temporary obstruction (>0.25") in sidewalk network		
Transition at connection to boarding area is greater than 0.25"		
Transit Stop Sidewalk Issues		
Transit stop sidewalk cross slope is greater than 2%		
Heaving/Sinking/Cracking present in the transit stop sidewalk		
Ponding present in the transit stop sidewalk		
Permanent obstruction (>0.25") in transit stop sidewalk		
Temporary obstruction (>0.25") in transit stop sidewalk		
Transition at connection to sidewalk network is greater than 0.25"		
Transit Stop Amenity Issues		
No transit stop signage		
Transit stop signage is non-compliant	X	Remove and replace transit stop signage
No clear space adjacent to stand-alone bench		
Stand-alone bench clear space length is less than 48"		
Stand-alone bench clear space width is less than 30"		
Stand-alone bench clear space cross slope is greater than 2%		
Stand-alone bench clear space running slope is greater than 2%

No clear space under shelter		
Shelter clear space length is less than 48"		
Shelter clear space width is less than 30"		
Shelter clear space cross slope is greater than 2%		
Shelter clear space running slope is greater than 2%		
Shelter opening clear width is less than 32"

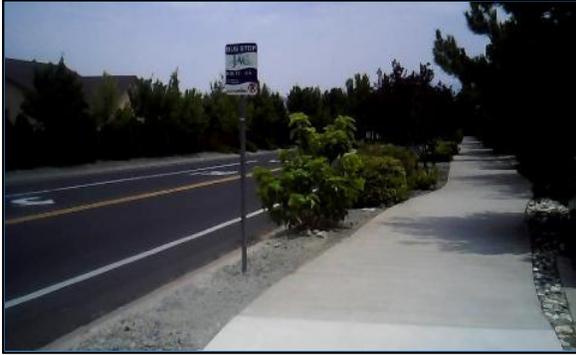
Boarding/Alighting Area

Boarding Area Issues	Issue Exists	Recommendations
Boarding area does not exist		
Boarding area length is less than 96"		
Boarding area width is less than 60"		
Boarding area running slope is greater than 2%	X	
Boarding area cross slope is greater than adjacent street grade		
Heaving/Sinking/Cracking present in the boarding area		Remove and replace boarding area
Ponding present in the boarding area		
Permanent obstruction (>0.25") in boarding area	X	Remove obstruction
Temporary obstruction (>0.25") in boarding area		
Transition at connection to the curb is greater than 0.25"	X	Fix connection transition
Boarding area is missing a connection to the street or sidewalk network	X	Install connection
Adjacent Sidewalk Network Issues	Issue Exists	Recommendations
Sidewalk network width is less than 48"		
Sidewalk network cross slope is greater than 2%		
Heaving/Sinking/Cracking present in the sidewalk network		
Ponding present in the sidewalk network

Permanent obstruction (>0.25") in sidewalk network		
Temporary obstruction (>0.25") in sidewalk network		
Transition at connection to boarding area is greater than 0.25"		
Transit Stop Sidewalk Issues	Issue Exists	Recommendations
Transit stop sidewalk cross slope is greater than 2%		
Heaving/Sinking/Cracking present in the transit stop sidewalk		
Ponding present in the transit stop sidewalk		
Permanent obstruction (>0.25") in transit stop sidewalk		
Temporary obstruction (>0.25") in transit stop sidewalk		
Transition at connection to sidewalk network is greater than 0.25"		
Transit Stop Amenity Issues	Issue Exists	Recommendations
No transit stop signage		
Transit stop signage is non-compliant	X	Remove and replace transit stop signage
No clear space adjacent to stand-alone bench		
Stand-alone bench clear space length is less than 48"		
Stand-alone bench clear space width is less than 30"		
Stand-alone bench clear space cross slope is greater than 2%

Stand-alone bench clear space running slope is greater than 2%		
No clear space under shelter		
Shelter clear space length is less than 48"		
Shelter clear space width is less than 30"		
Shelter clear space cross slope is greater than 2%		
Shelter clear space running slope is greater than 2%		
Shelter opening clear width is less than 32"

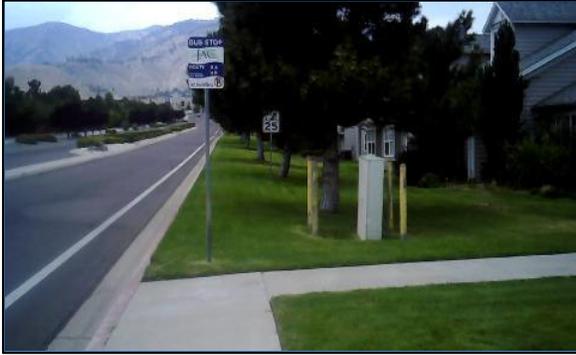
Boarding/Alighting Area

Boarding Area Issues	Issue Exists	Recommendations
Boarding area does not exist		
Boarding area length is less than 96"		
Boarding area width is less than 60"	X	Increase boarding area size
Boarding area running slope is greater than 2%		
Boarding area cross slope is greater than adjacent street grade	X	
Heaving/Sinking/Cracking present in the boarding area		Remove and replace boarding area
Ponding present in the boarding area		
Permanent obstruction (>0.25") in boarding area		
Temporary obstruction (>0.25") in boarding area		
Transition at connection to the curb is greater than 0.25"		
Boarding area is missing a connection to the street or sidewalk network		
Adjacent Sidewalk Network Issues		
Sidewalk network width is less than 48"		
Sidewalk network cross slope is greater than 2%		
Heaving/Sinking/Cracking present in the sidewalk network		
Ponding present in the sidewalk network		
Permanent obstruction (>0.25") in sidewalk network

Temporary obstruction (>0.25") in sidewalk network		
Transition at connection to boarding area is greater than 0.25"		
Transit Stop Sidewalk Issues		
Transit stop sidewalk cross slope is greater than 2%		
Heaving/Sinking/Cracking present in the transit stop sidewalk		
Ponding present in the transit stop sidewalk		
Permanent obstruction (>0.25") in transit stop sidewalk		
Temporary obstruction (>0.25") in transit stop sidewalk		
Transition at connection to sidewalk network is greater than 0.25"		
Transit Stop Amenity Issues		
No transit stop signage		
Transit stop signage is non-compliant	X	Remove and replace transit stop signage
No clear space adjacent to stand-alone bench		
Stand-alone bench clear space length is less than 48"		
Stand-alone bench clear space width is less than 30"		
Stand-alone bench clear space cross slope is greater than 2%		
Stand-alone bench clear space running slope is greater than 2%

No clear space under shelter		
Shelter clear space length is less than 48"		
Shelter clear space width is less than 30"		
Shelter clear space cross slope is greater than 2%		
Shelter clear space running slope is greater than 2%		
Shelter opening clear width is less than 32"
