# STAFF REPORT

**Agenda Title:** For Discussion Only: Review of the Range Evaluation Report prepared by Tactical Services Group and status update on range evaluations requested by the National Rifle Association and the National Shooting Sports Foundation.

# *Range Evaluation Report*

**Project #: NV20190103**  
**Subject: Carson City, Nevada Range**

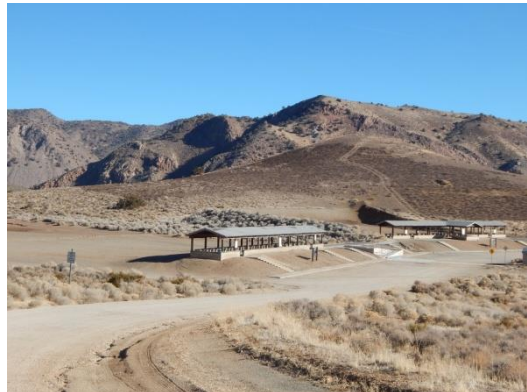
Figure 1

The range is a city park shooting facility located in a mostly rural brushy terrain area zoned "Public Community Use". (See fig. 1) The range property is under the control of the Carson City Parks and Recreation Department but the range is operated by the non-profit Carson Rifle and Pistol Club through a land use agreement. Reasonable accommodations for the safety of both those using the range and the general public are achieved by considering the entire context in which this particular facility is operated. The type of shooting conducted, the rules and controls that are practiced, the overall design of the range, and the surrounding environment must be considered.

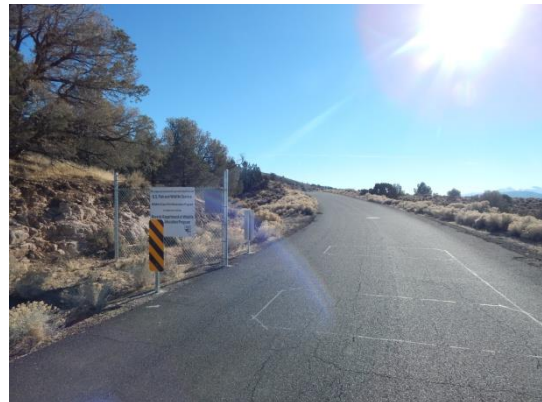
Figure 2

Range access is controlled by the locked gate and limited to the posted hours of operation. The road access to the facility is adequate and leads directly to the ranges. (See fig. 2)

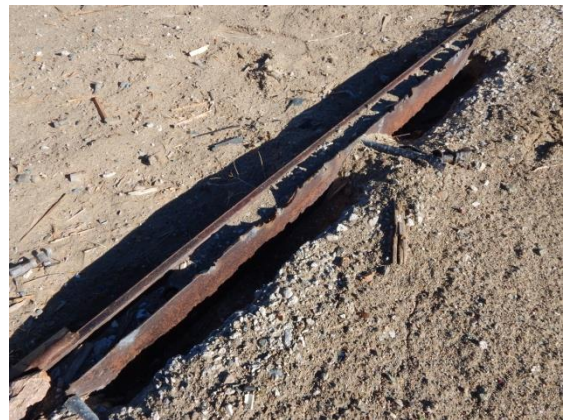
Figure 3

The intermediate target line positions are in need of repair. The concrete foundations are shot to the point that exposed rebar is found along the entire length. There are sections of old steel train rails that are shot to pieces. (See fig. 3)

8. Deteriorated concrete target stands, exposed rebar and steel rails should be removed. New target stands (permanent/temporary should be designed and placed to eliminate bullet impact, facilitate easy repair/replacement.

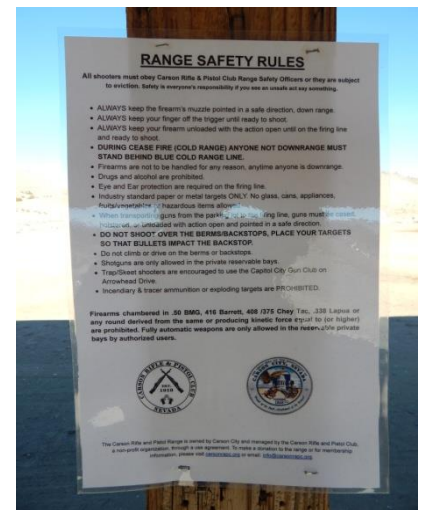
Figure 4

The range firearm safety rules and other safety signs are not adequate for the number of shooting positions in this bay. (See fig. 4) The firing line under the covered positions is adequately marked. The firing line for the 20 uncovered positions is not adequately defined.

7. The uncovered shooting positions/firing line on the Long Range bay must be better identified or established. This can be achieved in many ways such as a physical barrier, a change in material on the ground or some form of permanent marking.
8. The deteriorated concrete intermediate target stand structures should be removed from all bays to include the exposed rebar and rail road steel rails. If new target stand system is to be installed it should be designed as to eliminate bullet impact.

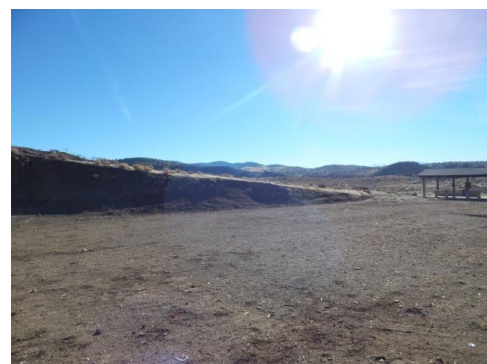
Figure 5

The 50 yard rifle bay backstop does not meet the minimum suggested height published in the NRARSB and is too low to expect total projectile containment. The high point of the backstop is approximately 12 feet. (See fig. 5)

3. The backstop height should be increased to the suggested height of at least 20 feet with a minimum of 4 feet width/depth at the highest part **ON ALL BAYS.** See the NRARSB for backstop design considerations. All berms and backstops would benefit from additional grooming and maintenance as is recommended by the NRARSB.

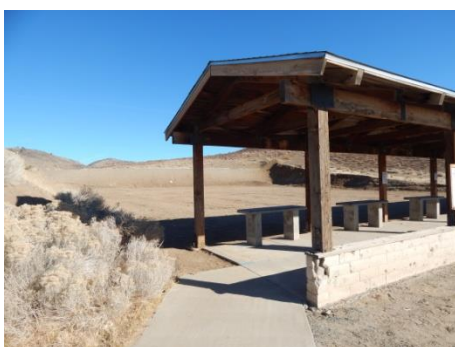
Figure 6

Side berms fail to meet the minimum suggested height published in the NRARSB and are too low to expect total projectile containment. They also taper from a high point at the backstop intersection back towards the firing line. (See fig. 6)

The Northwest Corner of the left side berm and the left side of the backstop is not high enough to guarantee projectile containment in the direction of the 100, 200, and 300 yard target positions of the adjacent Long Range bay. The Northwest corner of this particular bay is a major concern as the height of this side berm and backstop junction are critical elements to keeping people safe while changing targets down range in the Long Bay during Short bay shooting activities.

5. The Side Berm height should be increased to the suggested height of at least 8 feet with a minimum of 4 feet width/depth at the highest part **ON ALL BAYS.** See the NRARSB for backstop design considerations. All berms and backstops would benefit from additional grooming and maintenance as is recommended by the NRARSB.

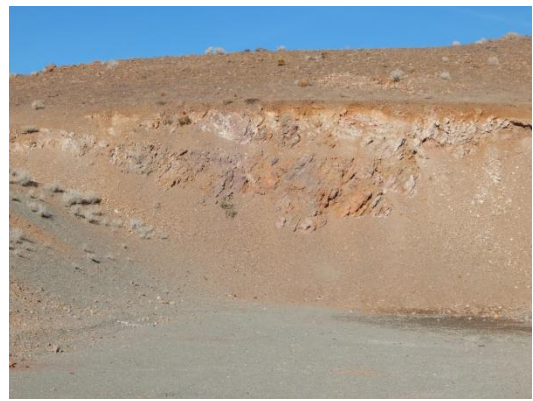
Figure 8

The 50 yard bay has a backstop and side berms that fail to meet the minimum suggested heights published in the NRARSB and are too low to expect total projectile contain-

ment. The backstop in this bay is positioned directly in front of a ragged rock outcropping. (See fig. 8)

The rocky surface directly behind the backstop in this bay is a dangerous situation as projectiles hitting this hard irregular rocky area have a higher potential to ricochet than to remain captured.

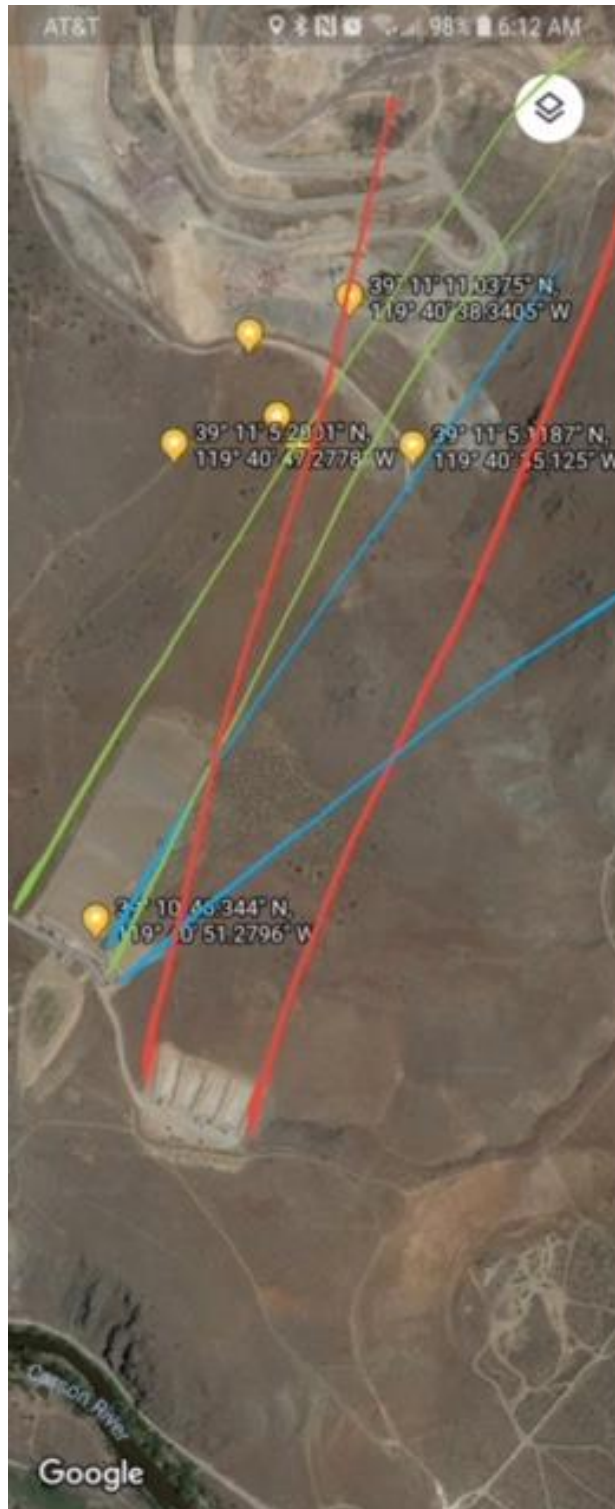
# Appendix A

Prior to my inspection, club members accompanied by City Public Works staff collected numerous bullets from the referenced landfill area during shooting activity at the range on November 18, 2018. The club members had established communications with the RSO at the firing line who confirmed the shooting locations and direction of the ongoing shooting activity. In talking with the club members and the City staff it is clear that they are certain the projectiles heard “whizzing” overhead originated from the range. They also indicated that the rounds heard were more than likely ricocheted as they did not hear the “crack” normally associated with a rifle round as it passes overhead. See Appendix A for an aerial view of the group’s findings.
