OPEN SPACE ADVISORY COMMITTEE STAFF REPORT

<u>For possible action to:</u> recommend to the Board of Supervisors acceptance of the monitoring report for the Horsecreek Ranch

Horse Creek Ranch Annual Pasture Utilization and Condition Assessment

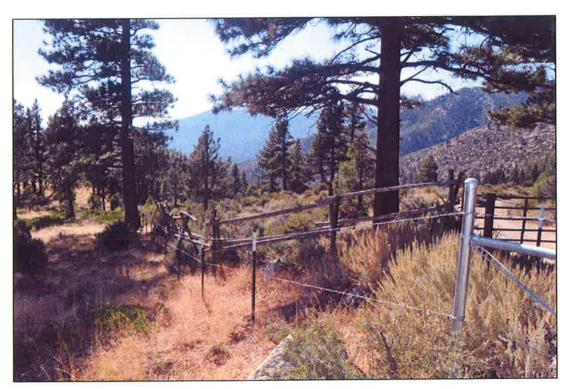
Photo – At the upper gated entrance, a new three-strand barbed wire fence extends to the south.

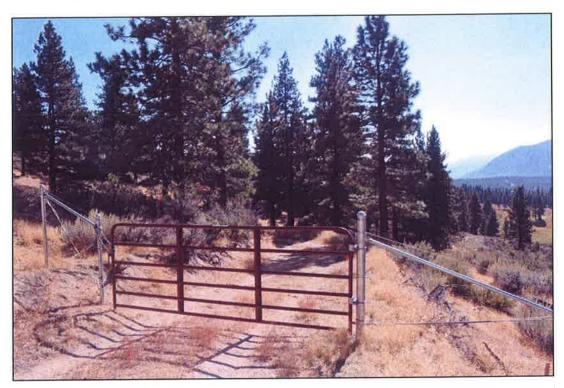
Photo: At the southeast property corner with the USFS, a new gate was installed to control access.

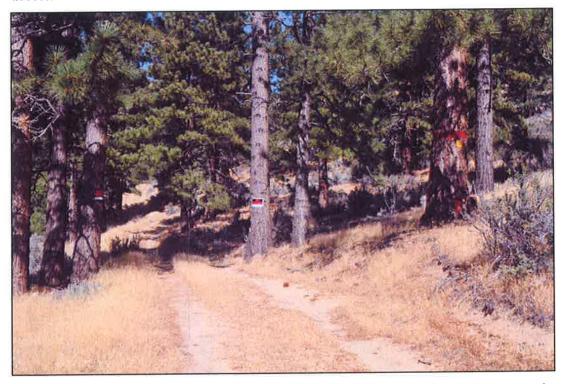
Photo: At the southeast property corner with the USFS, private property and no trespassing signs were posted.

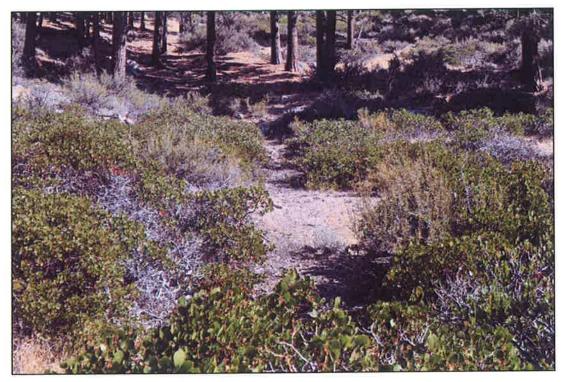
The previous report mentioned a few areas of trespass and the off-road tracks caused by dirt bike use. Since installation of the gate and barbed wire fence, the trespass and unauthorized vehicle use have dissipated.

Photo: The previously photographed dirt bike tracks were not apparent. View from the conservation easement uphill to the adjacent USFS lands on the east.

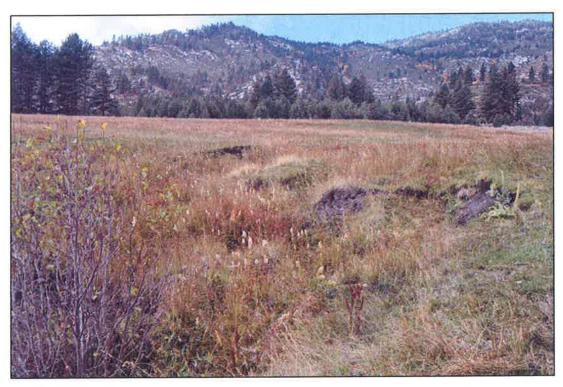
The following is an update and continued monitoring as referenced in the previous report: According to the Mr. Fagen, there was significant winter and spring runoff in the drainage located east of the cabins. Generally, the field conditions appear stable from last year and the vegetation seems to be establishing. Likewise for the lower meadow located south of the cabins. A few areas such as the headcut identified in Photos 4A - 4C should receive some stabilization work though, and Carson City will work with Mr. Fagen towards this goal.

Photo: The photo of this drainage, located south of the cabins, has been included to document current condition and vegetation growth. N 39 07' 42.7" W 119 50' 10.2"

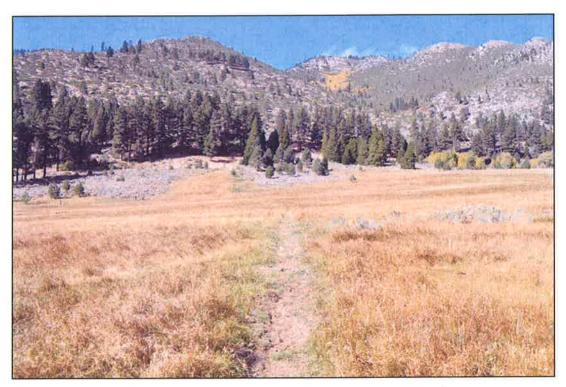
The previous report recommended monitoring for revegetation along the excavated pipeline area. During this field monitoring visit, preferred grass and forb species were not yet apparent. Rather, annual weeds such as cheatgrass and redstem filaree were most common. If natural revegetation is not successful within a few years, a mix of meadow grasses may need to be purchased and raked into the soil during the late fall months.

Photo: The photo of the pipeline excavation area has been included to document current condition and vegetation growth.
