# **CARSON CITY NEVADA**

Re: Current status of the Brown Street properties

On May 28, 2013 a walk around inspection was conducted, by Carson City Public Works Environmental Control Supervisor Kelly Hale, and Carson City Public Works Utility Manager David Bruketta, at the properties listed below:

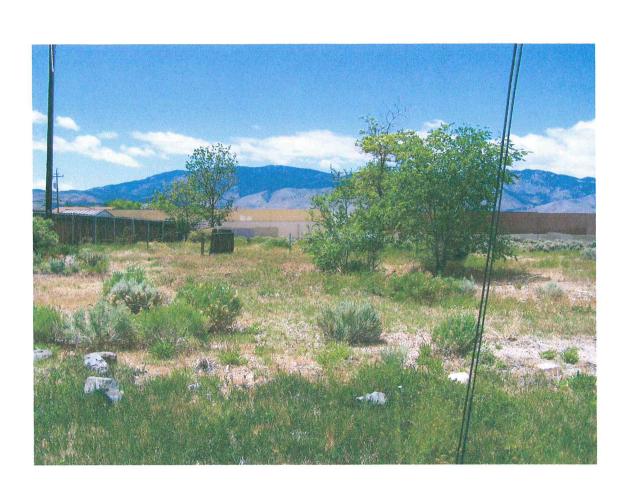
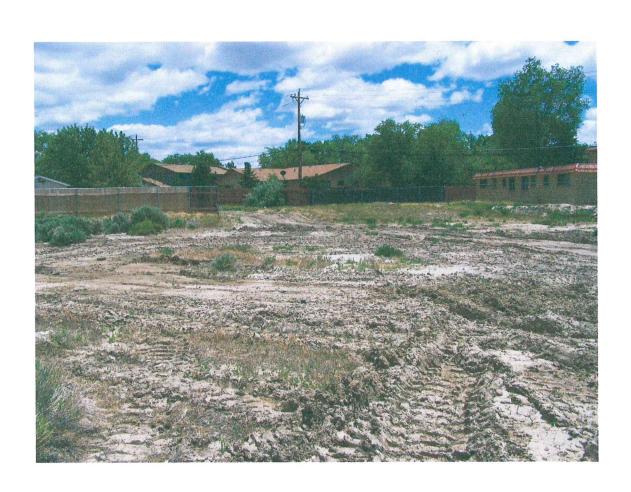
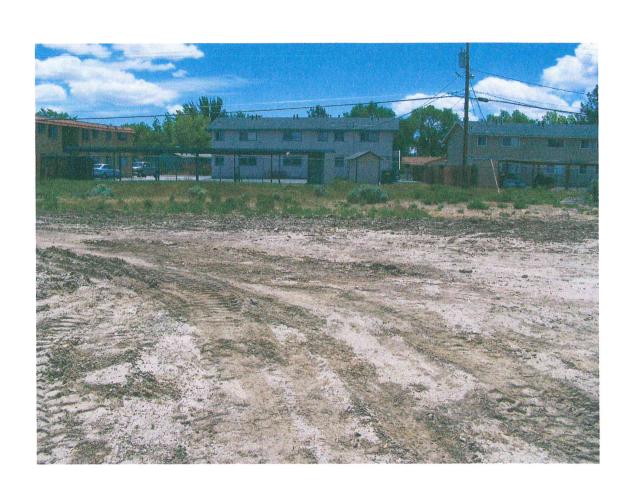
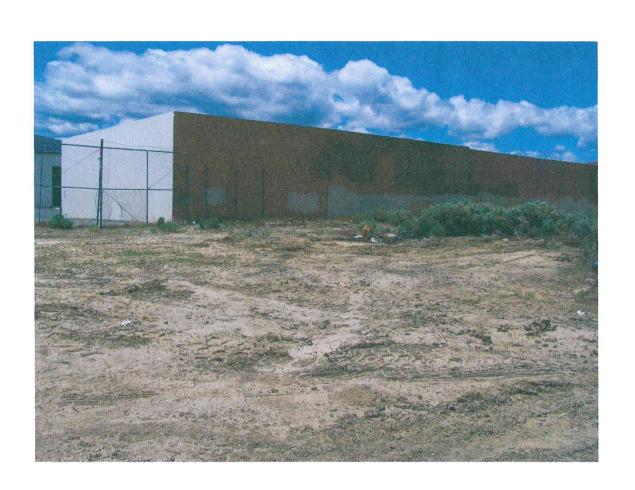
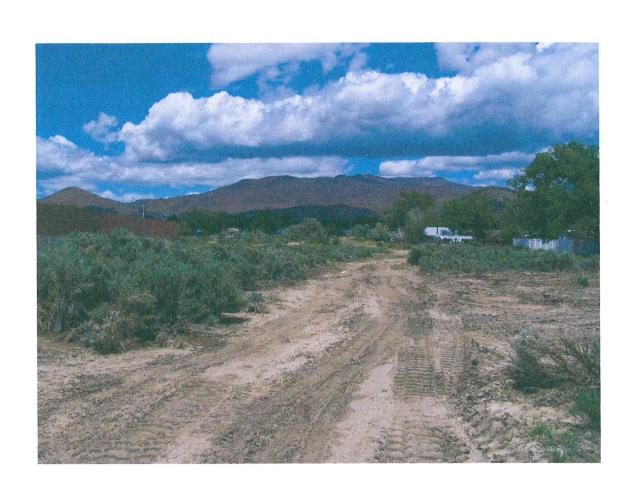
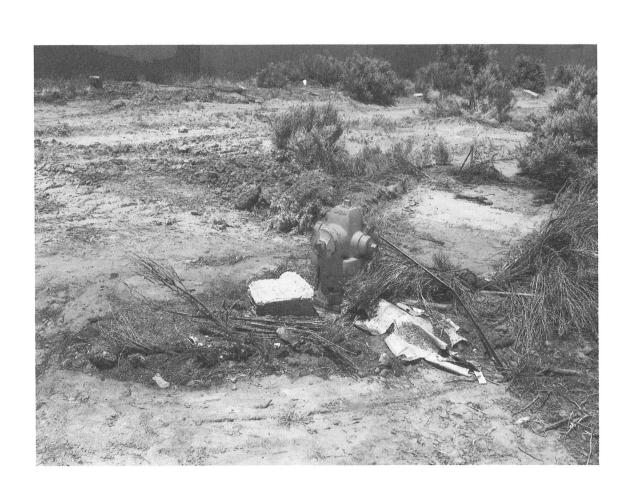
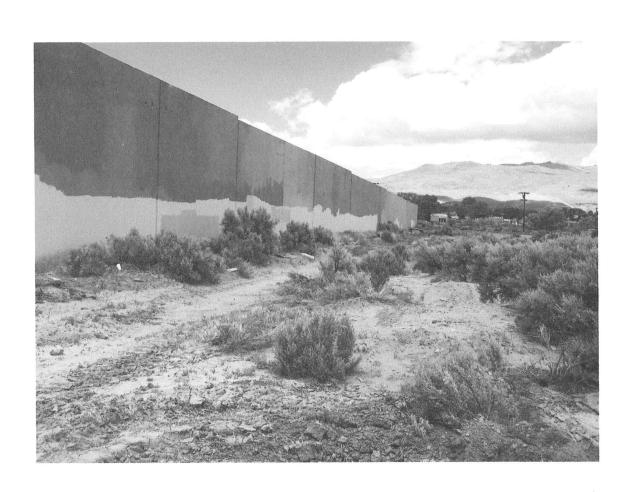
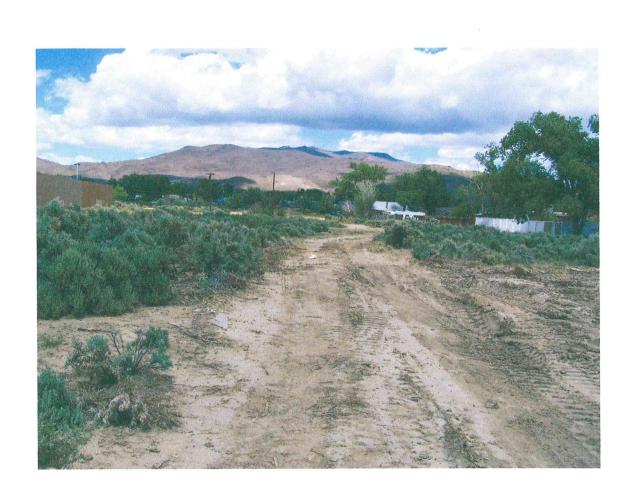
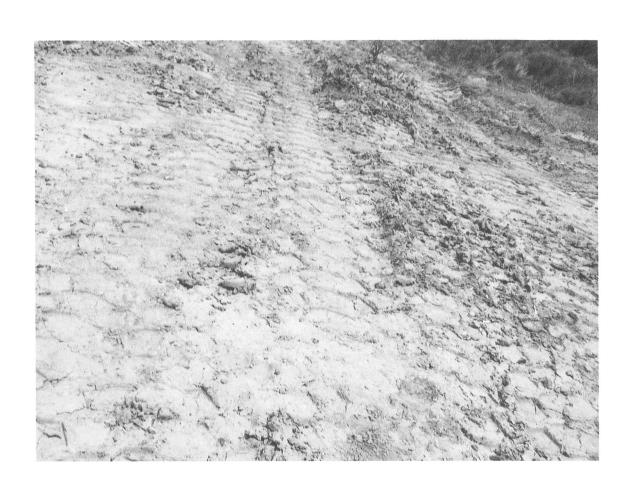
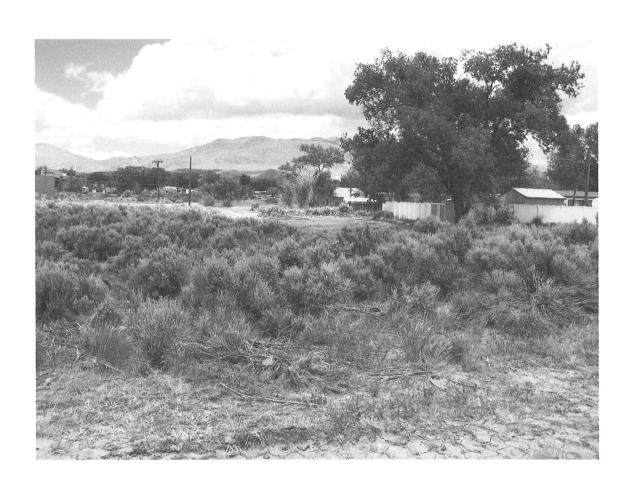
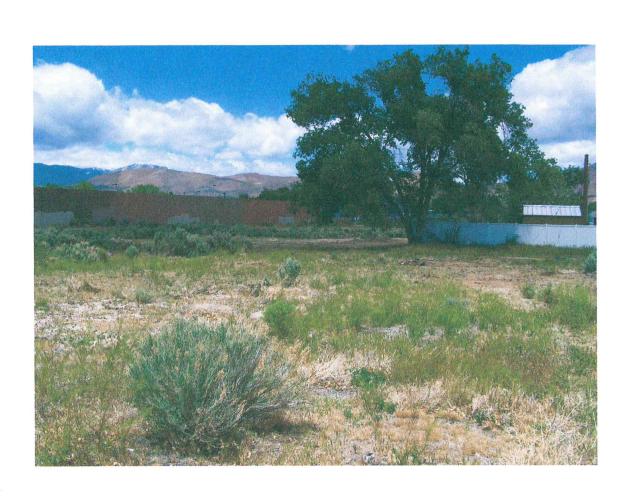
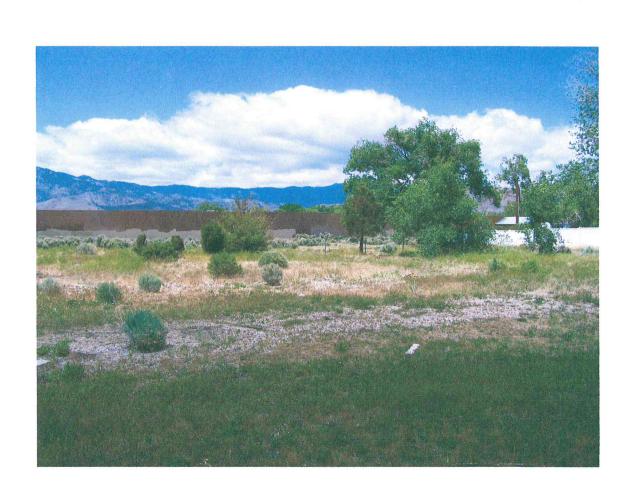
The site has some areas of disturbed soil (see attached photos) and some debris (trash) has been dumped onto the site. There is no evidence of soil staining, or odors that would indicate any dumping of liquid materials, above what has been previously noted as possible waste vehicle fluids. There were no containers, or drums seen on the site. The areas of disturbed earth all appear to be native soils, and there is no evidence seen of large scale excavations.

There are quite a few places where there are pieces of broken pipe, bricks, concrete, and other "construction" type debris. There are a few areas of the

property which have roofing materials (These appear to be mostly asphalt shingles.) on them, some partially buried.

The overall site condition does not appear to be substantially different from what was previously noted in the Phase I Assessment documentation. Pictures taken during the walk through inspection are attached
