### City of Carson City Agenda Report

**Subject Title**: <u>For Possible Action</u>: To accept the 2013 Monitoring Report for the Horsecreek Ranch Conservation Easement as recommended by the Open Space Advisory Committee. (Ann Bollinger)

**Date:** July 24, 2013

#### Conservation Easement, Exhibit C, Prohibited Uses and Practices

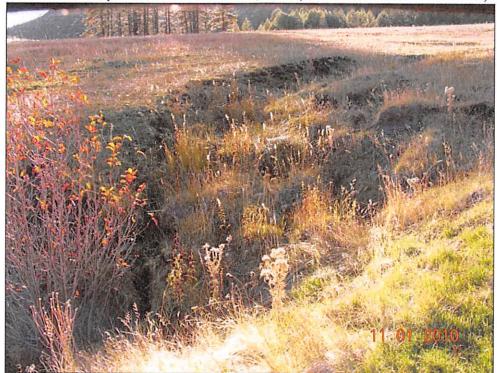
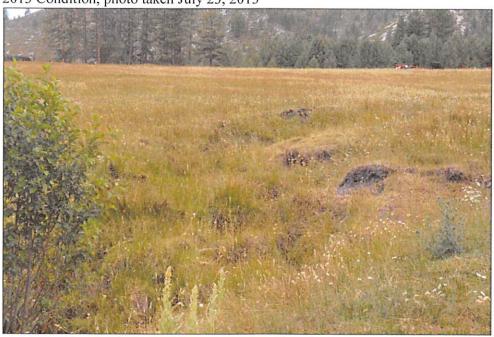
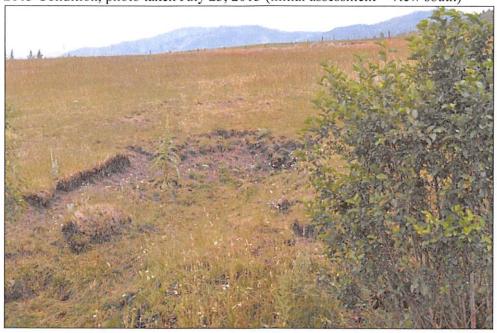
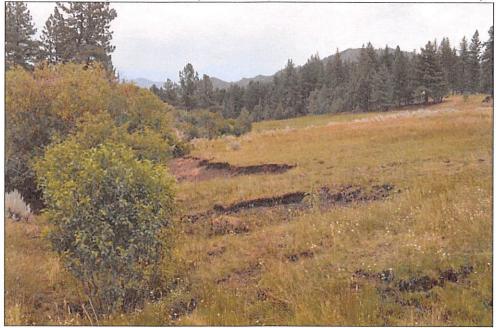
Photo Point: The photo of this drainage, located south of the cabins, has been included to document change and vegetation growth. N 39 07' 42.7" W 119 50' 10.2"

Near the southeast corner, one specific area is being monitored for landscape change. This low drainage area of the meadow appears to be vegetated and stable though a few isolated mounds or hummocks may be the result of cattle trampling. A qualitative assessment with the photo comparisons may be a little deceptive because the first photo was taken at the end of the growing season in November after grasses were grazed and/or died whereas the current photo was taken at the peak of the growing season in July when grasses are actively growing.

2013 Condition, photo taken July 23, 2013

2013 Condition, photo taken July 23, 2013 (initial assessment – view south)

2013 Condition, photo taken July 23, 2013 (initial assessment – view southeast)

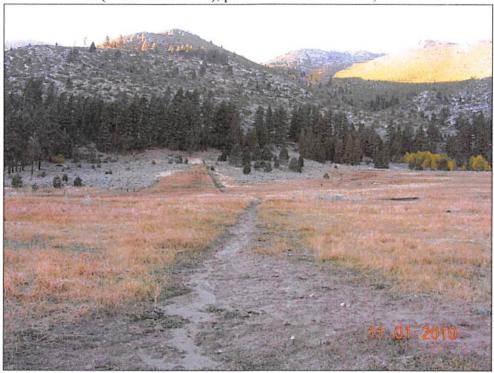
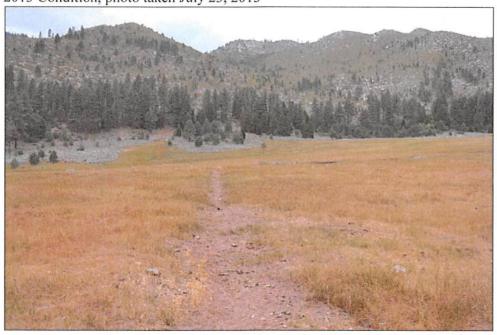
Photo Point: The photo of the pipeline excavation area has been included to document change and vegetation growth.

The linear excavation for the water pipeline to the cabins occurred prior to signing of the conservation easement in March 2009, but some of the impact remains visible. Natural revegetation seems to be occurring on the upper, wetter end of the excavated area. On the lower end closer to the cabins, however, the cattle seem to travel along the route and revegetation is not occurring. The disturbed area is minimal; therefore, at this time, no further action is recommended.

2010 Condition (initial assessment), photo taken November 1, 2010

2013 Condition, photo taken July 23, 2013

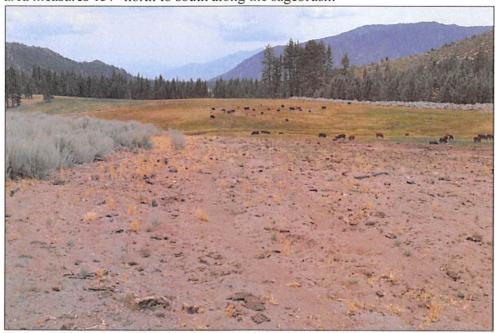
- The previous report recommended monitoring of the cattle loafing area located just outside the gated entrance to the cabins with the goal to limit further expansion. The below documentation provides photo points and respective measurements.

2013 Condition, photo taken July 23, 2013 (initial assessment – view south): The bare area measures 157' north to south along the sagebrush.

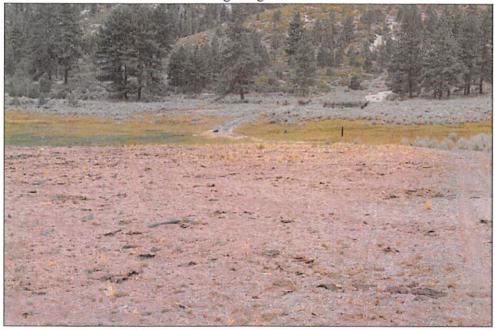
2013 Condition, photo taken July 23, 2013 (initial assessment – view west): The bare area measures 145' east to west along the gravel road.

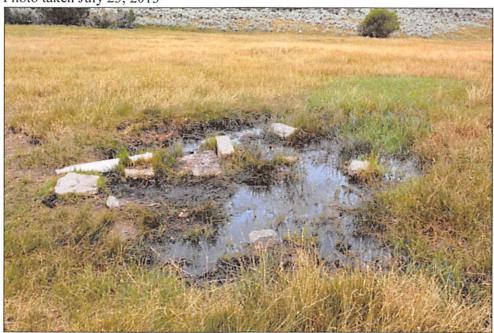
Photo taken July 23, 2013

- One vegetative response observed throughout the woody ecological sites of the property is the new growth and establishment of conifer seedlings including pine, fir, and cedar.
- One distribution box located approximately in the middle of the meadow is in complete disrepair. The water is ponding rather than spreading throughout the ditches. This replacement should occur prior to the next irrigation season.

- 1) Replacement of the concrete distribution box; and
- 2) Continued removal of bull thistle

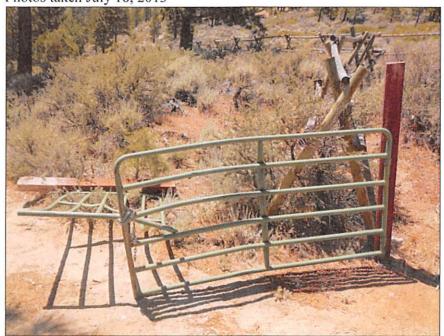
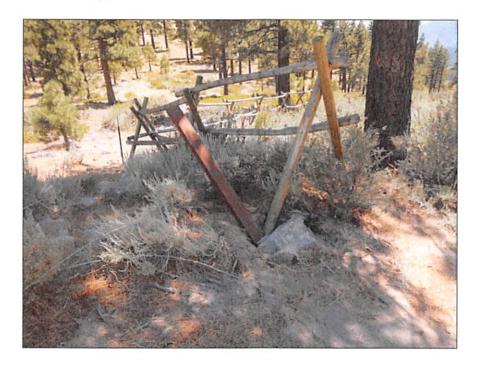
Photos taken July 18, 2013

On July 18, 2013, Mr. Paul Schmidt, the volunteer ranger for the Open Space Program, reported significant damage to the entrance gate to Horsecreek Ranch. Staff responded and inspected the property for further vandalism. The two lower gates remained closed, the cabins were secure, and no other damage was evident. Mr. Fagen paid for repairs and requested additional patrol from Carson City.
