STAFF REPORT

Agenda Title: <u>For Possible Action:</u> Discussion and possible action regarding the annual monitoring report for the Horsecreek Ranch Conservation Easement for 2021.

Exhibit A: 2021 Horsecreek Ranch Conservation Easement Monitoring Report

<u>Date:</u> October 21, 2021

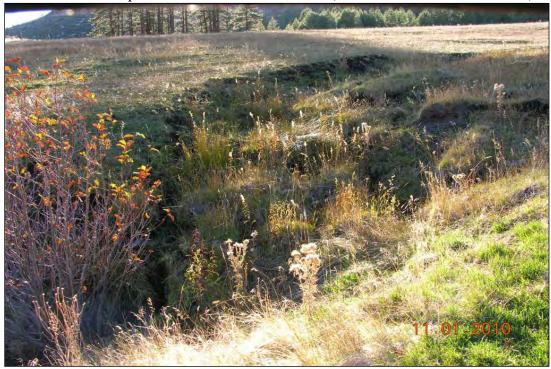
Near the southeast corner, one specific area is being monitored for landscape change. This low drainage area of the meadow appears to be vegetated and stable, though a few isolated mounds or hummocks may be the result of cattle trampling. A qualitative assessment with the photo comparisons may be deceptive due to the time of year each photo was taken – either during the growing season or at the end of the season after grasses were grazed and/or senesced. However, monitoring completed in 2021 just followed a rain event and illustrates that the erosion is slightly increasing in the hummocks area. Additionally, the new headcut observed in 2017 on the creek northeast of the cabins was monitored in 2021 and appears to be revegetating naturally, although certain pockets showed signs of scouring with new soil exposed. This site and associated reach of creek should continue to be monitored in future years to confirm successful revegetation of the headcut, or to document change in size or location, as it could migrate upstream. The previous owner of the property, Mr. Fagen had previously applied for USDA EQIP grants to fund the design and repair plan for the existing headcuts on the property. Access challenges and a lack of available contractors willing to complete the work prevented successful funding awards for this project. In the future, a conservation organization such as the Great Basin Institute or Nevada Division of Forestry could be contracted to complete the work through non-mechanized means, which would mitigate the access and contractor availability challenges. We advise mitigation to be explored and hope a repair design is revisited.

2010 Condition, photo taken November 1, 2010 (initial assessment – view west)

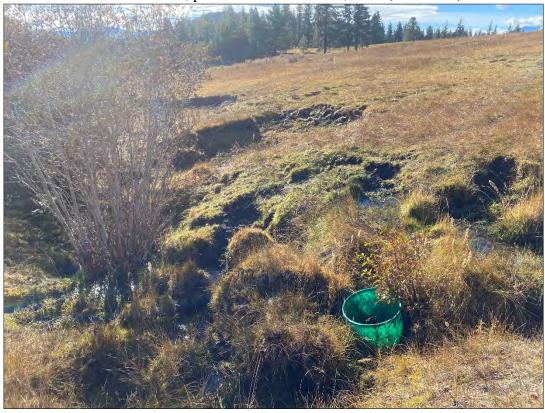
2021 Condition, photo taken October 21, 2021 (view west)

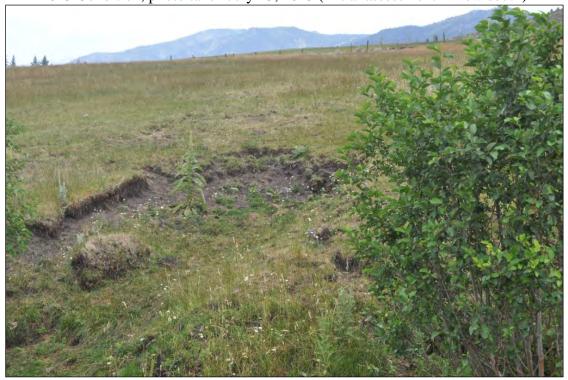
2013 Condition, photo taken July 23, 2013 (initial assessment – view south)

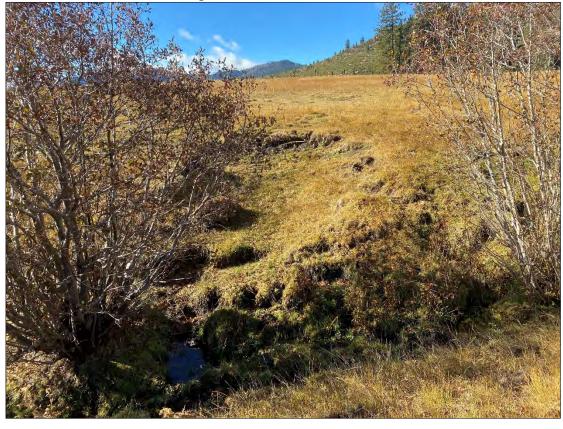
2021 Condition, photo taken October 21, 2021 (view south)

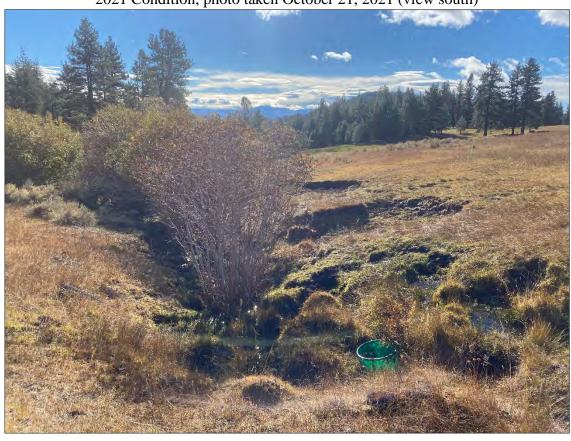
2021 Condition, photo taken October 21, 2021 (view south)

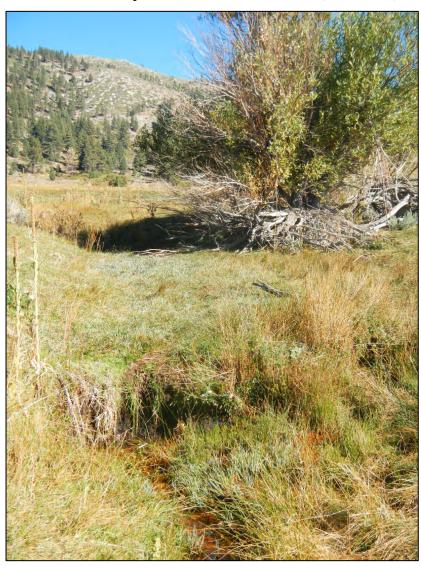
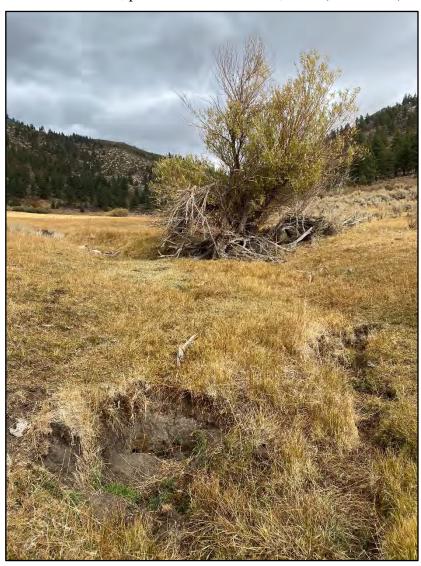
Photo Point: The photo of this headcut, located northeast of the cabins, has been included to document stream channel changes and erosion. N 39 07' 51.0" W 119 50' 11.4"

2021 Condition, photo taken October 21, 2021 (view north)

- 1) Continue to work to identify a mitigation strategy and repair plan for existing headcuts to be implemented in 2022.
- 2) Continued removal of bull thistle and potential forest thinning if possible.
- 3) Gate improvements at Kings Canyon Rd. The gate appears to be rotted and needs maintenance.

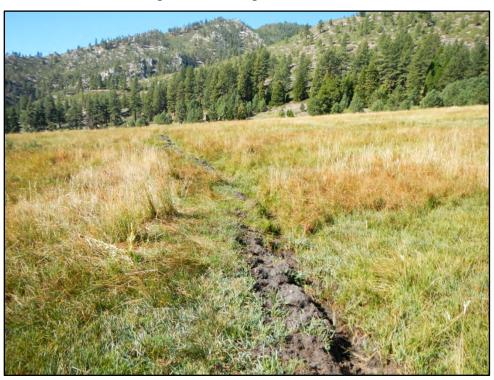
Photo Point: The photo of this lateral irrigation ditch, located in the upper meadow, has been included to document site improvements. N 39° 7' 58.1196"W 119° 50' 14.0172"

2019 Condition, photo taken September 12, 2019 (view west)

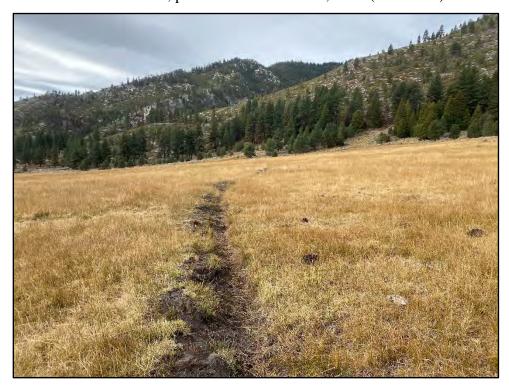
2021 Condition, photo taken October 21, 2021 (view west)

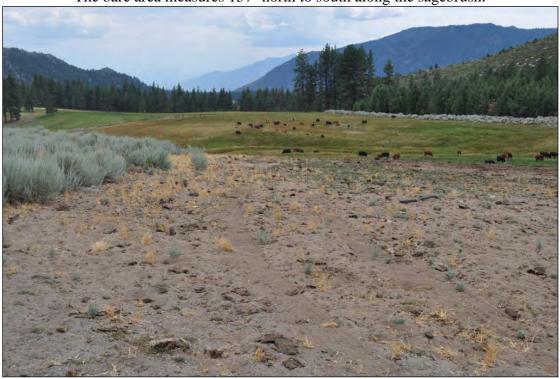
- The previous reports recommended the monitoring of the cattle loafing area located just outside the gated entrance to the cabins with the goal to limit further expansion. The following documentation provides photo points and respective measurements. The disturbed area consists primarily of cheatgrass and foxtail barley although sagebrush is successfully reestablishing on both the north and east edge of the disturbed area. The disturbed area has shown an overall reduction in size over the last two monitoring cycles, and this monitoring period showed that the extent of the loafing area north-south has decreased by 1 foot, while the extent east-west has decreased by 25 feet since 2020. Lastly, it is important to note that depending on the timing of monitoring, cheatgrass abundance and cover varies indicating that cattle are likely grazing the cheatgrass. Cows were not present for this field visit.

2013 Condition, photo taken July 23, 2013 (initial assessment – view south): The bare area measures 157' north to south along the sagebrush.

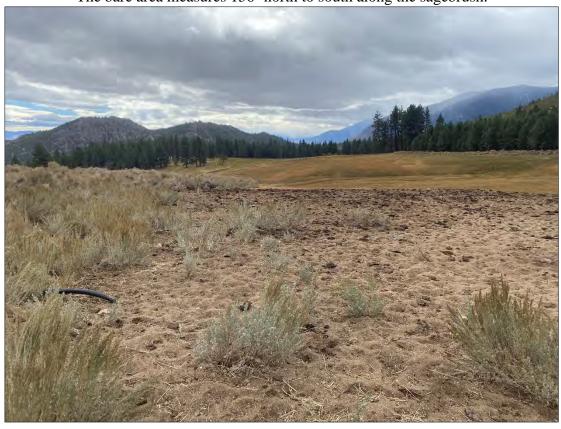
2021 Condition, photo taken October 21, 2021: The bare area measures 156' north to south along the sagebrush.

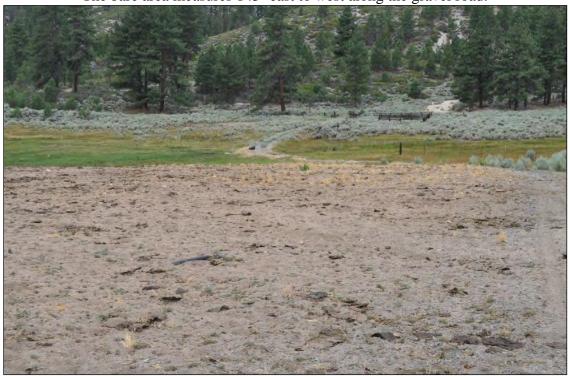
2013 Condition, photo taken July 23, 2013 (initial assessment – view west): The bare area measures 145' east to west along the gravel road.

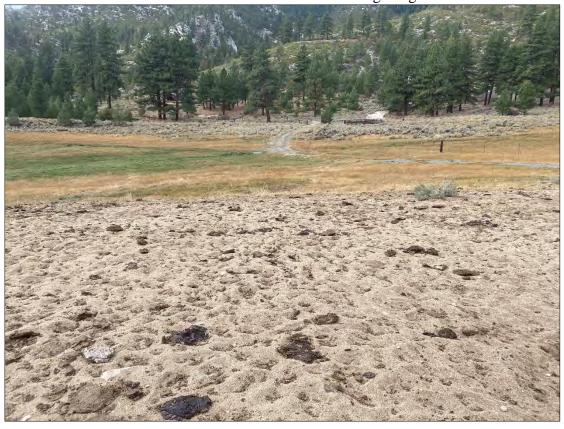
2021 Condition, photo taken October 21, 2021: The bare area measures 120' east to west along the gravel road.

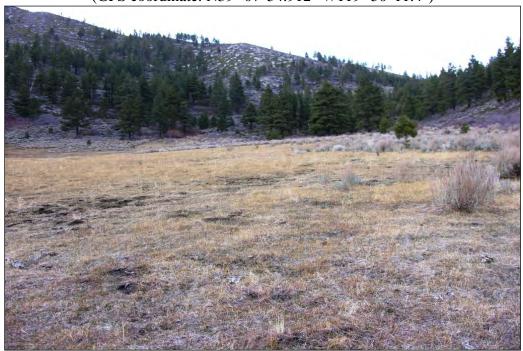
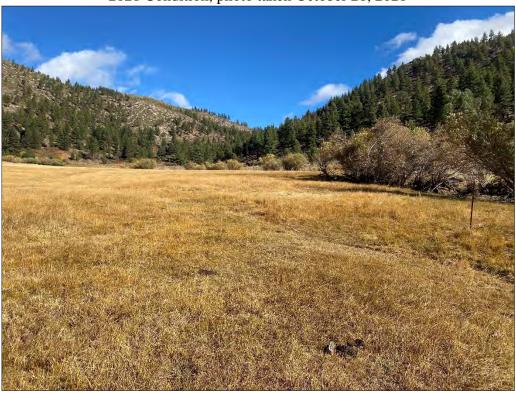
Photo Point 1A (view northeast): A photo point located at the edge of the shrub dominated granitic fan and the irrigated meadow. This would be used to monitor shrub invasion into the meadow area indicating irrigation problems.

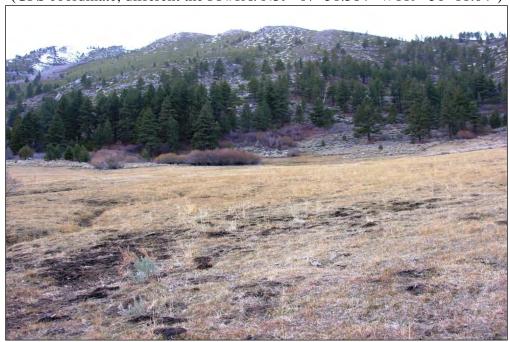
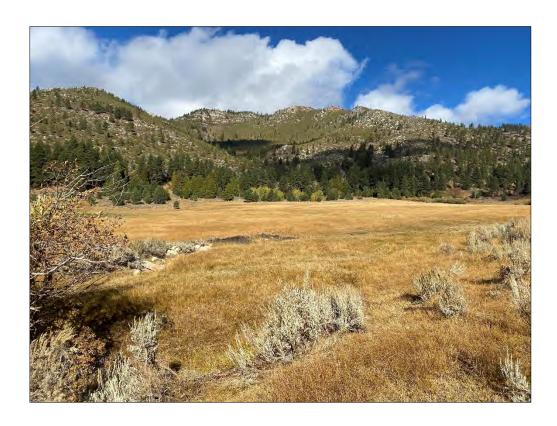
Photo Point 1B (view northwest): A photo point located at the edge of the shrub dominated granitic fan and the irrigated meadow. This would be used to monitor shrub invasion into the meadow area indicating irrigation problems. Note: This photo point is adjacent to the new headcut.

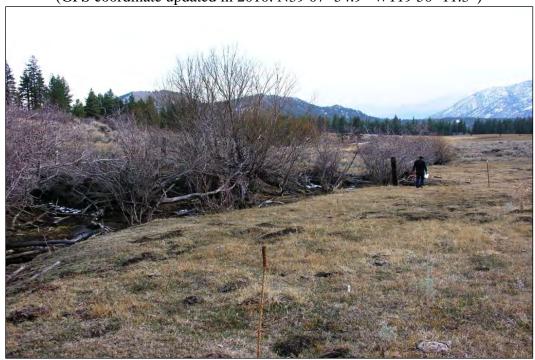
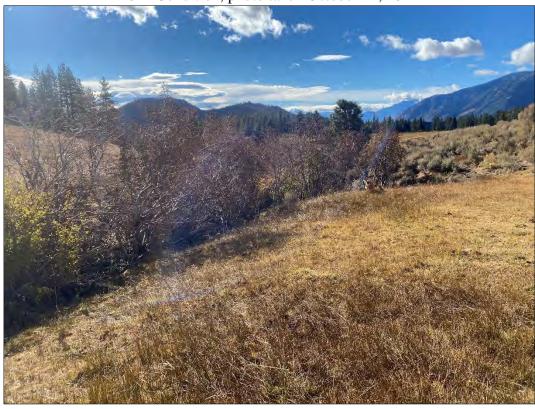
Photo Point 2 (view south): A photo point located in bottom of the active stable drainage channel to the southeast of the house to monitor side slope stability.

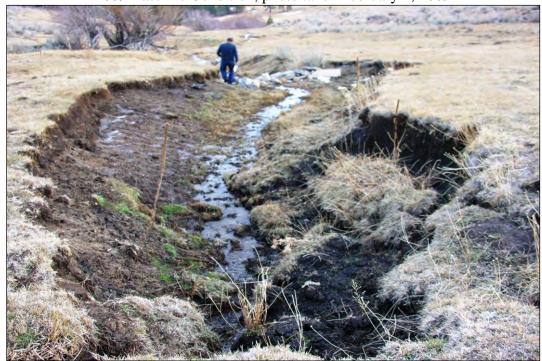
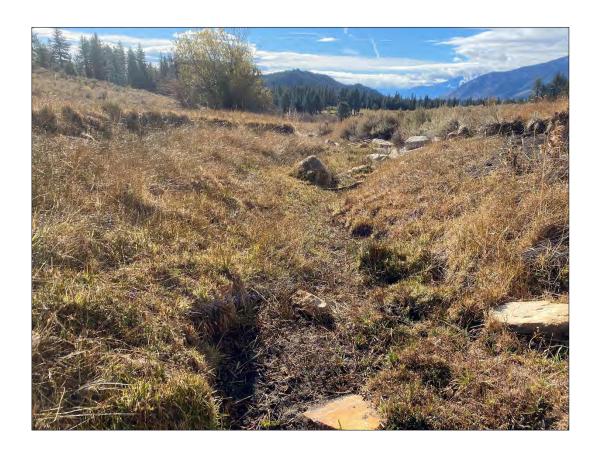
Photo Point 3 (view south): A photo point located immediately east of the house in the active channel where rip-rap has been placed for stabilization.

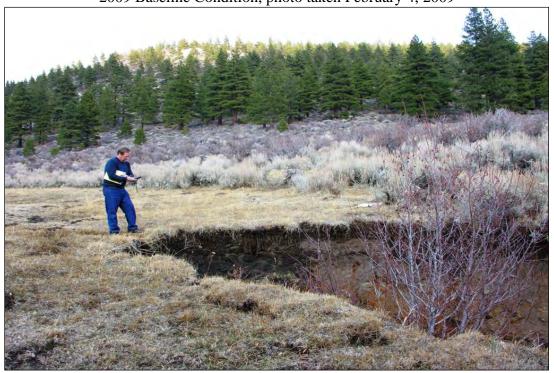
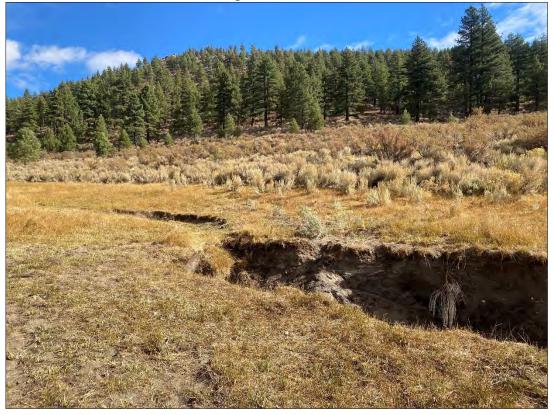
Photo Point 4A (view north): A photo point located at the most northern active headcut after required stabilization to monitor effectiveness.

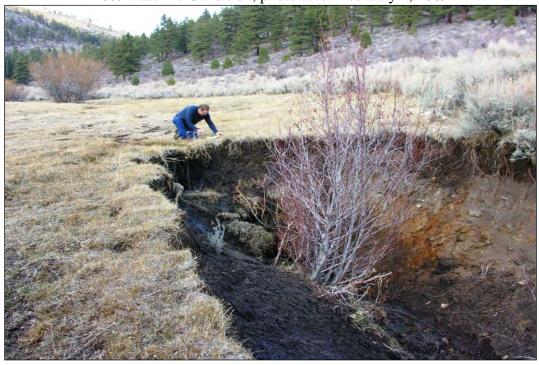
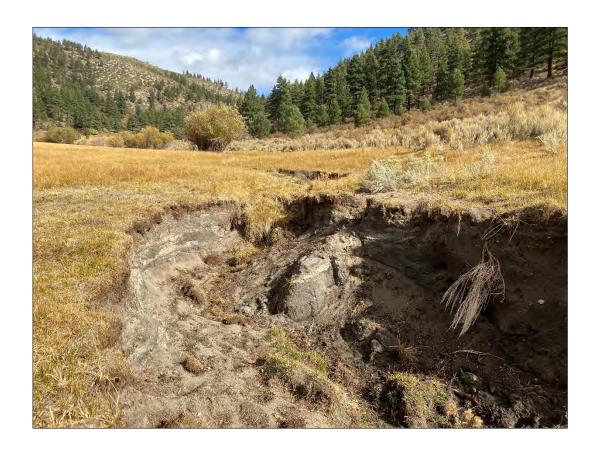
Photo Point 4B (detail): A photo point located at the most northern active headcut after required stabilization to monitor effectiveness.

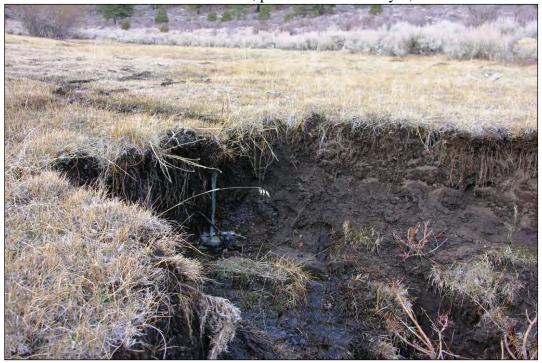
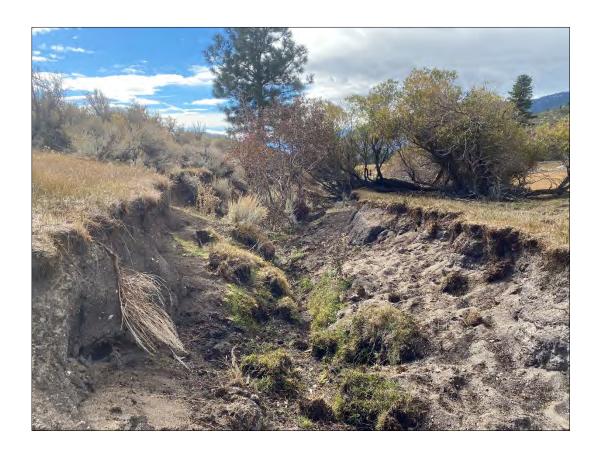
Photo Point 4C (detail): A photo point located at the most northern active headcut after required stabilization to monitor effectiveness.

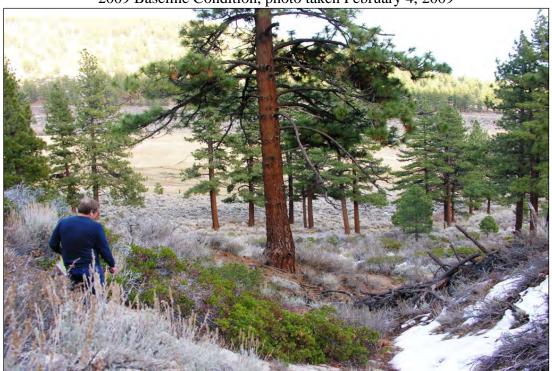
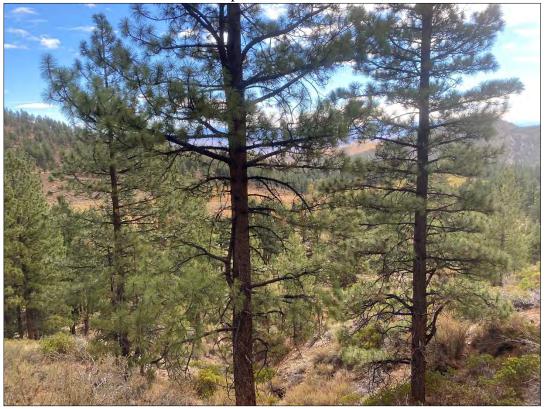
Photo Point 5 (view east): A photo point on the hillside conveyance ditch at a location where a previous washout has occurred to monitor ditch maintenance.

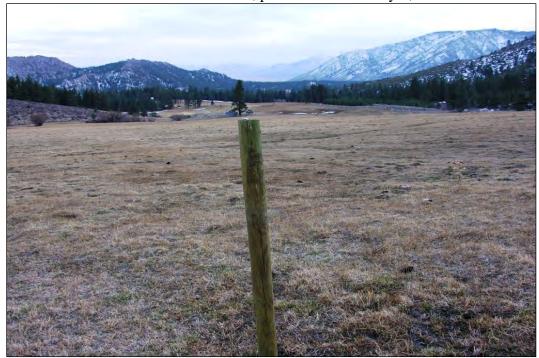
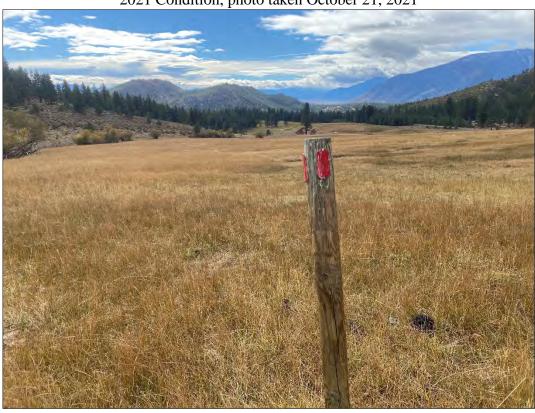
- The Pasture Utilization and Condition Assessment was conducted by Carson City staff and included a visual observation of the monitoring plot as described in the Baseline Condition Report (Photo Point 9). A diversity of pasture, wetland associated (*Juncus*), and invasive grasses (cheatgrass) exhibited various utilization levels depending on species. It should be noted that cover of invasive grasses (cheatgrass) has reduced. Overall, grazing at this location appeared patchy and an average stubble height of 1.25" was recorded.

Photo Point 9: A permanently marked 100' x 100' area to monitor pasture condition. This annual inventory will be used to monitor not only pasture condition but irrigation efficiency, vegetative response to drought and appropriate livestock utilization.
