SUBJECT: **HRC-14-029 – For Presentation and Discussion Only:** *The Future of the Nevada State Prison*, the Nevada State Prison Steering Committee's Final Report to the Nevada Legislature

The Future of the Nevada State Prison

Recommendations to the 2015 Legislature
Pursuant to 2013 Assembly Bill 356

Inventory of Existing Conditions

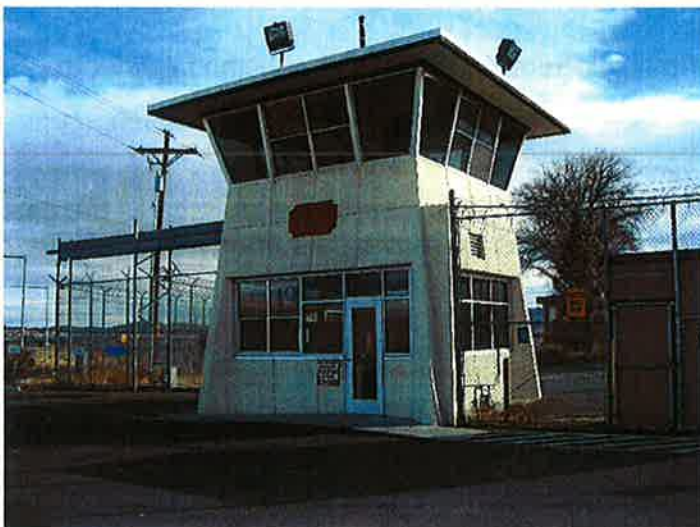
MAIN GATE / TOWER 1

- The Main Gate / Tower 1 is located on the west side of the prison and next to a vehicle gate.
- This building is in generally fair shape.
- The building is a painted precast concrete structure that has two levels.
- It has approximately 450 square feet of space and was constructed in 1963.

- The interior wall, floor and ceiling finishes are in poor condition.
- The interior finishes are faded and damaged to a point where the concrete walls and floors are showing wear and deterioration.

- The building's sanitary wastewater system is showing signs of deterioration.
- The drains operate slowly.
- Deposits within the pipes will cause them to be restricted, which will slow the flow of water.
- This would be an issue if the building were to continue to be operated as a prison security post, 24/7. This is not the case and the system is adequate for the projected needs.

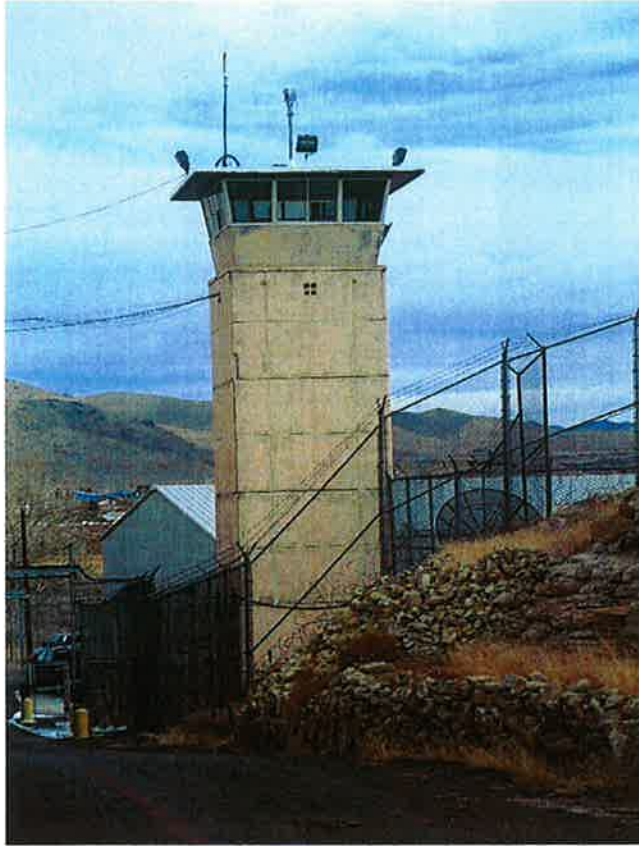
GUARD TOWER 2

- Guard Tower #2 is a painted precast concrete structure with a single-ply membrane roof.
- The tower is located inside of the secured area in the northeast corner of the site.
- It is three stories tall and has a 360 degree view of the prison grounds.
- It has 624 square feet of usable interior space which is accessed via a tall, winding, and intimidating staircase/ladder system.
- The tower is in fair condition.

- The roofing system was replaced in 2004.
- It would on require exterior maintenance for the representation of a prison security post.

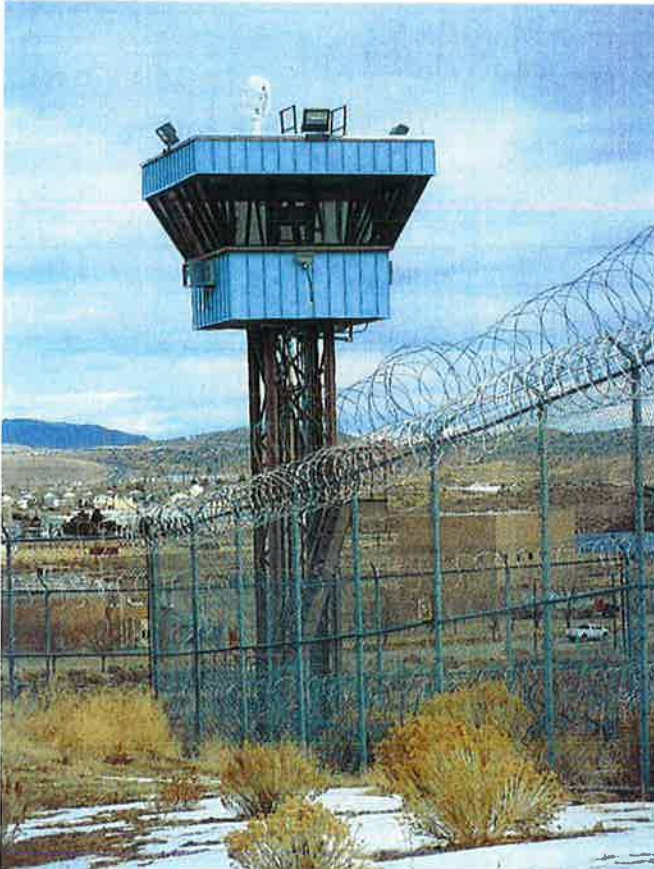
GUARD TOWERS 3 & 4

- Guard Towers 3 and 4 are painted structural steel buildings with metal siding and roofs.
- They are located outside of the secured area in the northeast and southeast corners of the site.
- They were constructed in 1981, to serve as perimeter security for the "hill units".
- The interiors allow for a 360 degree view of the prison grounds.
- The buildings are in fair shape though there are concerns regarding their structures.

- There is no projected use presented for these structures.
- Recommend be maintained in arrested decay.

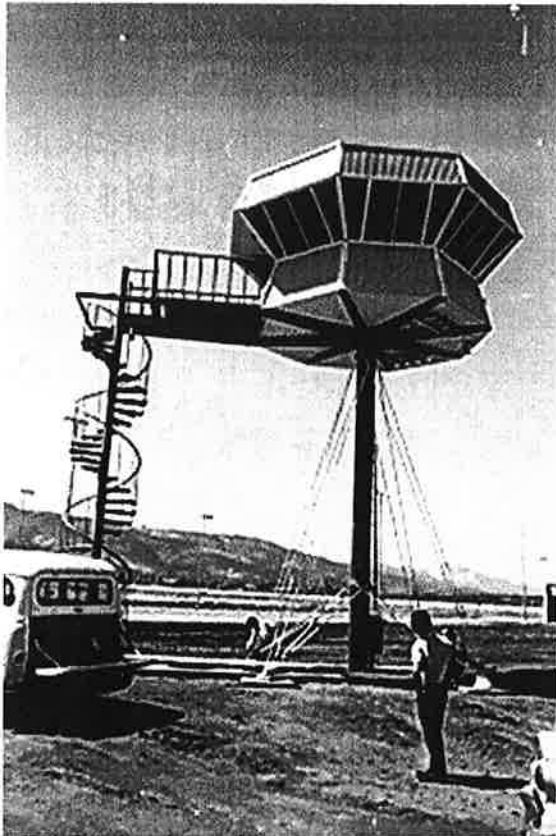
TOWER 5

- Guard Tower #5 is a painted structural steel building (Space Needle) with metal siding and roof accessed by a steel spiral stairway.
- The tower is located outside of the secured area in the southwest corner of the site.
- The structure was constructed in 1966.
- There are windows that allow for a 360 degree view of the prison grounds.
- The building is in fair shape.

- There is no projected use presented for this structure.
- Recommend be maintained in arrested decay.

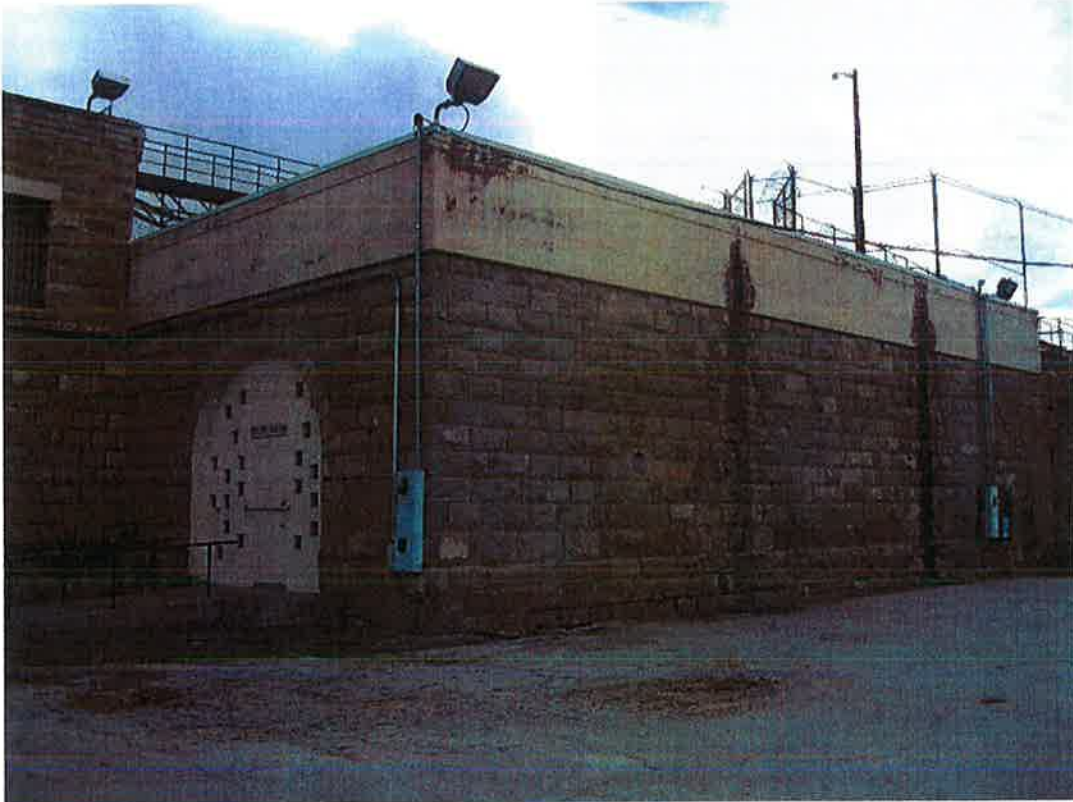
COURTHOUSE

- The Courthouse is a stone masonry structure with a single-ply roof membrane.
- This building is attached to the Administration / Cell Block building and is one of the oldest structures on site.
- It was originally constructed in the 1927-28, as a sally port for major vehicle access to the old prison yard.
- It was covered with a roof in the 1960's as a construction project by the Synanon Foundation to provide 1,475 square feet of interior space.
- It then served as a chapel and offices for caseworkers.
- The facility was remodeled for court proceedings.
- The building is in fair shape

- The interior finishes are in fair condition.
- It is recommended that the interior walls be painted at least once in the next two to three years.
- The interior floor covering is mostly carpet and is showing signs of extreme wear.

- Several areas are worn out and tears are evident throughout the carpeted areas causing a tripping hazard.
- This flooring should be replaced with carpet tile to allow for future replacement of only those sections of carpet that are worn or damaged without the need to remove the entire carpeted area.

- This replacement would cost approximately \$15,000.
- The building has a suspended acoustical tile ceiling system.
- The T-bar framing is bent and rusted in many areas and a number of the ceiling tiles are damaged and stained.

- This 1927-28 portion of the structure should be retrofitted to meet today's seismic standards.
- This project would cost approximately \$75,000.
- It is recommended that the building be painted in the next 3-5 years.

- The replacement of this ceiling system would be nice but not immediately necessary at this time, regardless of its use.
- The estimate for this ceiling replacement is \$15,000.

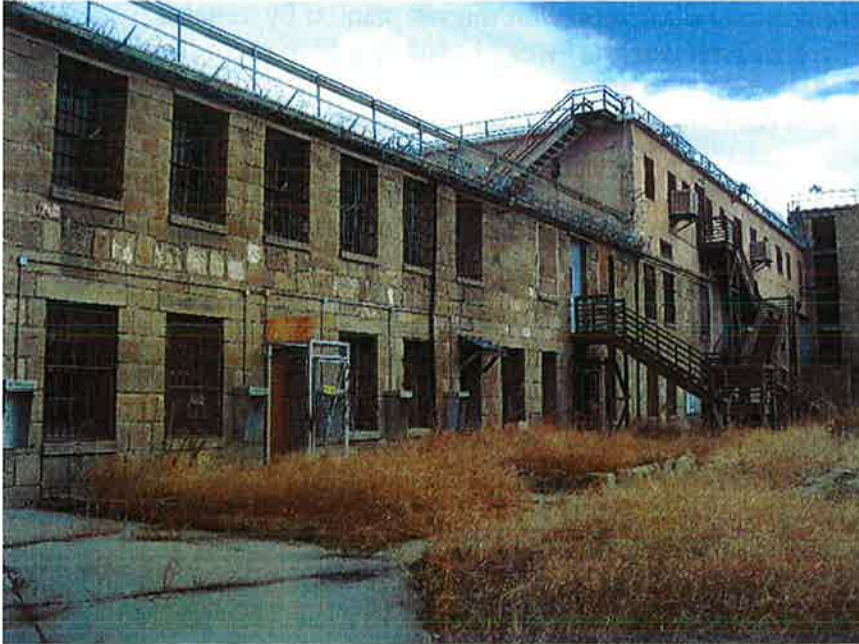
NORTH WING (Hospital Wing)

- The northern wing of the structure housed a complex assortment of functions.
- There is an access to a cellar area, called "Sagebrush", after the inmate newspaper that was once published by them.
- Today it simply provides access to some utilities.
- The first floor of the wing contained large, open, shop areas.
- These spaces are dim and worn, but could be remodeled for office or file space on an easily accessible ground level through doors that are outside the secure area of the structure.

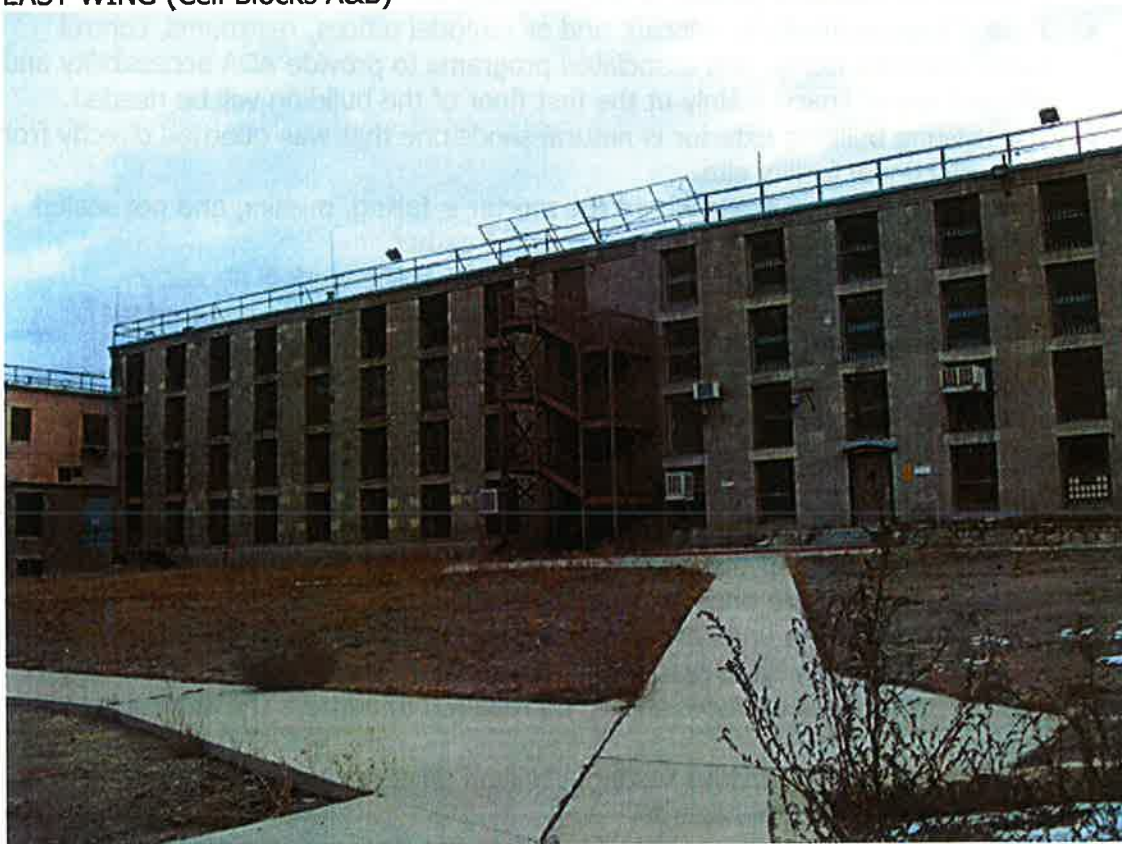
EAST WING (Cell Blocks A&B)

- The existing building exterior is natural sandstone that was quarried directly from the correctional facility site.
- There are numerous areas where the mortar is failing, missing and not sealed properly due the age and exposure to the weather.

- Some of the window units are cracked or damaged, seals are broken, are difficult to operate and they have reached the end of their useful life.
- Prior to painting, all surfaces should be repaired to address the extensive wall issues.

- The existing concrete stairs are showing signs of wear and deterioration.
- Floors in this building are concrete and require no work for any proposed use.

- Electrical and plumbing access is through a "pipe chase" that runs through the center of the building.
- These utilities are worn and inadequate for use as an institution.

- The utilities are not a significant issue for the proposed uses of the structure.
- Some of the domestic water and waste lines have been damaged or shut down, mainly water in Unit 2 and 5 and waste lines in Unit 2.

- There is no cooling except for numerous evaporative coolers mounted on the roof of Unit 3 which are not ducted to all levels of the structure
- The majority of the utilities in the Cell house are located in the "pipe chase" and are original, with a few areas repaired or replaced.

- At the time of the 2009 survey, all of unit 5 and some of unit 3 were having problems and the system was not 100 percent operational. Some of the pipe, hangers, connectors and couplers are deteriorating and water leaks are developing.

- Dielectric corrosion is occurring between different types of pipe metals, internal corrosion is occurring on the 4" pipe and compression clamps are located in areas where leaks have occurred.

- Other small repairs have been done over time as needed to keep system operational.
- A break in the pipe has the potential to short out the power supply, alarm system, flood the lowest levels of the building and presents a safety hazard.

- A project for replacing the utilities in the "Sagebrush" basement area was completed in 2001.
- This building is equipped with an automatic fire detection and alarm system, but the system is old, does not meet current code requirements and is missing in some locations.

- The sewer / waste water infrastructure in the building is over 50 years old except for some small areas that have been repaired or replaced over the years as needed.

- Some of the sanitary sewer pipe, hangers, connectors and couplers have or are deteriorating to a point where raw sewage may be leaking in some areas.

- The waste vents in the cell block chases are too close to the exhaust vents on the roof and in unit 5, some have been damaged and does not vent properly.

- Cleaning, repair and re-pointing of the exterior stone work is necessary.
- Due to the vertical nature of the building, scaffolding will be required to accomplish this project.

- Not included in the previous testing was lead paint encapsulation and other possible environmental hazards.
- The cost of this inspection would depend on the intended use of the various portions of the structure.

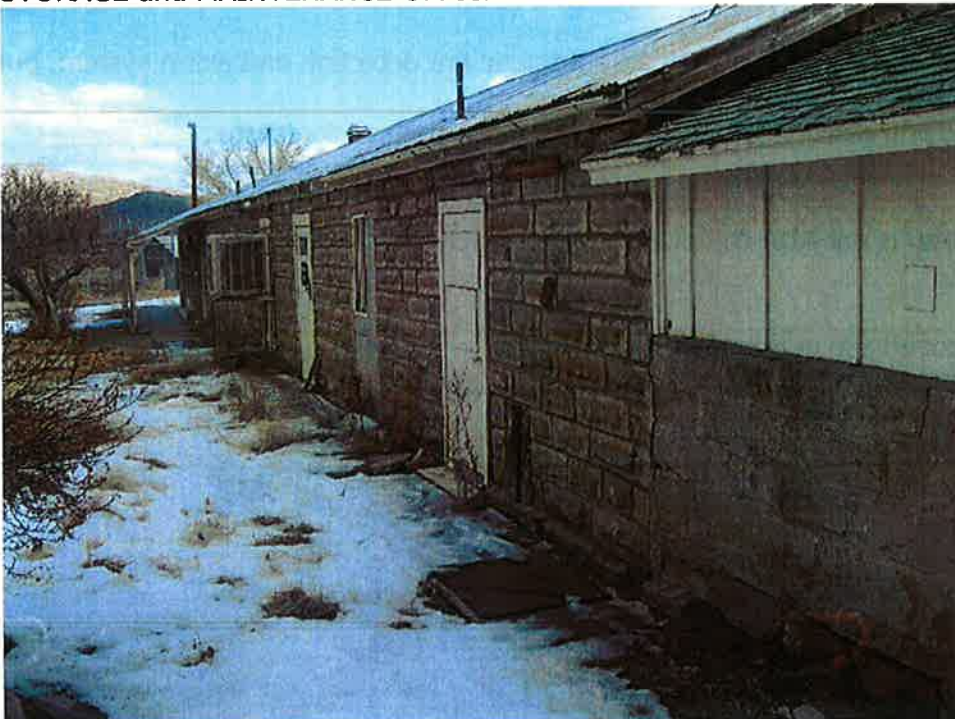
STORAGE and MAINTENANCE OFFICE

- The Storage and Maintenance Office is a stone masonry and wood framed structure on a concrete slab-on-grade.
- The building has low hazard storage adjacent to the welding shop.
- The roofing is corrugated metal.
- The building contains small office areas, storage areas, a welding area and restrooms in roughly 3 separate spaces and three different occupancies.
- Some portions of this structure are over 50 years old.
- 2,190 sf.
- Constructed in 1952
- The structure is in fair shape.

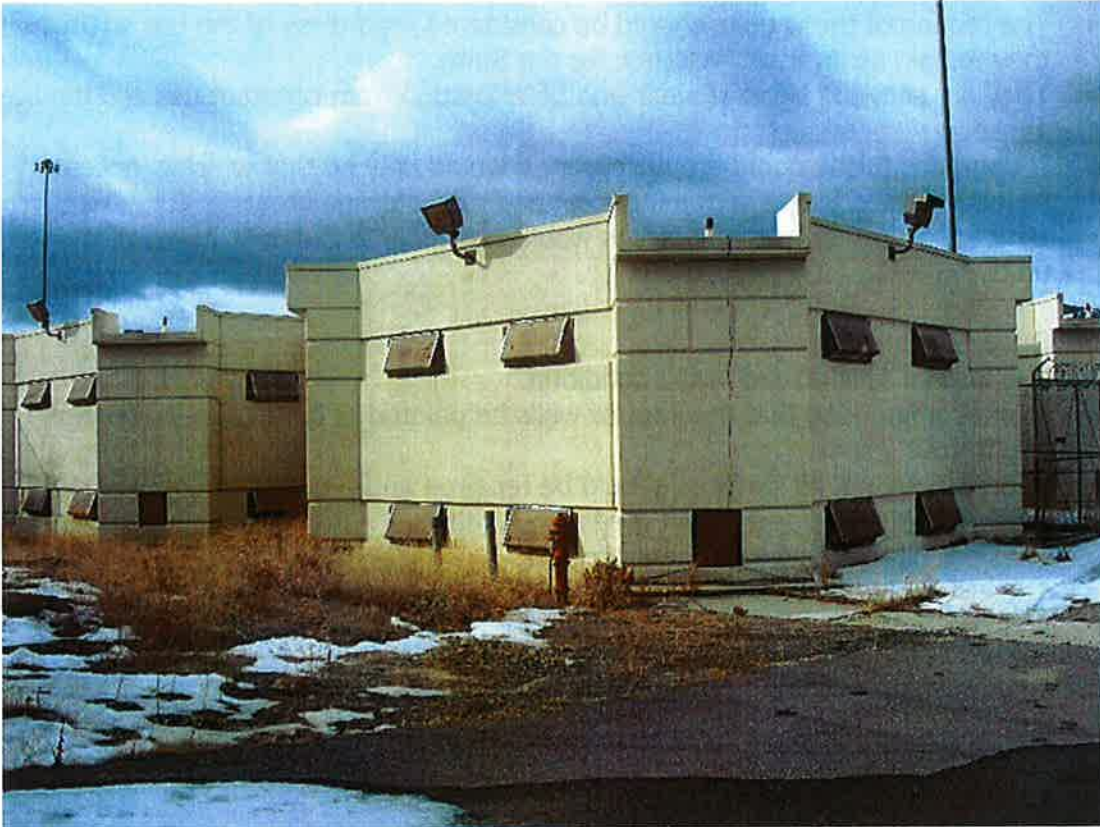
UNITS 6-7-8-9-10-11

- These housing units are known as the "Hill Units" and are painted precast concrete structures with single-ply membrane roofs
- Each contain 48 cells for 98 inmates, showers and a central control room all on two levels.
- The units are in fair shape.
- Each unit has 7,801 sf of space and were constructed in 1981.

contributing factors to wear and deterioration. The current roofing system was installed in 1995.
