4.4 Siding and Trim Design Guidelines

**GUIDELINES FOR
EXTERIOR WOODWORK**

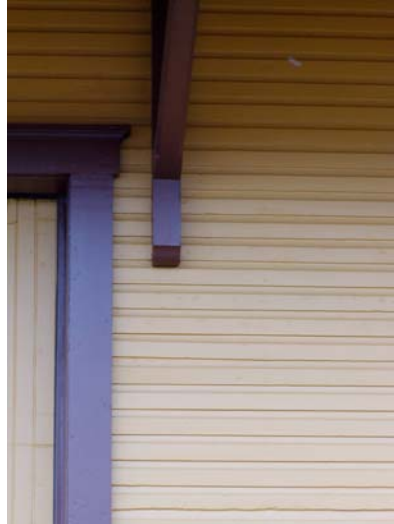
TYPICAL ‘LAPPED’ SIDING

Wood siding typically used in Grapevine houses are horizontal siding with either a top front rabbet and a bottom rear rabbet that lap the board below or tongue-and-groove edges; this siding is installed directly against the wall (exterior studs) of the house, and is commonly referred to as ‘drop’ or novelty siding.

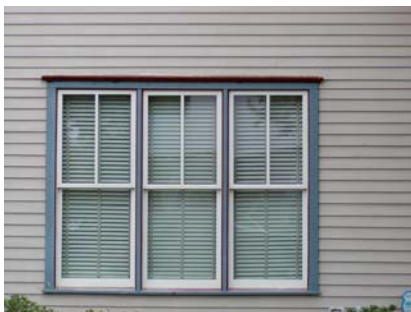
TYPICAL NOVELTY SIDING

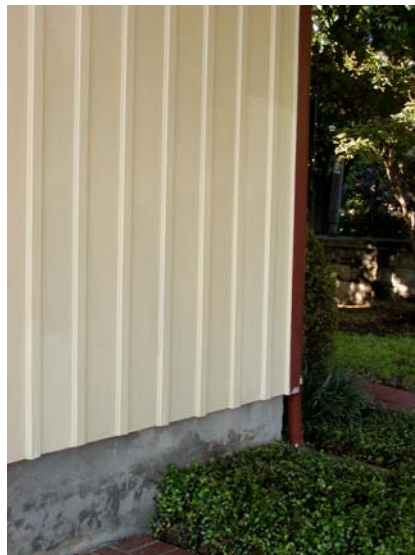
BOARD AND BATTEN SIDING

Board and batten siding is also a common siding type and is used at the side and rear of commercial properties, some houses and particularly at accessory buildings. Wide vertical boards are applied directly to the structure, and are then covered at the joints with narrow boards (battens). A ‘reverse’ board and batten siding has the smaller boards (battens) applied directly to the structure with the larger boards at the top.

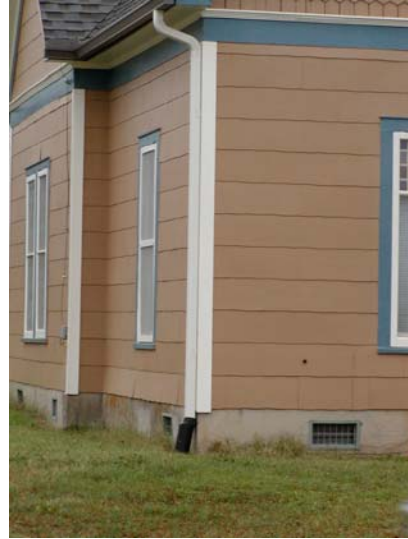
**ASBESTOS SIDING which
RETAINS THE WINDOW TRIM,
CORNER BOARDS and FASCIA**

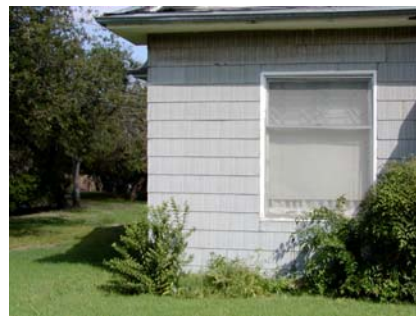
**ASBESTOS SIDING with
HISTORIC TRIM REMOVED**

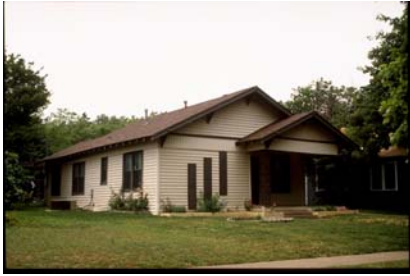
METAL SIDING with CHANGES AT WINDOWS and LOSS of MAJORITY OF TRIM

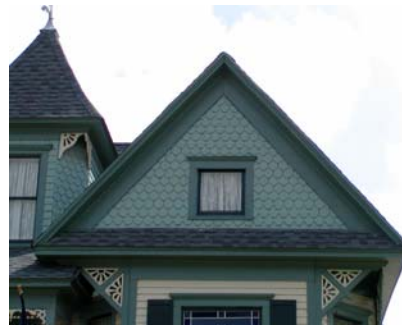
TRIM AT A QUEEN ANNE HOUSE: GABLE TRIM, WINDOW TRIM, FINIAL AT ROOF, TEXTURED SHINGLES AT GABLE and DECORATIVE CORNER BRACKETS.

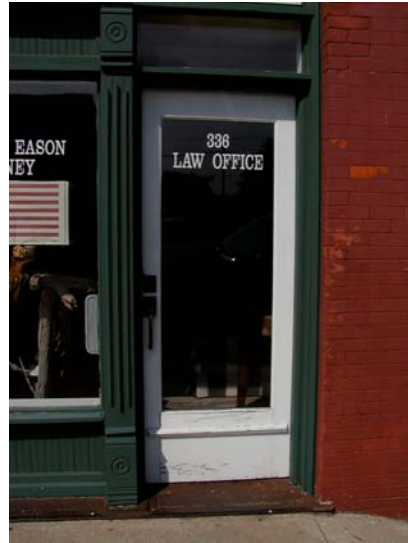
WOOD TRIM at DOORS, WINDOWS and BASE OF SIDING at COMMERCIAL STOREFRONT REINFORCES TRIM DESIGN

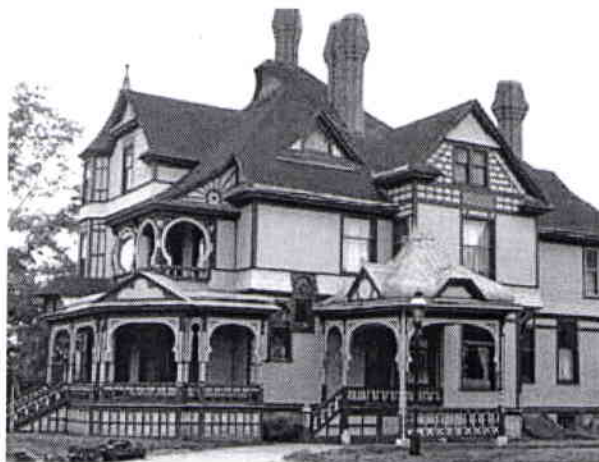
Whether it is used for exterior cladding, roofing, interior finishes, decorative features, or structural members, wood is frequently an essential component of historic and older buildings which should be retained and preserved. Photo: NPS files.

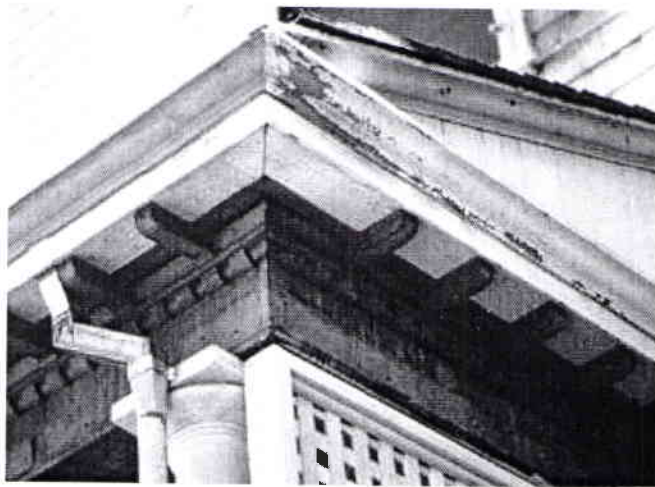
An example of "limited replacement in kind" points out an appropriate scope of work within the treatment, Preservation. Targeted repairs to deteriorated wood cornice elements (fascia board and modillions) meant that most of the historic materials were retained in the work. Photo: NPS files.

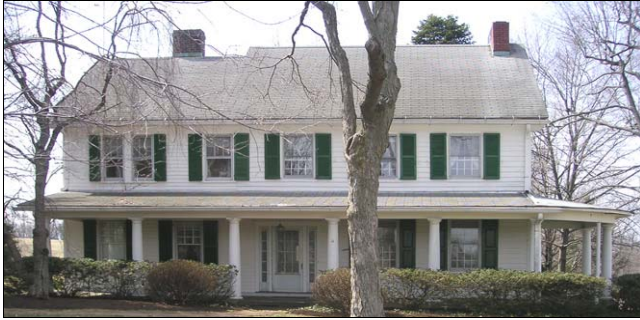
Wood clapboard siding is one of the most common historic exterior wall materials in Hopewell Township.

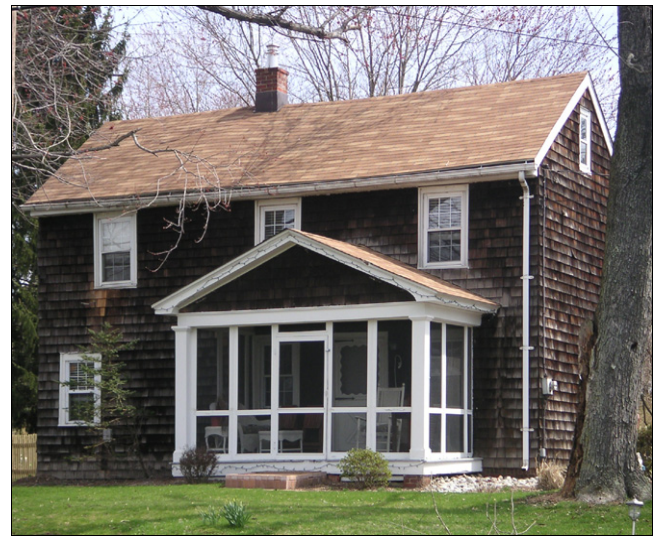
The dark brown color of these stained beveled shingles blends with the natural surroundings.

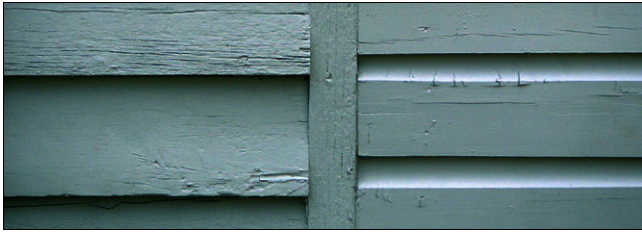
The original building to the left has clapboard siding, and the later addition, located to the right, has German siding.

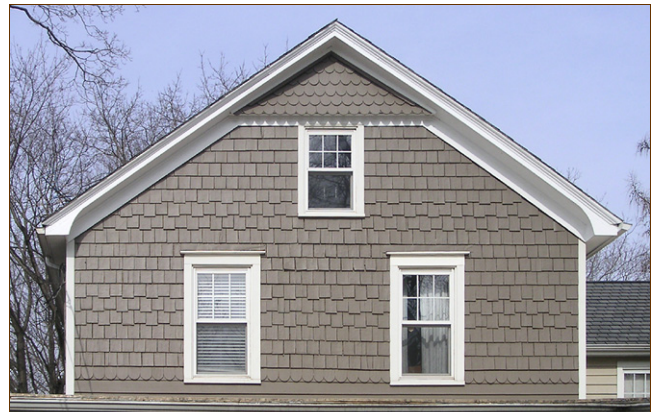
This house combines fishscale, beveled and staggered shingles.

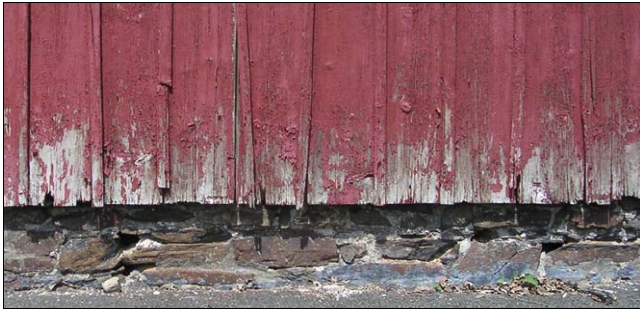
Historically board and batten siding was typically used for secondary buildings and farm structures. This example includes visible signs of deterioration. Problems include bare wood from peeling and missing paint, splitting or checking along the bottom edges of the siding, and unsecured battens.

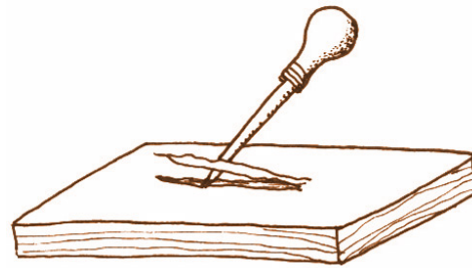
Less penetration and long splinters are an indication of healthy wood

- If the penetration is less than ¼ inch, the component does not need replacement
- If the penetration is more than ½ inch, the component might need replacement
- If long splinters are produced, the wood is healthy and the component does not need replacement
- If short sections broken across the grain are produced, the component might need replacement

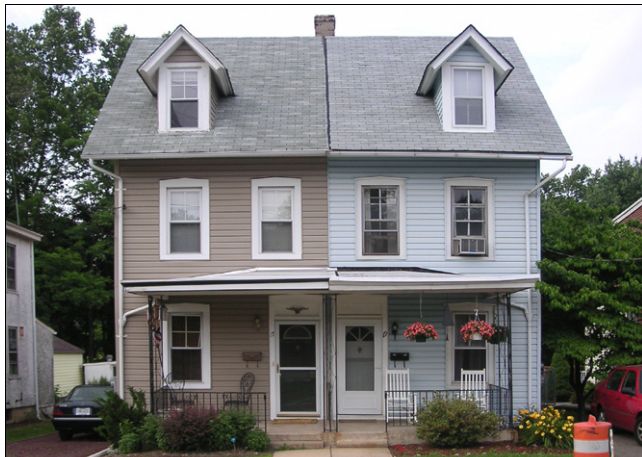
Vinyl siding of different colors has been installed at each residence. The siding is not aligned and obscures wood window surrounds.

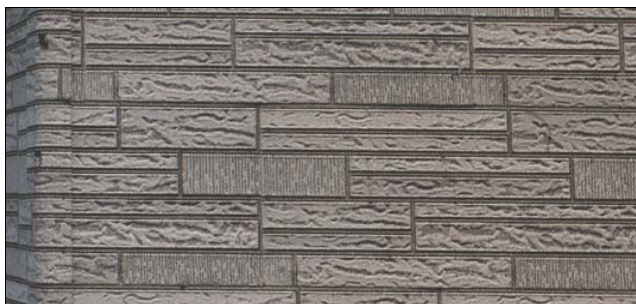
Asphalt siding often simulates brick or stone wall surfaces.

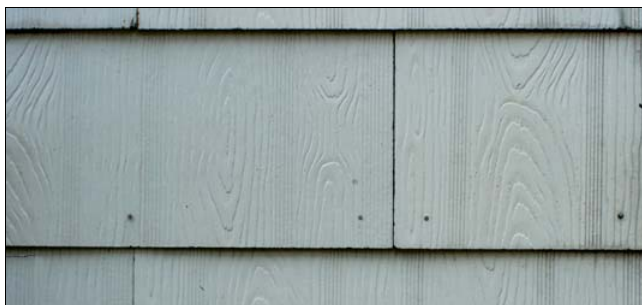
Asbestos siding is often embossed with a wood grain pattern. The removal of asbestos siding can be dangerous and should be undertaken by trained professionals.

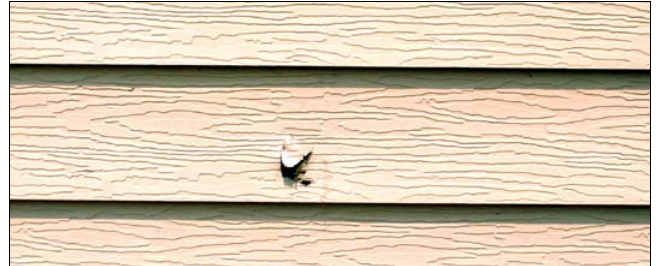
If considering artificial siding, a smooth finish is recommended rather than a wood-grain finish. Replacement of this aluminum siding section would be the best way to repair the puncture. Since siding colors tend to fade from sunlight, the replacement siding probably would not match the existing siding.

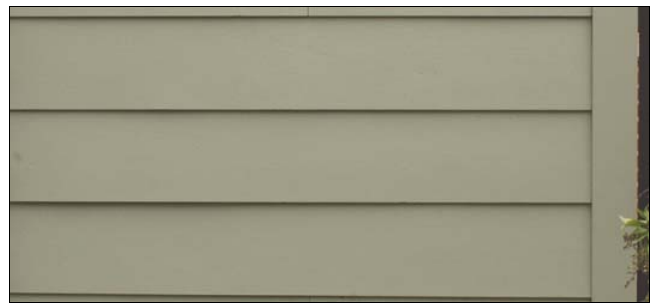
Fiber-cement siding material is a good economical alternative for an addition to an historic house. The surface of the Hardiplank siding above was painted to match the existing paint scheme.

Fiber-cement siding is a lightweight, solid material that is a durable and visually more compatible material to wood than vinyl or aluminum siding. It is manufactured in similar sizes and shapes to wood products including siding, shingles and trim, making it easier to duplicate historic characteristics. The installation method is similar to wood, and it can be cut to shape on-site using hand tools, and painted to match any color scheme. Manufacturers indicate that fiber-cement products are resistant to rot, termites, fire and delamination, and are dimensionally stable, allowing paint to last longer. Fiber-cement products cost more than vinyl or aluminum siding but much less than wood siding. They are increasingly common in this region, and some manufacturers offer warranties for as long as 50 years.

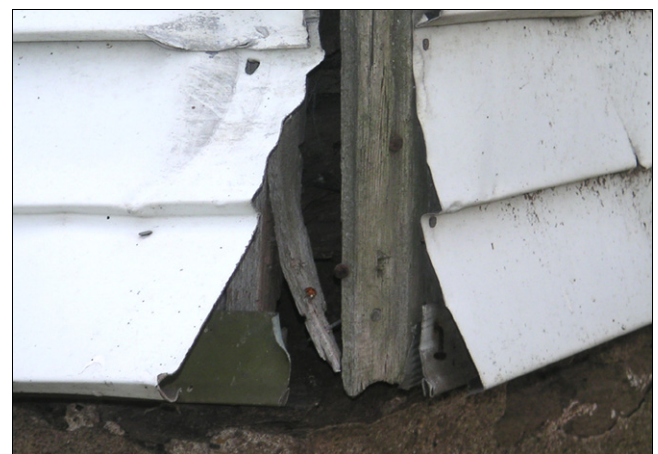
The wood siding remains under the aluminum siding.

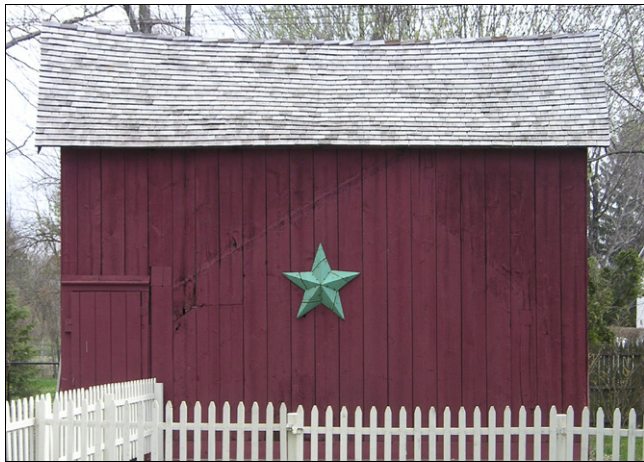
Agricultural outbuildings historically were typically painted red and usually featured vertical board or board and batten siding.

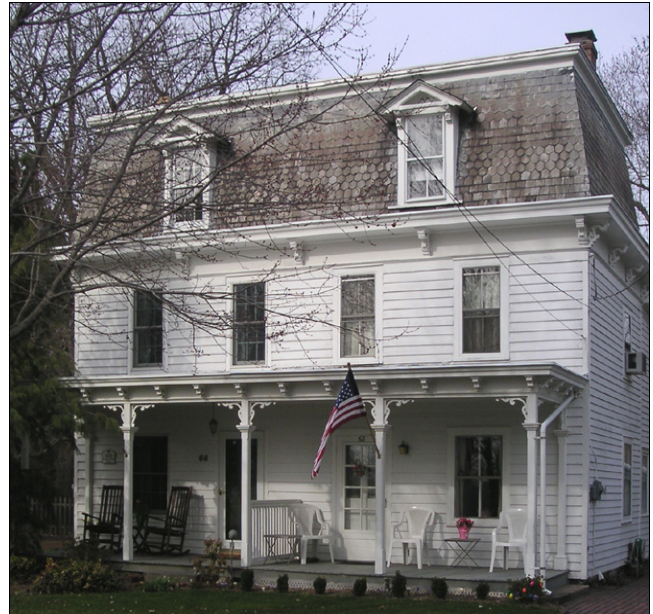
The owners of each half of this semi-detached house applied a uniform paint scheme, making it appear like a larger single home. Architectural woodwork details including the overhanging cornice, decorative brackets and porch posts remain and provide architectural richness.

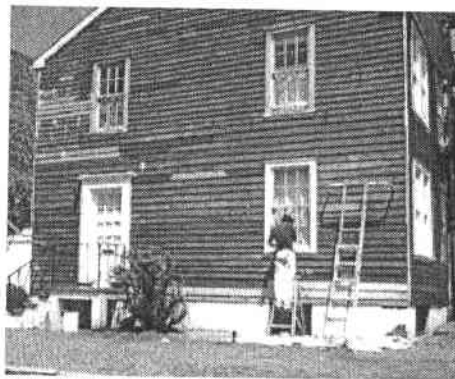
Repair may also include the limited replacement in kind--or with compatible substitute material--of those extensively deteriorated or missing parts of features where there are surviving prototypes such as brackets, molding, or sections of siding. Limited replacement-in-kind of deteriorated wood clapboards is shown at left.
