33 PRESERVATION BRIEFS

The Preservation and Repair of Historic Stained and Leaded Glass

Neal A. Vogel and Rolf Achilles

National Park Service
U.S. Department of the Interior

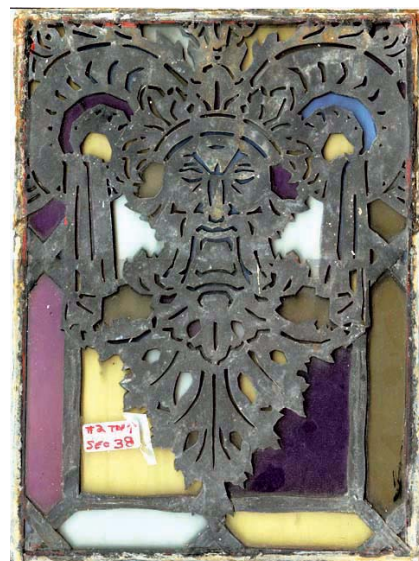
Figure 10. This lead-silhouette stained glass face graces a 1928 coach house in Buffalo, and is attributed to D'Ascenzo Studios of Philadelphia.

Some creative efforts expanded leaded glass media in new directions. Lead-overlay or “silhouette” glass was one novelty that climaxed in the late 1920s and early 1930s. Some designers sandwiched glass between layers of hand-cut sheet lead, while others sandwiched the perforated sheet lead between layers of glass. These windows present a playful reversal from traditional stained glass; in “silhouette” glass the lead metalwork, rather than the glass, becomes the primary art form (Fig. 10). However, such novelties failed to catch on during the Depression. World War II delivered the final blow and ornamental glass is seldom found in residential, commercial, and secular architecture after circa 1940. The great age of American stained glass was over. Fortunately, leaded glass panels survived in uncounted numbers throughout the country, and are now once again appreciated as virtually irreplaceable features of historic buildings.

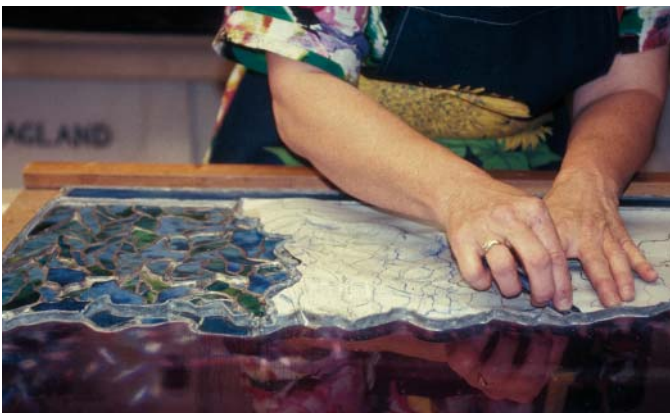
Figure 14. The external glass plate has been removed to clean the interlayer of this plated Tiffany Studios window.
