HAMM BUILDING ST. PAUL, MINNESOTA

HISTORIC GLASS NUMBER 1

Repair and Reproduction of Prismatic Glass Transoms

Chad Randl
Technical Preservation Services
National Park Service

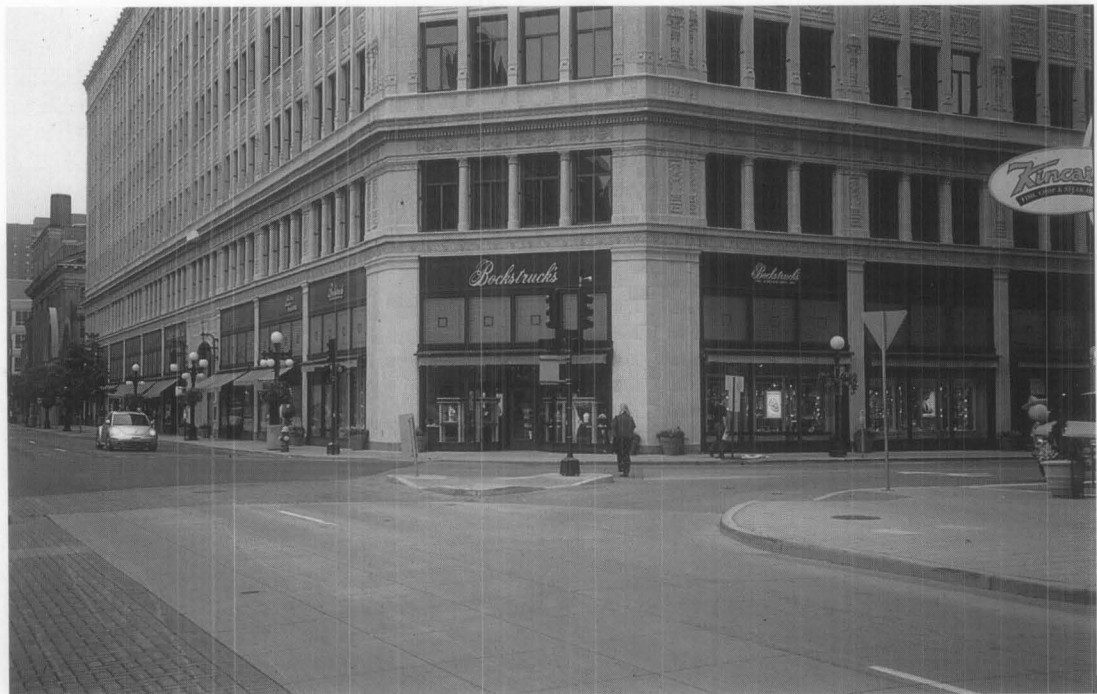
Figure 2. The Hamm Building featured fifty-six prismatic panels set directly above the awnings. Each panel contained over two hundred individual tiles. Photo shows completed project. Photo: Chad Randl

Another important feature of the Hamm Building exterior was the large band of prismatic glass located just above the storefront awnings (see figure 2). Divided into groups of three and four panels separated by terra cotta pilasters,

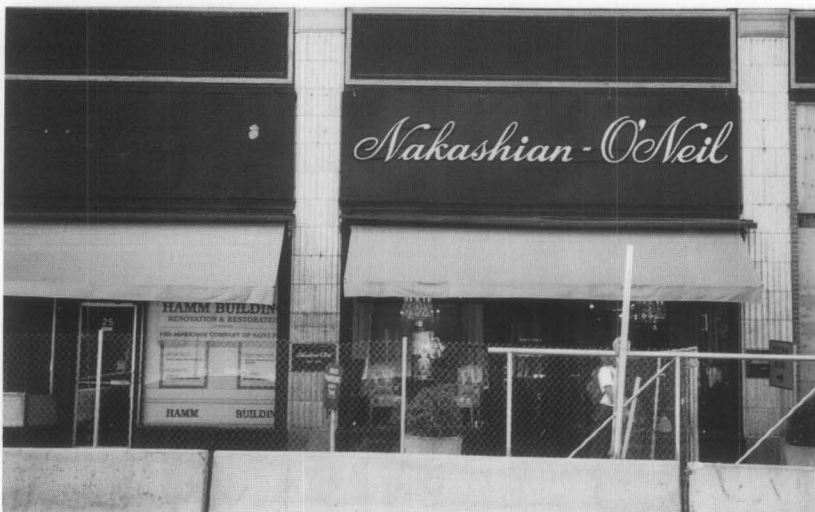
When the Hamm Building was rehabilitated beginning in 1996, plans were made to return the prism glass transoms to their historic appearance. At the time, all but sixteen of the panels were obscured behind plywood sheets (see figure 4). Installed decades before, the covering was probably a response to the gradual deformation of the assemblies and water infiltration that resulted from deferred maintenance. The desire for a more contemporary appearance and more prominent sign

Figure 4. When the Hamm Building rehabilitation began, most of the prismatic tiles (above the awnings) were hidden beneath plywood panels. Photo: Oertel Architects.

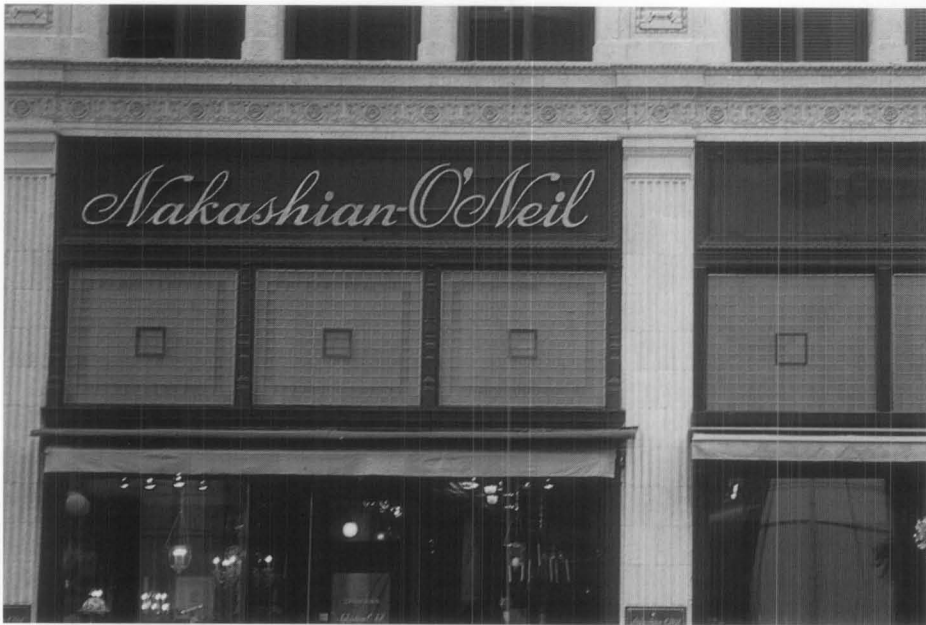
Figure 9. Panels with original tiles are shown on the left next to those featuring replacement textured glass. Photo: Chad Randl.

missing or damaged elements required replacement, new materials approximated the appearance of the original features (see figure 9). Lastly, modifications to the transoms improved the strength of the transoms but did not intrude upon the historic appearance of the prismatic tiles and the Hamm Building exterior.
