### Rock-faced concrete blocks

William Kibbel III, The Home Inspector

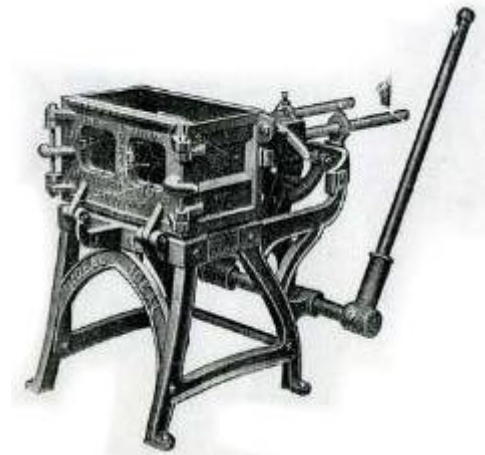
The ornamental blocks for many of these buildings were actually manufactured on-site. There were block making "machines" that were quite portable. They were available in mail-order catalogs, including Sears, Roebuck and Co. These machines had interchangeable face plates to create the surface textures. In addition to the common rock-face, there were also plates to cast blocks with scrolls, wreaths and faceted edges.

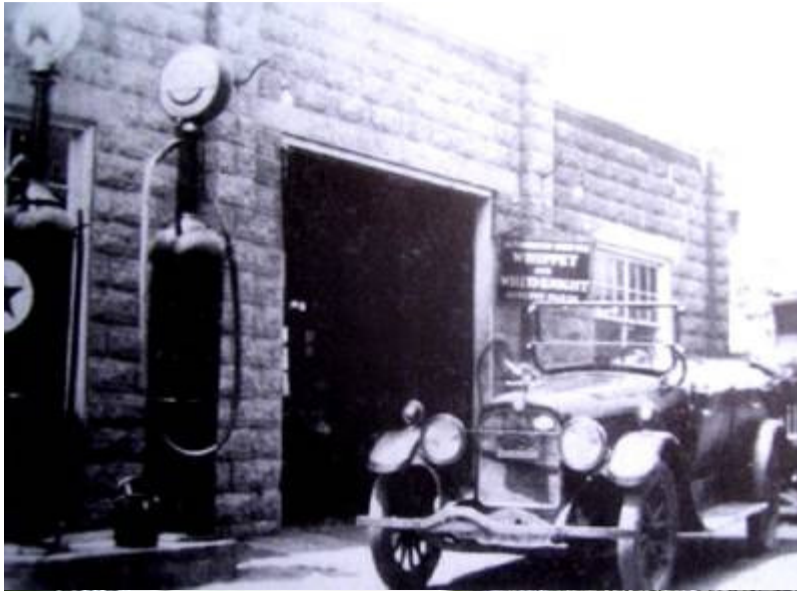
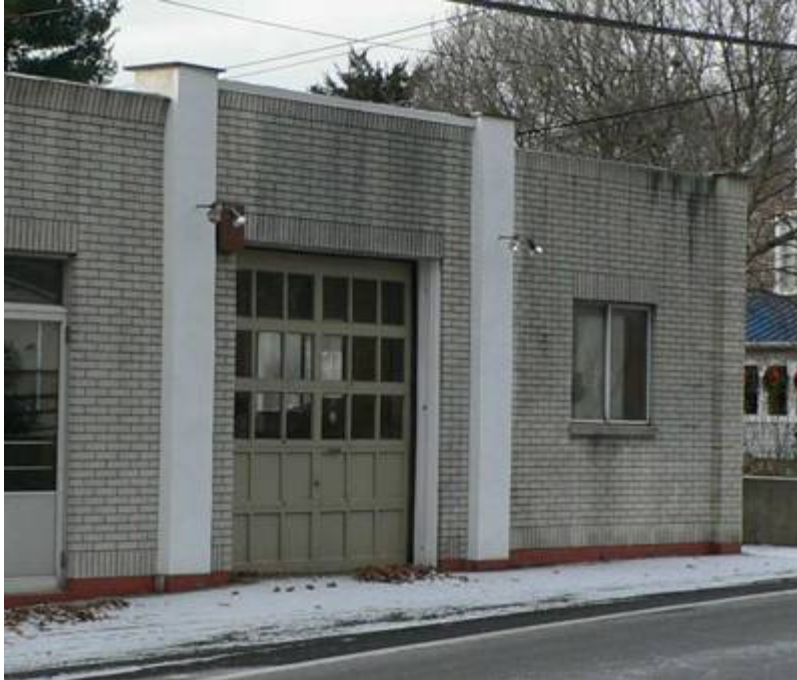
The practice of blocks being cast on-site has no method for quality control. Improper proportions in the concrete mix, not thoroughly mixing the ingredients, too much or too little water and inadequate curing or aging has resulted in some significant failures of the face of the blocks. Individual blocks can be repaired by an experienced mason but the color will not likely be an exact match. If there is significant deterioration to individual blocks, beyond minor cracks, pitting or small spots of disintegration, then replacement may be needed. It can be a major effort to find salvaged blocks with the same pattern. There are some limited reproductions available but an exact match may not be possible.

If there has been deterioration to many of the blocks in large areas, the most common treatment has been to coat the whole exterior of the building with cement mortar. A stucco finish or the cement coating that imitates brickwork has been used extensively over the last 80 years or so. I've found so many that have been obscured by this method
