20 PRESERVATION BRIEFS

The Preservation of Historic Barns

Michael J. Auer

U.S. Department of the Interior
National Park Service
Cultural Resources
Heritage Preservation Services

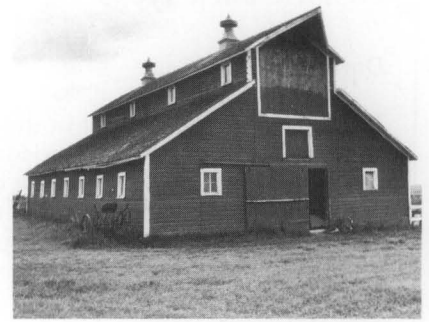
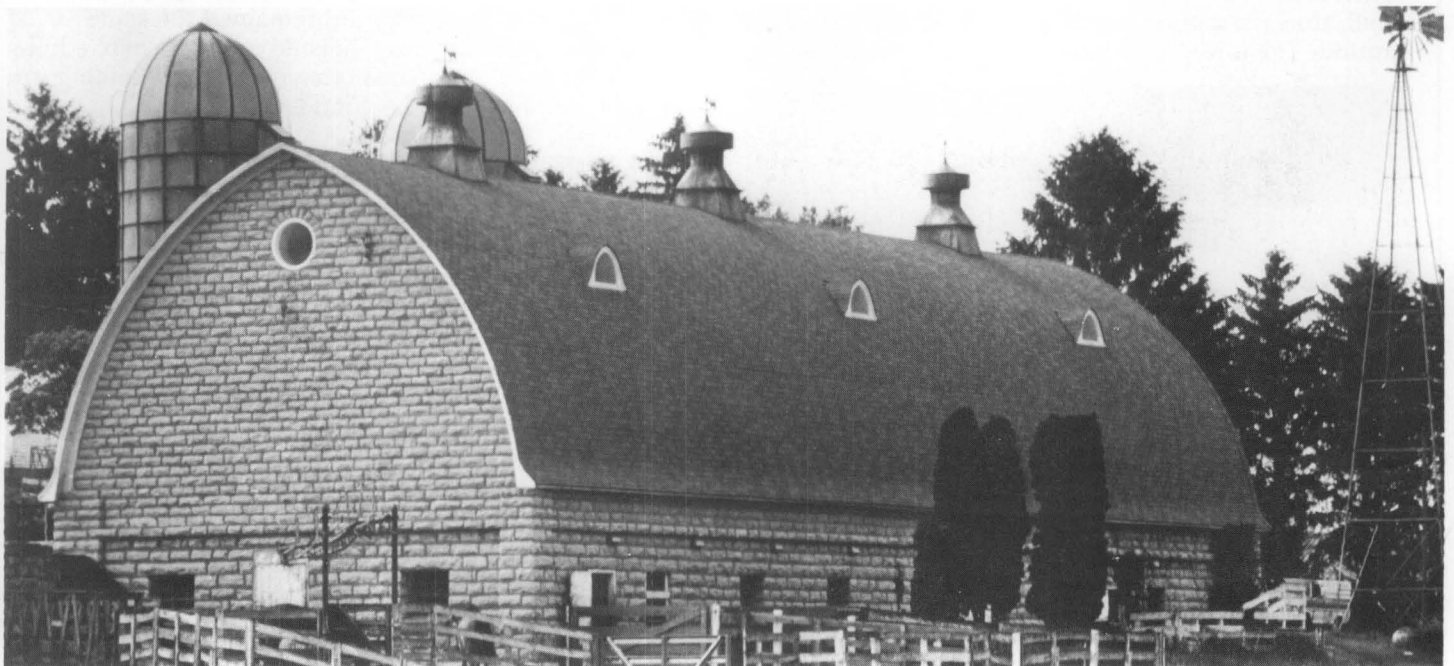
Fig. 1. Arch roof, native limestone walls two feet thick at the base, porthole window, dormers, silos, rooftop ventilators, weathervanes, windmill, fences, fields, and family pride in the builder are all components of the historic character of this Iowa barn. Photo: John Walter, Successful Farming.

From the days when Thomas Jefferson envisioned the new republic as a nation dependent on citizen-farmers for its stability and its freedom, the family farm has been a vital image in the American consciousness. As the main structures of farms, barns evoke a sense of tradition and security, of closeness to the land and community with the people who built them. Even today the rural barn raising presents a forceful image of community spirit. Just as many farmers built their barns before they built their houses, so too many farm families look to their old barns as links with their past. Old barns, furthermore, are often community landmarks and make the past present. Such buildings embody ethnic traditions and local customs; they reflect changing farming practices and advances in building technology. In the imagination they represent a whole way of life (Fig. 1).

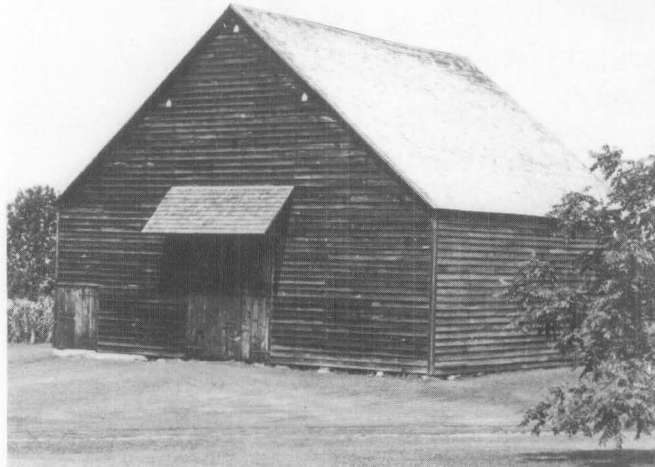
Built in the late 1700s, this New York Dutch barn survives in excellent condition. Gable roof, center wagon doors with pent roof, stock door at the corner and horizontal clapboarding are all typical features of the Dutch barn. Three holes for martins, traditional features of Dutch barns, can be seen near the top of the facade (they have been plugged and are lighter than the surrounding clapboards). Photo: Clarke Blair.

The first great barns built in this country were those of the Dutch settlers of the Hudson, Mohawk, and Schoharie valleys in New York State and scattered sections of New Jersey.² On the exterior, the most notable feature of the Dutch barn is the broad gable roof, which in early examples (now extremely rare), extended very low to the ground. On the narrow end the Dutch barn features center doors for wagons and a door to the stock aisles on one or both of the side ends. A pent roof (or pentice) over the center doors gave some slight protection from the elements. The siding is typically horizontal, the detailing simple. Few openings other than doors and traditional holes for martins puncture the external walls.³ The appearance is of massiveness and simplicity, with the result that Dutch barns seem larger than they actually are.

To many observers the heavy interior structural system is the most distinctive aspect of the Dutch barn. Mortised, tenoned and pegged beams are arranged in "H"-shaped units that recall church interiors, with columned aisles alongside a central space (here used for threshing). This interior arrangement, more than any other characteristic, links the Dutch barn with its Old World forebears. The ends of cross beams projecting through the columns are often rounded to form "tongues," a distinctive feature found only in the Dutch barn.

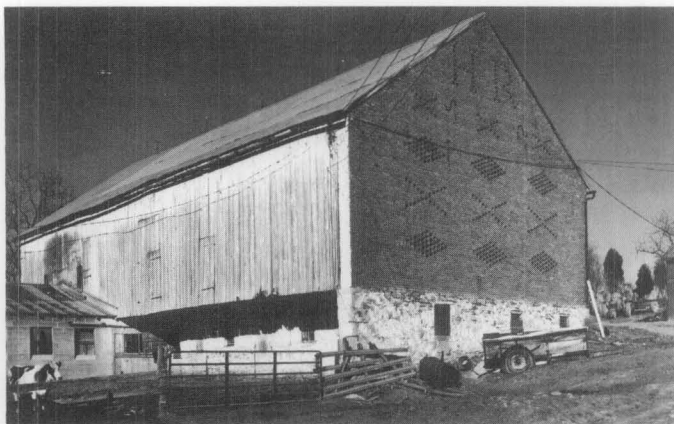
The gently sloping roadbed in this photograph shows the "bank" from which bank barns get their name. Massive timbers stretching across the full width of the barn create the overhang that also characterizes these barns. In barns with brick end walls, patterns were sometimes created by leaving spaces between bricks. The device furnishes ventilation as well as decoration. Photo: Jack E. Boucher, HABS.

levels served as threshing floor and storage. The hillside entrance gave easy access to wagons bearing wheat or hay. (Fodder could also be dropped through openings in the floor to the stabling floor below.) The general form of the bank barn remained the same whether it was built into a hillside or not. Where a hill was lacking, a "bank" was often created by building up an earthen ramp to the second level.

Bank barns were ordinarily constructed with their long side, or axis, parallel to the hill, and on the south side of it. This placement gave animals a sunny spot in which to gather during the winter. To take further advantage of the protection its location afforded, the second floor was extended, or cantilevered, over the first. The overhang sheltered animals from inclement weather. The extended forebay thus created is one of the most characteristic features of these barns. In some bank barns, the projecting beams were not large enough to bear the entire weight of the barn above. In these cases, columns or posts were added beneath the overhang for structural support.

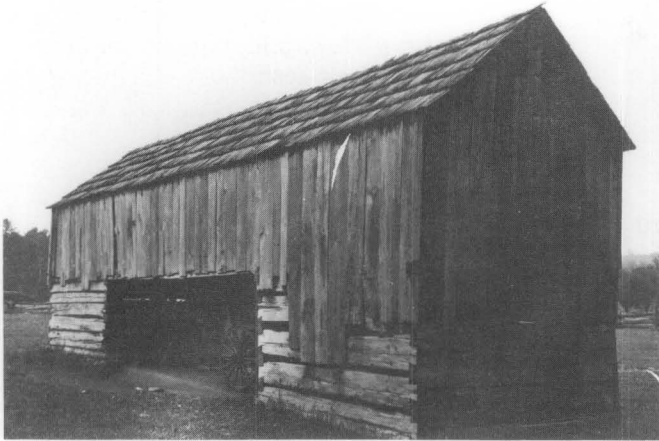
This late-nineteenth century crib barn is located in eastern Tennessee, in what is now the Great Smoky Mountains National Park. The central driveway between the cribs allowed a team and wagon to drive through after unloading. The materials and details are typical of the region. They include, on the exterior: hand-hewn saddle notched logs on the lower, crib portion; board framing on the upper, loft area; wood shingle roof. The interior features wood hinges on the crib doors and earth floor. Photo: Robert Madden.

The cribs sometimes face a covered gallery or aisle running across the front. In another arrangement, the cribs are separated by a central driveway running through the building. This latter arrangement defines the *double crib barn*.

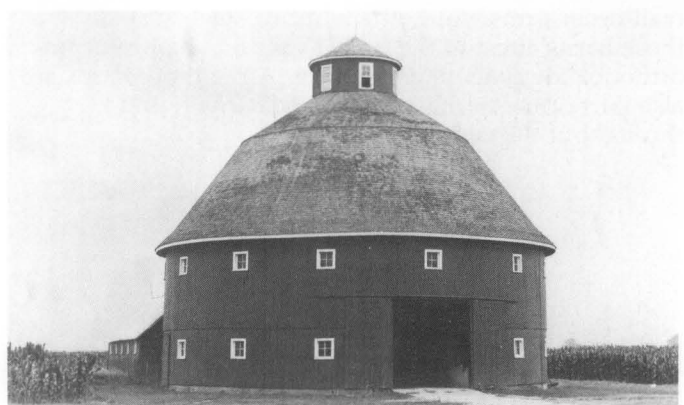
Circular barns are found throughout the country, but are especially numerous in the Midwest. This 1911 Illinois round barn is 60 feet in diameter. The cupola atop the hipped roof is 60 feet above ground. Its 10 single and 5 double stalls on the ground floor were fed from a loft. The square windows spaced at regular intervals around the perimeter add a note of simple contrast to the overall circular motif. Photo: Keith A. Sculle, Illinois Historic Preservation Agency.

Round barns were promoted for a number of reasons. The circular form has a greater volume-to-surface ratio than the rectangular or square form. For any given size, therefore, a circular building will use fewer materials than other shapes, thus saving on material costs. Such barns also offer greater structural stability than rectangular barns. And because they can be built with self-supporting roofs, their interiors can remain free of structural supporting elements, thereby providing vast storage capabilities. The circular interior layout was also seen as more efficient, since the farmer could work in a continuous direction.

In general, multi-sided barns—frequently of 12 or 16 sides—are earlier than “true round” barns. Earlier examples also tend to be wood sided, while later ones tend to be brick or glazed tile. Interior layouts also underwent an evolution. Early round barns placed cattle stanchions on the first floor, with the full volume of the floor above used for hay storage. In later barns, the central space rose from the ground floor through the entire building. Cattle stanchions arranged around a circular manger occupied the lower level; the circular

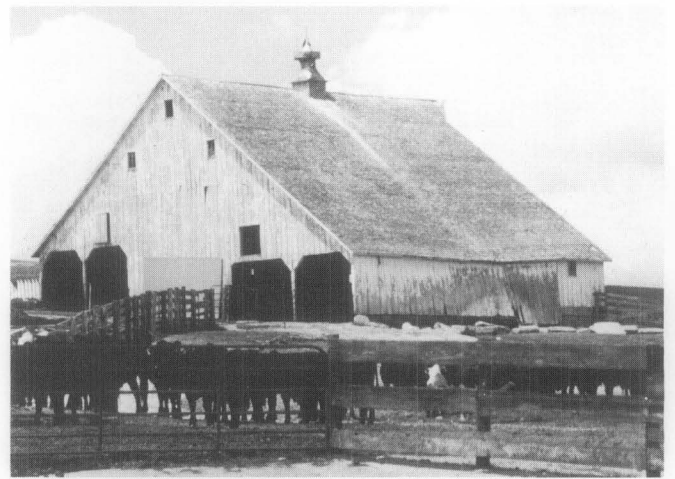
The long, sweeping roof is a characteristic of the Prairie or Western barn. The projecting peak over the hayloft is another. This Iowa barn was built about 1910. Photo: Mary Humstone.

A peak roof projecting above a hayloft opening is one of the most familiar images associated with barns. The feature belongs to the prairie barn, also known as the Western barn. The larger herds associated with agriculture in the West and Southwest required great storage space for hay and feed. Accordingly, prairie barns are on average much larger than the other barns discussed in this brief.⁶ Long, sweeping roofs, sometimes coming near the ground, mark the prairie barn; the extended roof created great storage space. (Late in the nineteenth century, the adoption of the gambrel roof enlarged the storage capacity of the haymow even more.)

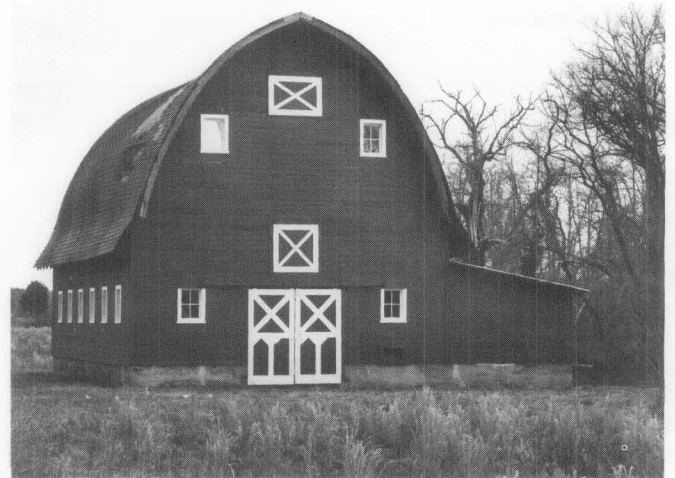
In the early 20th century barn patterns were developed by agricultural schools and prefabricated units were sold by mail-order firms. This Maryland barn was bought about 1920 from a Sears catalogue. Photo: Robert J. Hughes

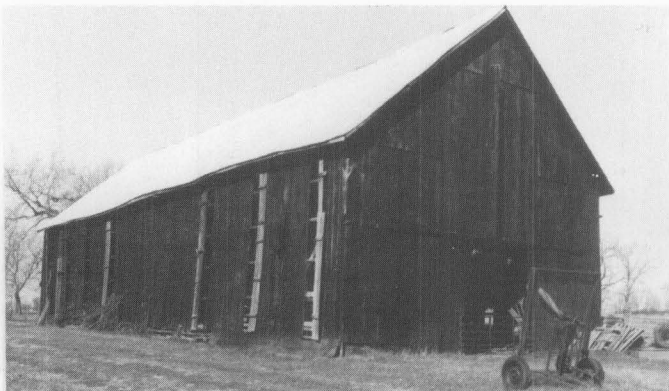
Panels on this 1900 Kentucky tobacco barn open to aid in the curing process. Photo: Christine Amos, Kentucky Heritage Council.

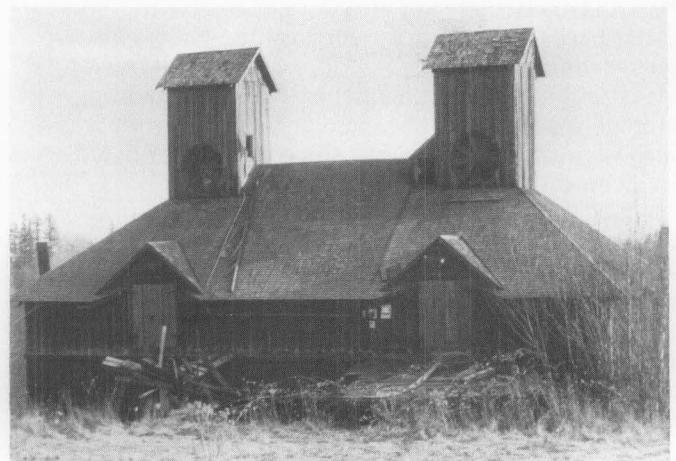
The two ventilating towers are the character-defining aspect of this Oregon hop-drying barn. Photo: Allan Nelson.

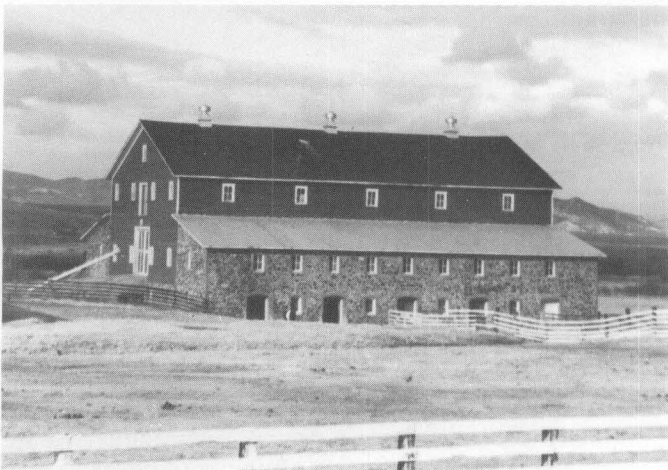
Fig. 2. Mountains, fields, fences, sheds, trees: The setting of this enormous Montana barn is an important element of its character. The barn was built in 1887-1889 after disastrous livestock losses in the winter of 1886-1887. It could hold 500 cattle and store a quarter-million cubic feet of hay. Photo: John N. DeHaas, Jr., Montana Historical Society.

Setting. Setting is one of the primary factors contributing to the historic character of a barn (see Fig. 2). Farmers built barns in order to help them work the land; barns belong on farms, where they can be seen in relation to the surrounding fields and other structures

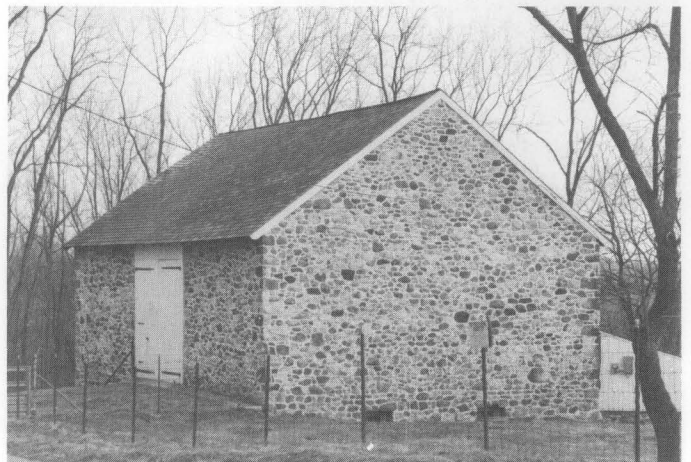
Fig. 3. The stone walls of this Delaware barn are its most notable feature. Built about 1810, the barn is a bank barn. Photo: Valerie Cesna, Delaware Bureau of Archeology and Historic Preservation.

Materials. Among the major impressions given by well-maintained historic barns are those of strength, solidity and permanence (see Fig. 3). These impressions largely result from the durability and ruggedness of the materials used in them. Weathered wood siding, irregularly shaped stones, or roughhewn logs on the exterior; dressed beams, posts scarred by years of use, and plank flooring on the interior all contribute to the special character of barns.

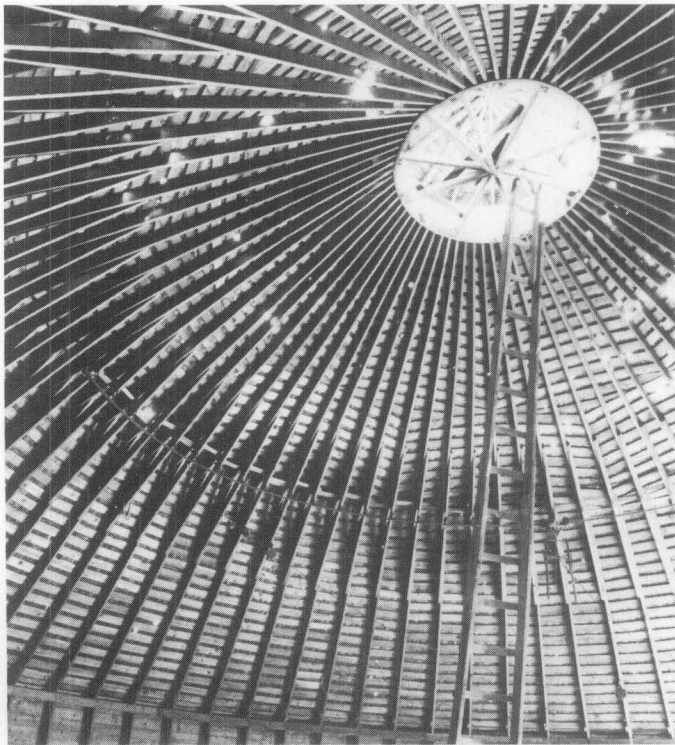
Fig. 4. Nowhere is the sense of space associated with barn interiors more evident than in a round barn. The storage capacity of this 1930 barn is immense. Just visible midway up the wall is a circular track and pulley system used to move hay from the wagon entrance on the lower level and to distribute it around the loft. When needed, hay was dropped to the stalls below through an opening in the loft floor. Photo: Keith A. Sculle, Illinois Historic Preservation Agency.

Interior Spaces. The impression received upon stepping into many historic barns is that of *space* (see Fig. 4). Not infrequently, the entire building appears as a single large space. To enter these buildings is sometimes to experience the entire expanse of the building at once. Even when haylofts and animal stalls “consume” part of the building, they often do not keep the full expanse of the interior from being seen. In large barns, this can be an imposing sight. More commonly, the barn is a combination of confined spaces on the lower floor and a large open space above; in this case, the contrast between the confined and open spaces is also striking. The openness of the interior, furthermore, often contrasts with the “blankness” typical of many barn exteriors, with their relatively few openings.

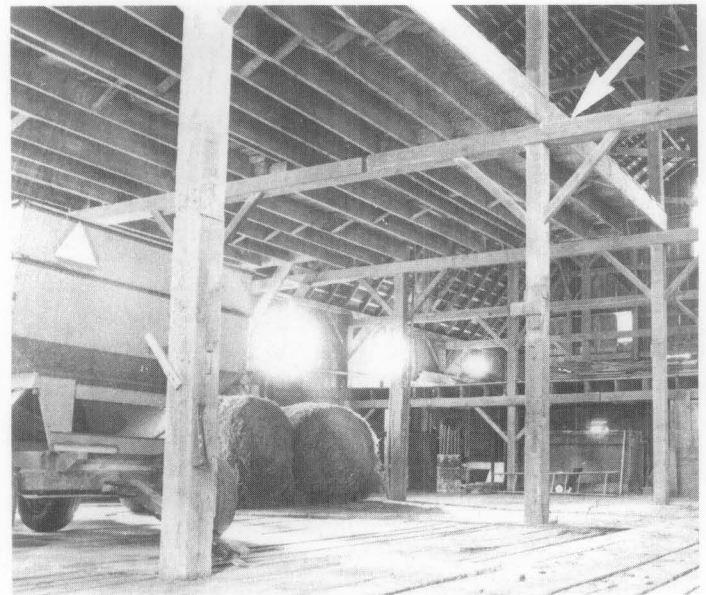
Fig. 5. The exposed structural framework of this large 1890 Illinois barn is impressive. In a recent rehabilitation a portion of the haymow floor (see arrow) was raised to provide clearance for large machinery. Photo: Dale Humphrey, Galesburg Register Mail.

Structural Framework. The exposed structural framework is a major component of the character of most historic barns (see Fig. 5). Typically, barns were built for strictly utilitarian purposes. Accordingly, barn builders made no effort to conceal the structural system. Yet for that very reason, barns achieve an authenticity that accounts for much of their appeal.

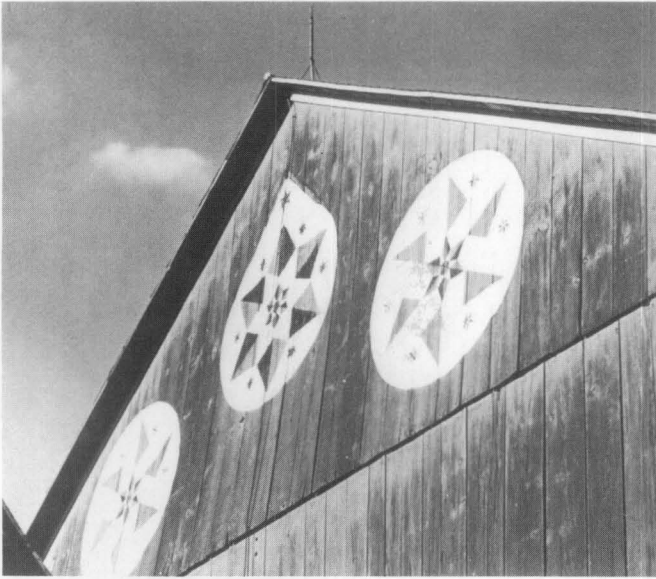
Fig. 6. Hex signs are among the wide range of decorative elements found on American barns. Photo: Lee H. Nelson.

Decorative Features. Historic barns, like modern ones, are structures built for *use*. Nevertheless, decorative elements are not lacking on barns. Foremost among these is color (red being most common). Dutch barns traditionally sported distinctively shaped martin holes in the upper reaches of the building. Traditional hex signs on Pennsylvania barns are so well known as to have entered the mainstream of popular culture and taken on a life of their own (see Fig. 6). Decorative paint schemes, including contrasting colors to “pick out” cross members of the external framework, are common (these most frequently take the form of diamonds or “X’s” on the main doors). Sign painters often took advantage of the size and visibility of barns in an age before billboards. “Mail Pouch Tobacco” signs were nearly as numerous in the first quarter of the 20th century as patent medicine ads were in the last quarter of the 19th. Another decorative motif on historic barns is the arrangement of spacings between bricks to form decorative patterns (as well as to ventilate the barn).

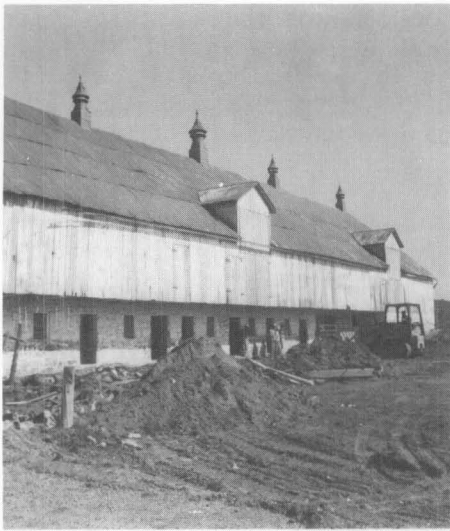
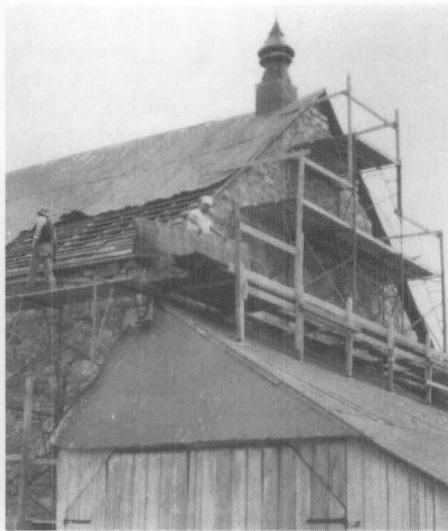
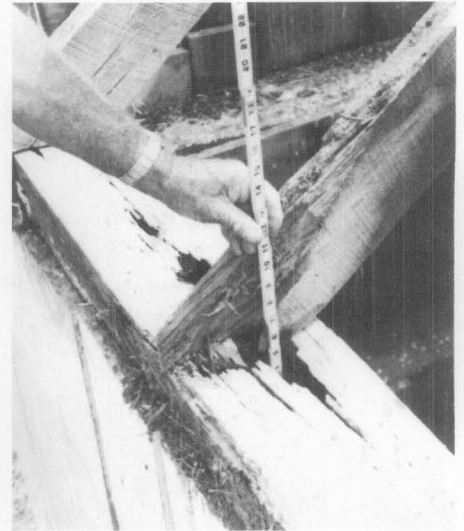
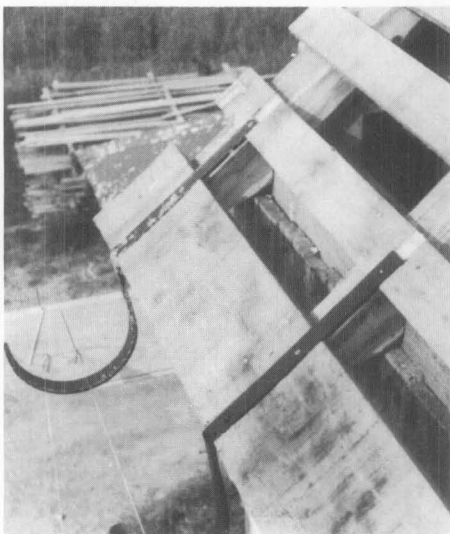
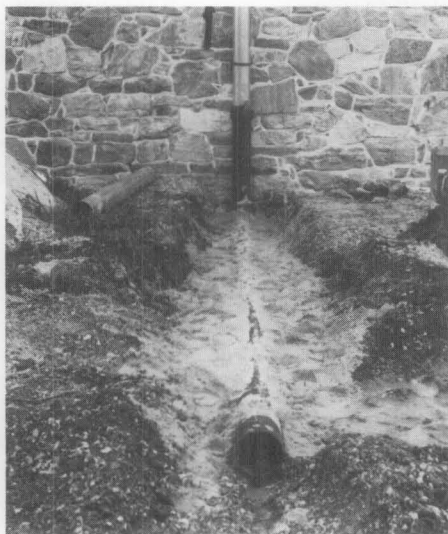
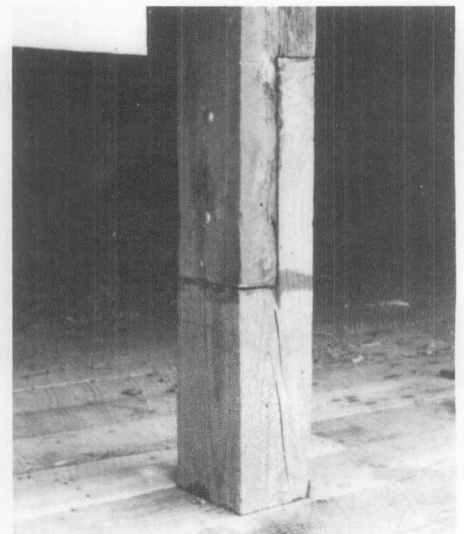
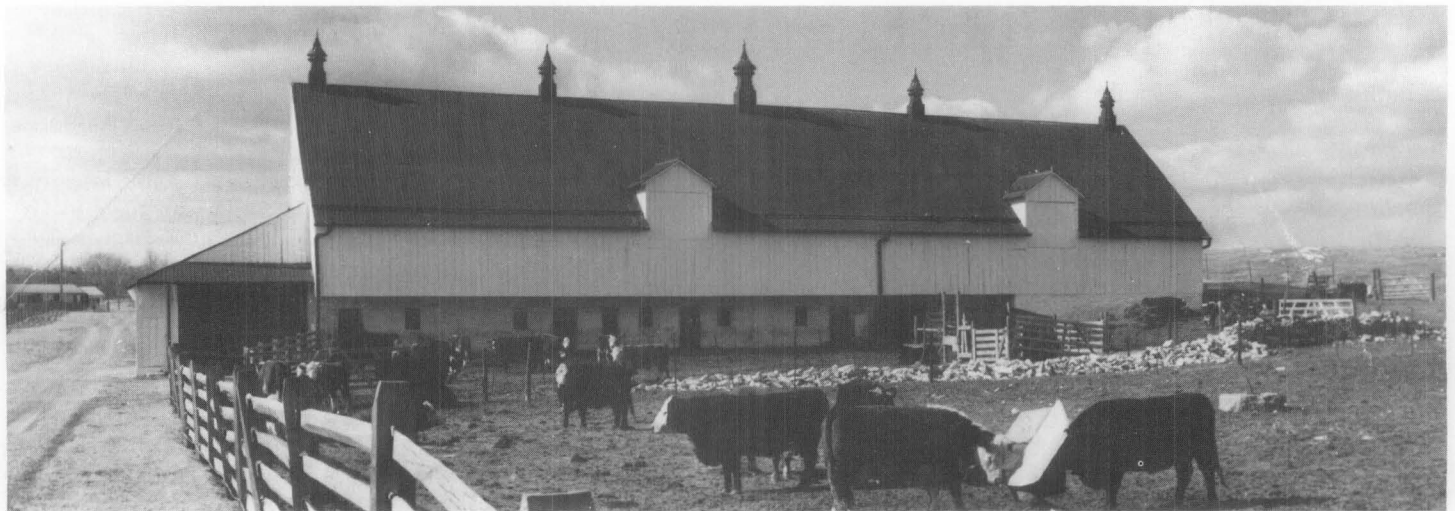
Fig. 7. Now part of Antietam National Battlefield, this bank barn (built in the 1820s and enlarged in 1898 and 1914) looks out over fields and hills where Union and Confederate armies fought on the bloodiest day in American history. Owned by the National Park Service, the barn underwent major repairs: (a) the foundation was regraded for better drainage; (b) the deteriorated metal roof was removed; (c) removal of the metal roof disclosed the rotten wall plate and roof rafters; (d) these elements were replaced, and collars to hold a new gutter system were added; (e) new downspouts and drain pipes were installed to carry water off the roof and away from the foundation; (f) damaged structural members were strengthened with new sections; (g) new roof and other work finished, the barn remains a working farm structure. Photos: (a-f), Courtesy, Williamsport Preservation Training Center, NPS; (g), Jack E. Boucher, HABS.

Many historic barns require more serious repairs than those normally classed as "routine maintenance" (see Fig. 7). Damaged or deteriorated features should be repaired rather than replaced wherever possible. If replacement is necessary, the new material should match the historic material in design, color, texture, and other visual qualities and, where possible, material. The design of replacements for missing features (for example, cupolas and dormers) should be based on historic, physical, or pictorial evidence.

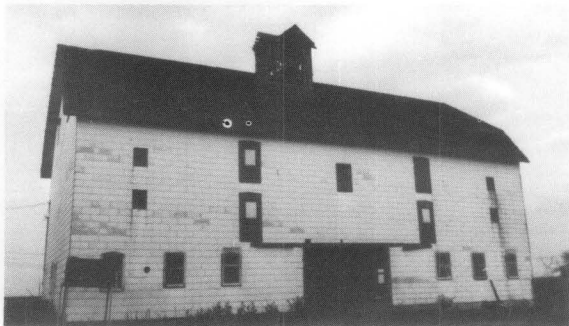
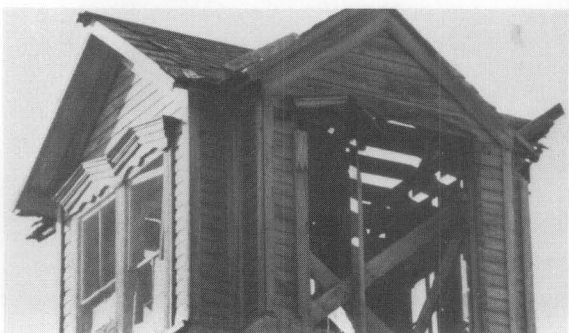
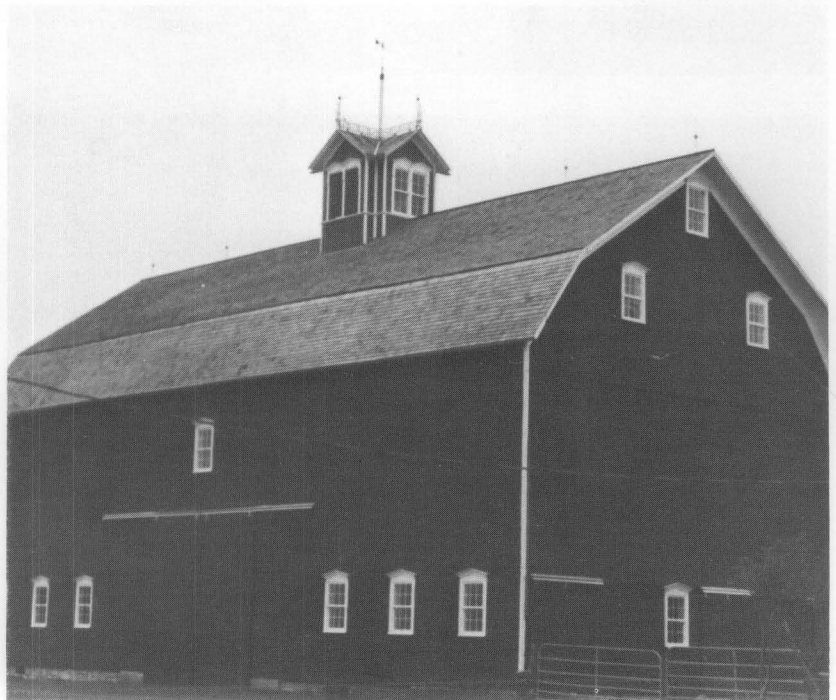
Fig. 8. Built in the Gothic Revival style in the 1890s, this four-story Indiana barn had fallen into disuse, and was deteriorating. In the process of returning it to use, the owner installed a new roof that matches the wooden shingles found beneath the deteriorating asphalt shingle roof; removed the modern asbestos shingle siding; repaired the windows, and reconstructed the cupola (including its lightning rod and weathervane). (Before and after views are of opposite sides of barn.) Photos: Before, Courtesy, Gary Post-Tribune; After, Courtesy, Kankakee Valley News.

Some barns have served the same uses for generations, and need only periodic repairs and routine maintenance. Others have become obsolete and need extensive updating for modern farming methods. (To house livestock, for example, a barn may need new feeding, watering, waste removal, electrical, plumbing and ventilation systems.) Similarly, barns that can no longer be used for agriculture at all normally require changes to adapt them for commercial, office, or residential use. In such cases barns need more extensive work than the maintenance and repair treatments outlined above. However, when rehabilitating a historic barn for a new farming operation or a new use entirely, care must be taken to preserve its historic character while making needed changes (see Figs. 8, 9 and 10).

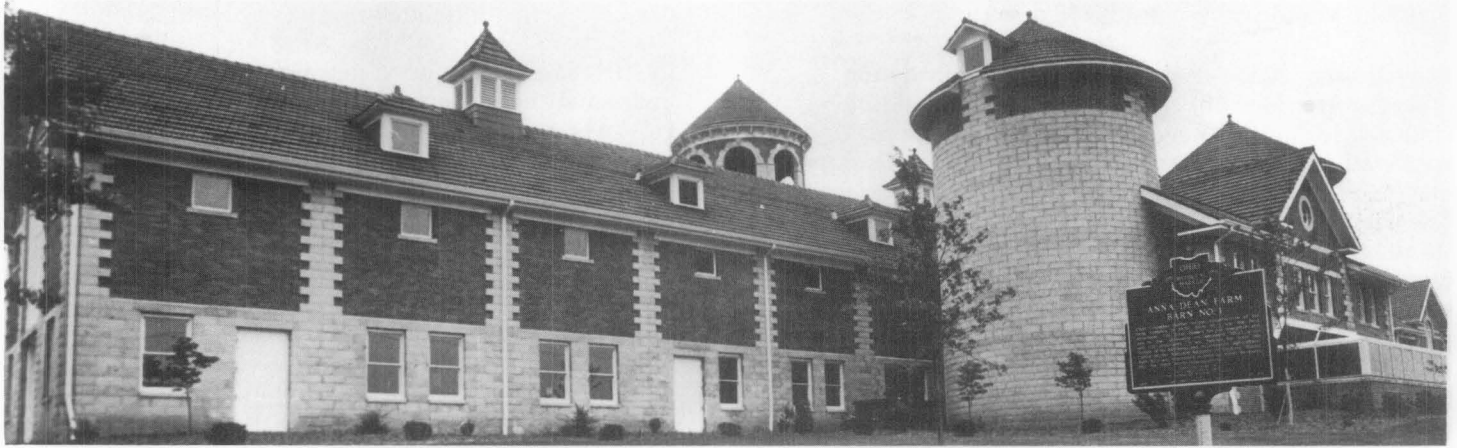
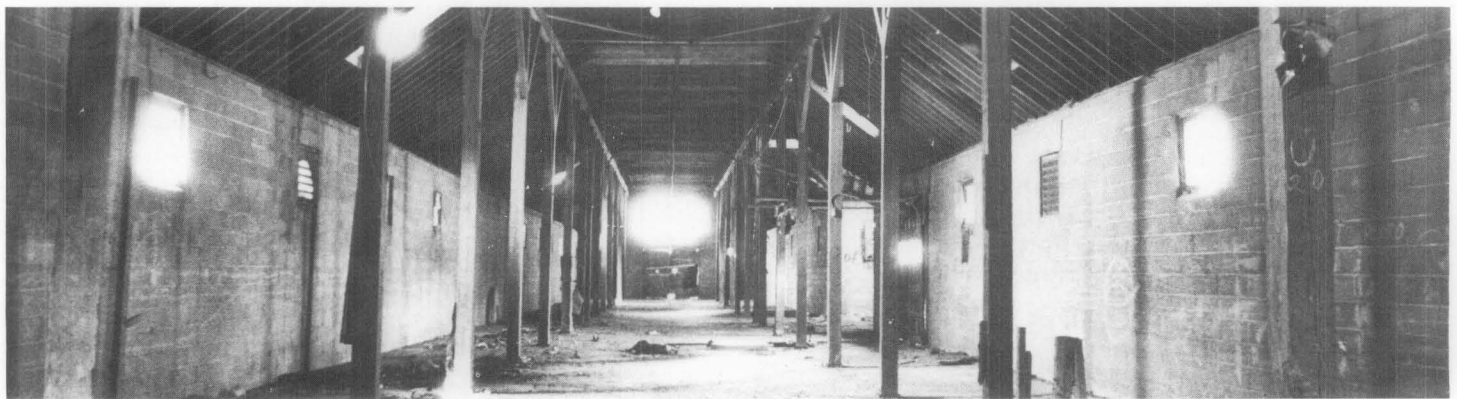
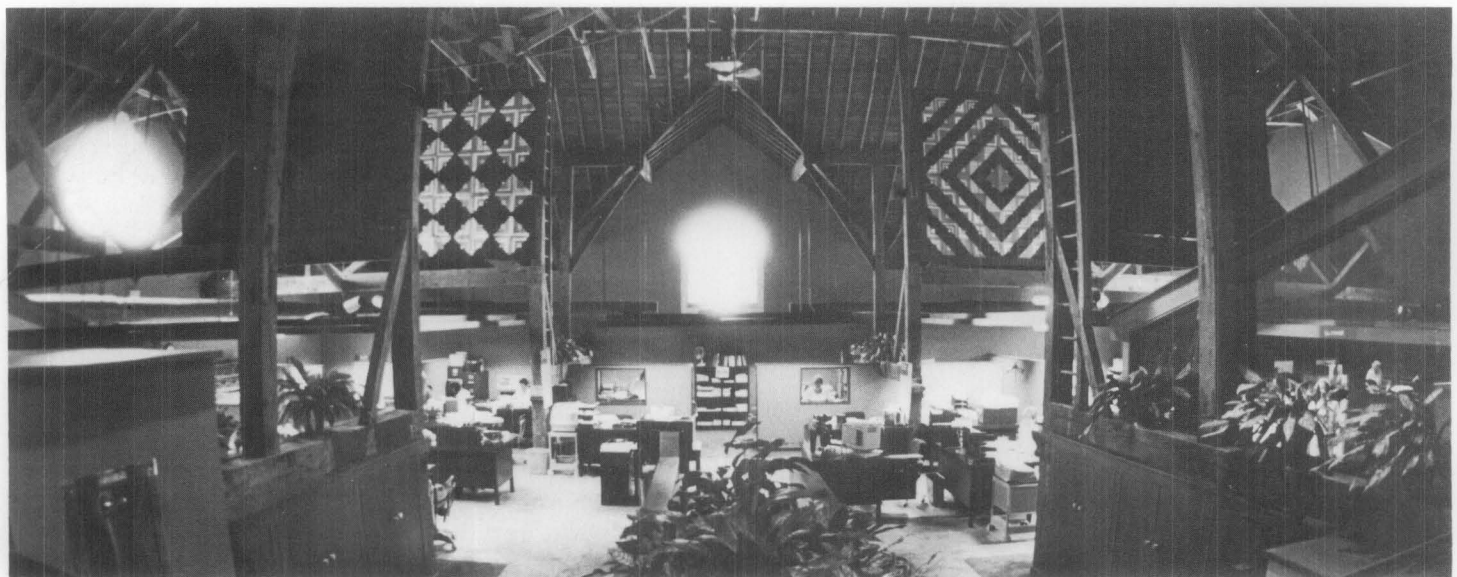
Fig. 9. This enormous Ohio barn (285 feet by 125) was built between 1909 and 1912. It was one of 102 structures on "America's Finest Farm." (Other buildings included the world's largest greenhouse and the world's largest barn—nearly 800 feet long). The barn seen here was rehabilitated for use as headquarters for an international agricultural firm. Although the use has changed, comparison of the interior photographs shows that the barn has retained its historic character. (After view, interior, is taken from a cross axis; distortion is from fish-eye lens.) Photos: Exterior and interior, after: Ron Kuntz, UPI; Interior, before: Courtesy, Barberton (Ohio) Historical Society.

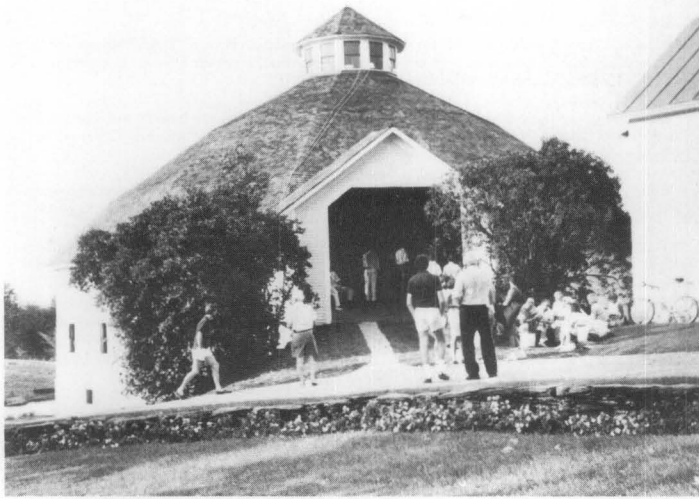
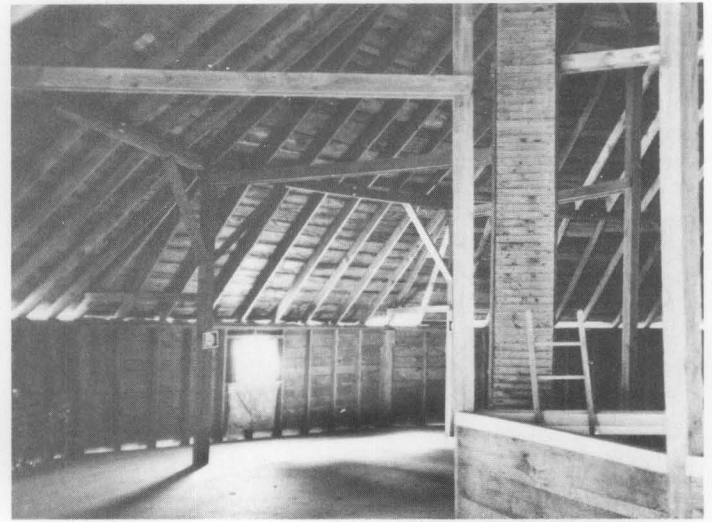
Fig. 10. This 1910 Vermont round barn is 80 feet in diameter. Disused and decaying, the building was converted to a community center, with artists' studios and spaces for weddings, parties and conferences. The barn underwent extensive structural repair and other work. Careful selection of new use permitted the building to be rehabilitated while retaining its principal spaces and features—and its historic character—intact. Photos: Jay White.
