Technical Preservation Services

National Park Service
U.S. Department of the Interior

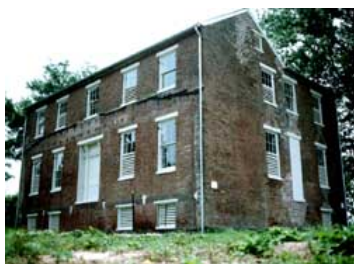
This building has been successfully mothballed for 10 years because the roof and walls were repaired and structurally stabilized, ventilation louvers added, and the property maintained. Photo: NPS files.

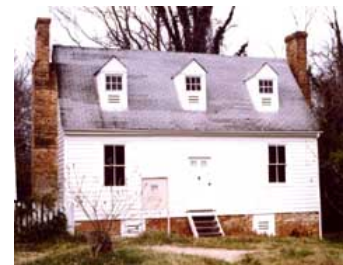
Regrading has protected this masonry foundation wall from excessive damp during its 10-year mothballing. Note the attic and basement vents, temporary stairs, and interpretive sign. Photo: NPS files.

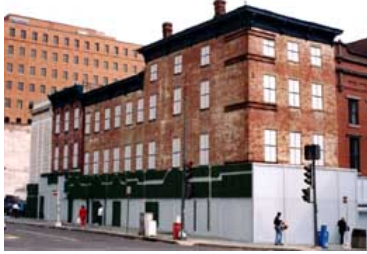
Urban buildings often need additional protection from unwanted entry and graffiti. This commercial building uses painted plywood panels to cover its glass storefronts. The upper windows on the street sides have been painted to resemble 19th century sash. Photo: NPS files.

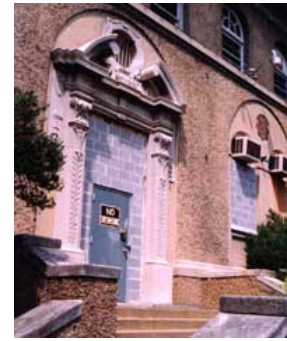
The first floor openings of this historic building have been filled with cinder blocks and the doors, window sash, and frames removed for safe keeping. The security metal door features heavy duty locks. Photo: NPS files.
