STAFF REPORT

Facility Condition Assessment

For
Carson City
Northgate
2621 Northgate Lane
Carson City,
NV 89706

Date of Report: March 03, 2020

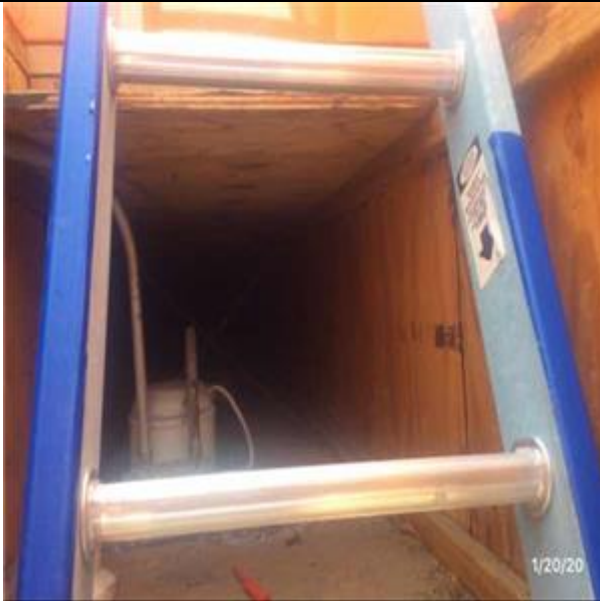
View of Wood Joists Supporting Exterior Grade Plywood

- + B Shell: Undertake structural engineering assessment to assess the impact (if any) of water ingress to roof structure. Carry out remedial action based on structural engineer recommendations. at an estimated cost of \$5,000 in year 2020

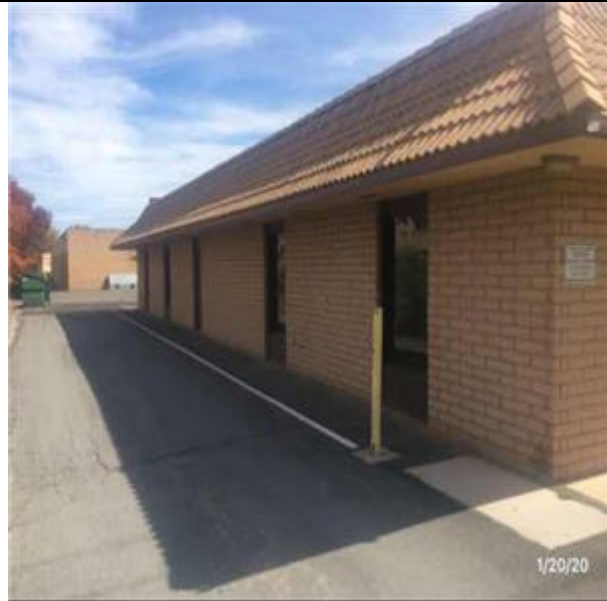
B2011 Exterior Wall Construction :- View of Veneer Brick

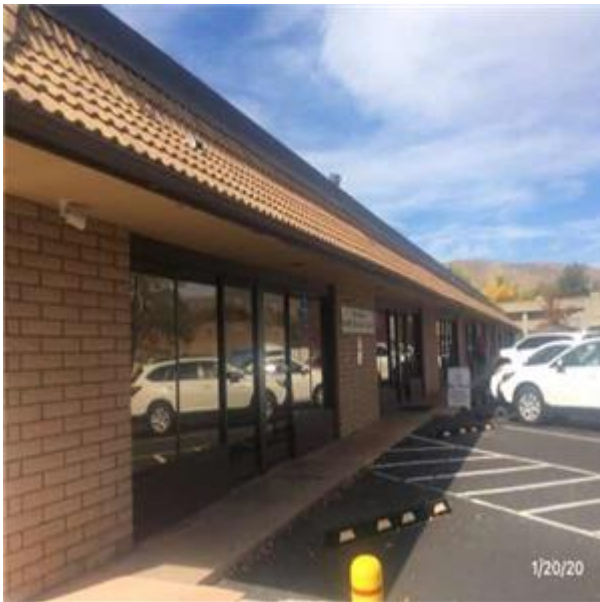
View of Aluminum Window Units - Fixed or Single Hung

- + B Shell: Replace Single Aluminum Glazed Doors at an estimated cost of \$174,134 in year 2022
- + B Shell: Replace Aluminum Window Units - Fixed or Single Hung at an estimated cost of \$202,665 in year 2022

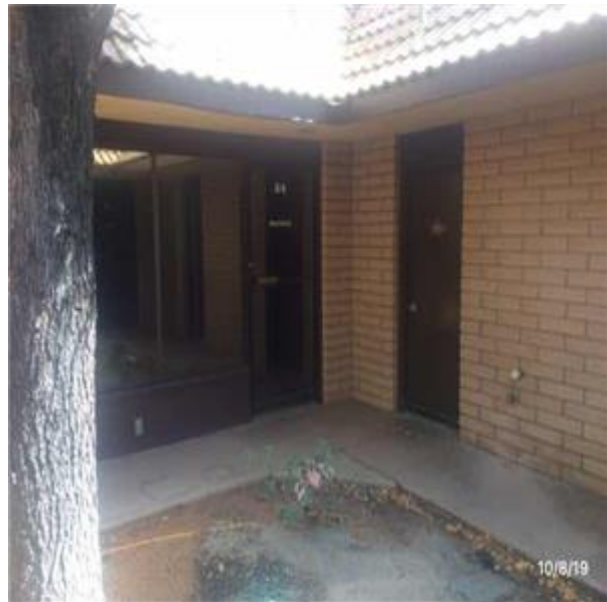
B2031 Glazed Doors & Entrances :- View of Single Aluminum Glazed Doors

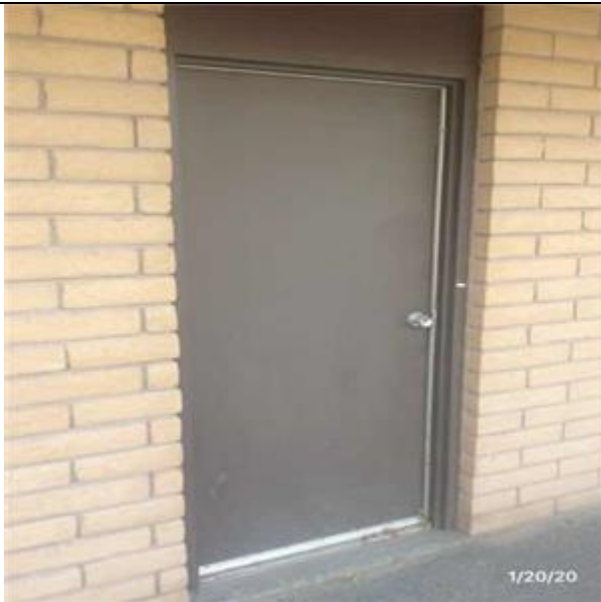
View of Single HM Doors

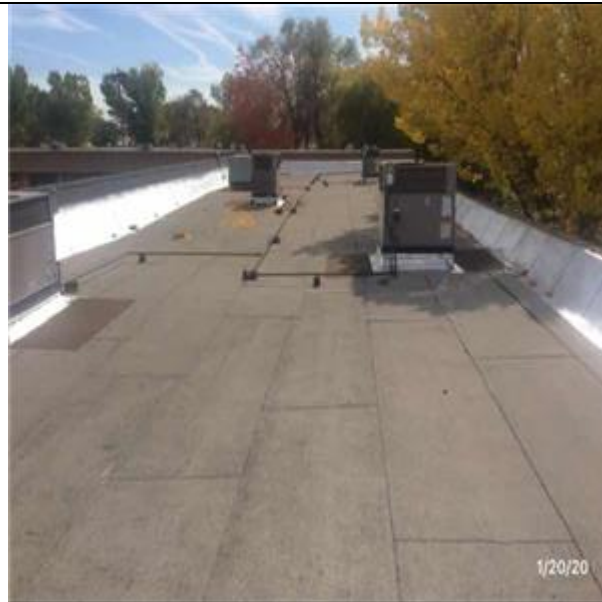
It should also be noted, the flat roof finish was replaced approximately eight years ago, however, the roof and roof drains have failed, and it was reported that a thermal image roof survey discovered excess moisture between the roof finish and wood roof structure. Due to this issue, water has penetrated the roof structure and the interior ceiling finishes which could have potentially caused structural damage to the building. The roof finish is currently scheduled to be replaced in 2023, however, it is recommended this is brought forward to the beginning of the 10-year study period. An allowance has also been included to carry out a structural engineering assessment to identify any areas of damage to the roof structure. Any repairs or replacements should be carried out based on the structural engineers' recommendations.

B3011 Roof Finishes :-
View of BUR (Built-up Roofing) Covering

- + B Shell: Replace Aluminum Perimeter Gutters at an estimated cost of \$8,653 in year 2020
- + B Shell: Replace BUR (Built-up Roofing) Covering at an estimated cost of \$193,583 in year 2020

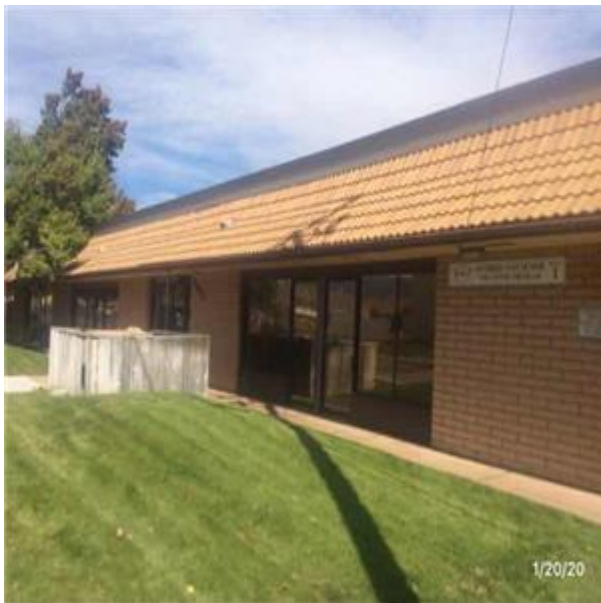
View of Clay Roof Tile

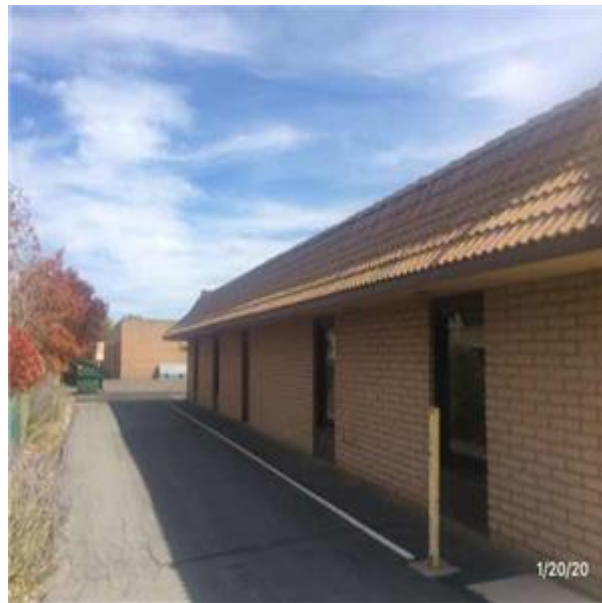
B3016 Gutters and Downspouts :-
View of Aluminum Perimeter Gutters

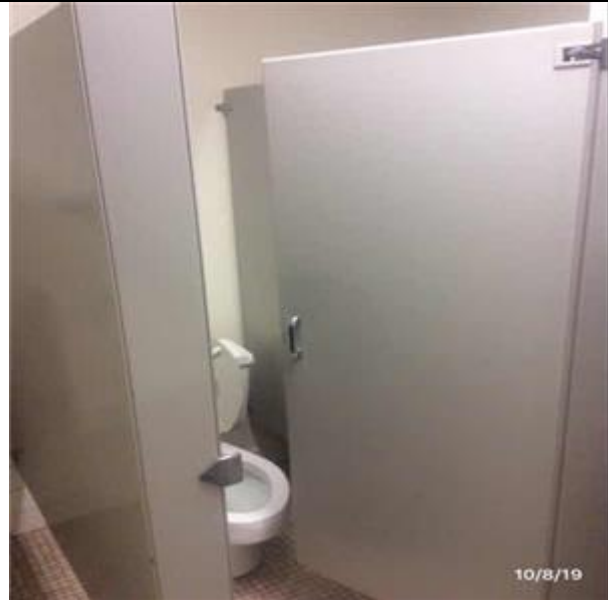
C1014 Site Built Toilet Partitions :-
View of Toilet Partition

- + C Interiors: Replace Painted Finish - Standard at an estimated cost of \$97,100 in year 2024
- + C Interiors: Replace Toilet Partition at an estimated cost of \$23,134 in year 2025

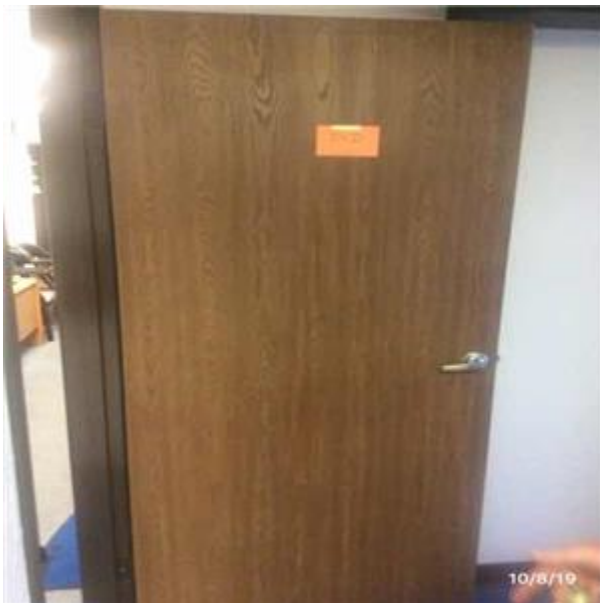
View of Interior Single Wood Door(s)

- + C Interiors: Replace Interior Single Wood Door(s) at an estimated cost of \$80,758 in year 2027
- + D Services: Replace Packaged Rooftop A/C With Heat, Under 20 Tons - W-4 at an estimated cost of \$9,464 in year 2020

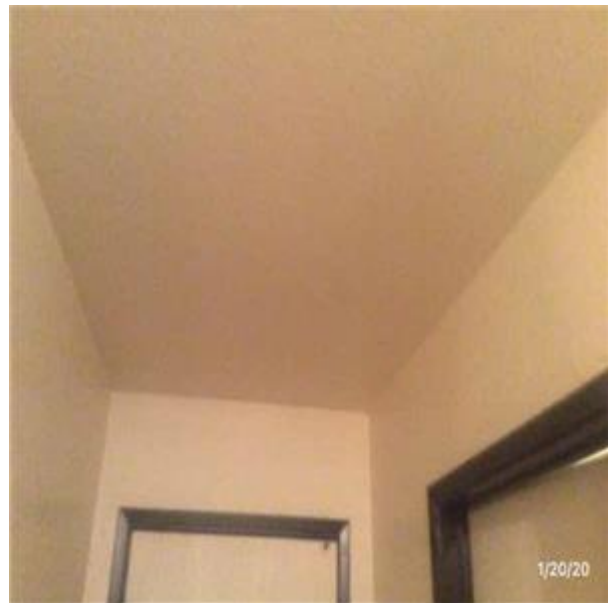
C3012 Wall Finishes to Interior Walls :-
View of Painted Finish - Standard

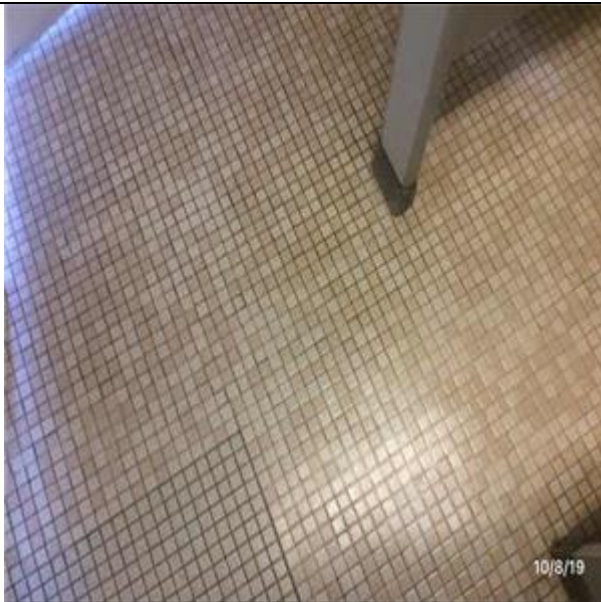
View of Ceramic Tile

- + C Interiors: Replace Ceramic Tile at an estimated cost of \$8,032 in year 2025
- + C Interiors: Replace Carpet Tiles - Standard at an estimated cost of \$26,010 in year 2026

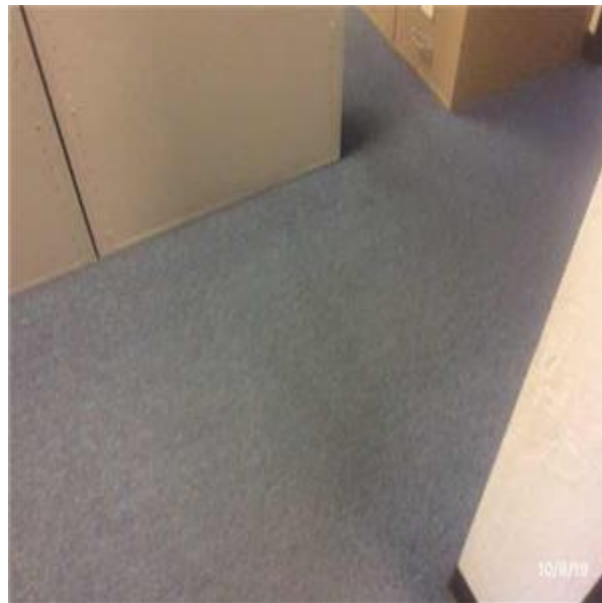
C3025 Carpeting :-
View of Broadloom Standard without Padding

- + C Interiors: Replace Broadloom Standard without Padding at an estimated cost of \$39,607 in year 2021
- + C Interiors: Replace Acoustic Ceiling System - Standard at an estimated cost of \$83,424 in year 2021

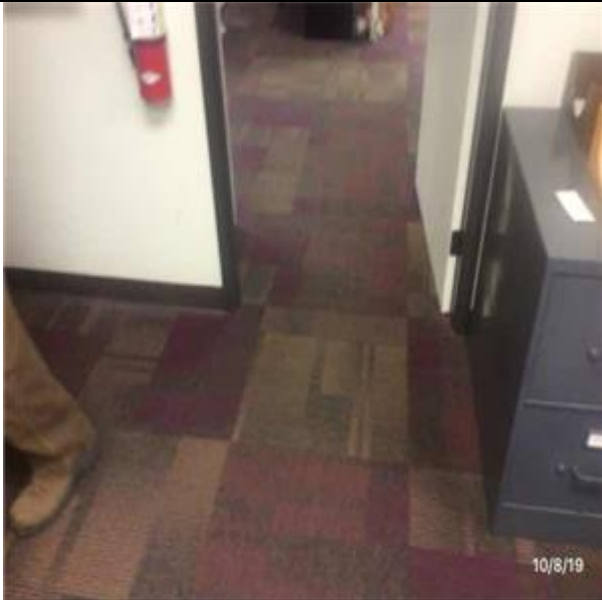
View of Carpet Tiles – Standard

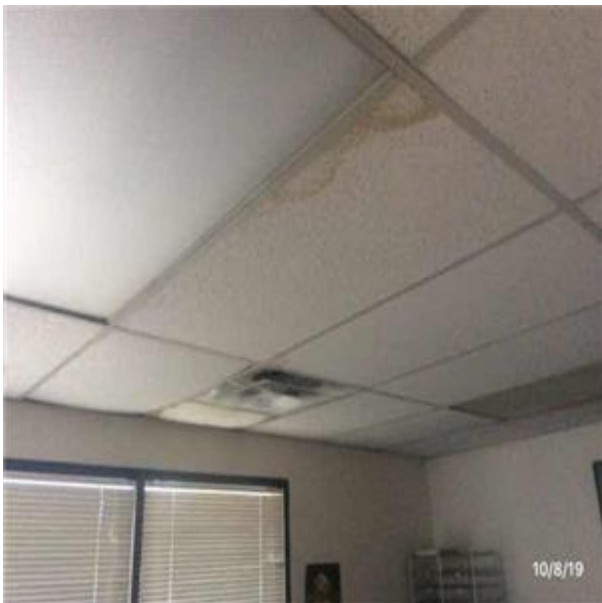
View of Acoustic Ceiling System – Standard

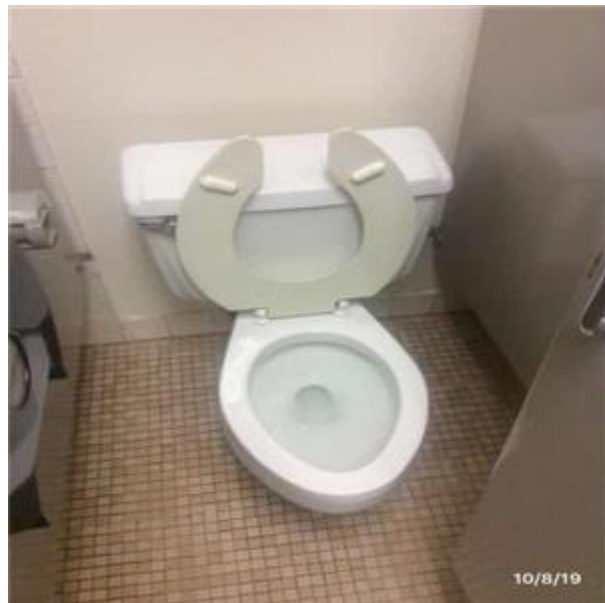
D2011 Water Closets :-
View of Floor Mounted Water Closets

- + D Services: Replace Wall Hung Lavatories at an estimated cost of \$22,240 in year 2025
- + D Services: Replace Floor Mounted Water Closets at an estimated cost of \$28,980 in year 2025
- + E Equipment & Furnishing: Replace Floor Mounted Base Cabinets - Standard at an estimated cost of \$45,426 in year 2023
- + E Equipment & Furnishing: Replace Wall Mounted Cabinets - Standard at an estimated cost of \$11,266 in year 2023
- + G Building Sitework: Replace Concrete 3' - 4' Wide at an estimated cost of \$83,738 in year 2023

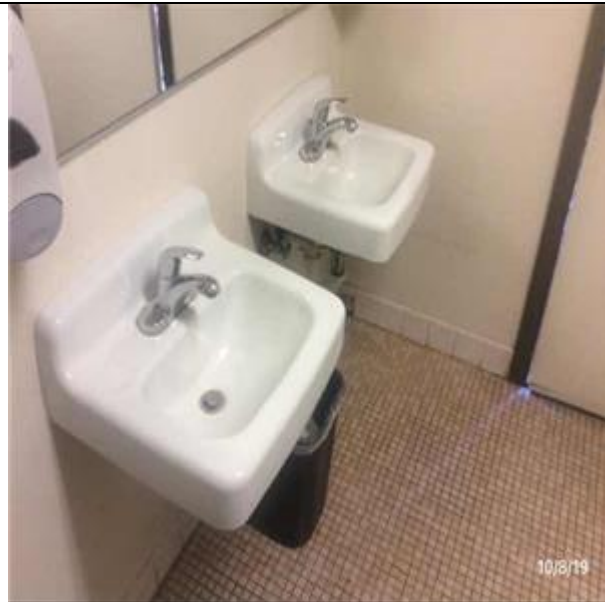
D2013 Lavatories :-
View of Wall Hung Lavatories

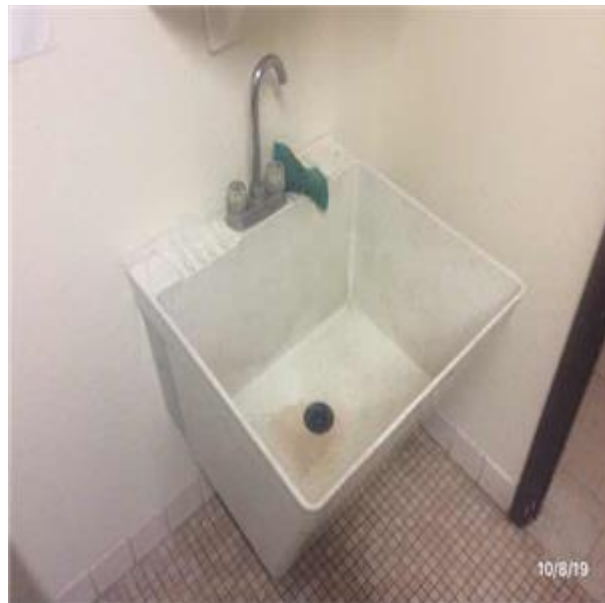
D2014 Sinks :-
View of Service Sink Floor Mounted

- + D Services: Replace Interior Light Fixtures - Fluorescent at an estimated cost of \$123,442 in year 2022
- + D Services: Replace Service Sink Floor Mounted at an estimated cost of \$7,245 in year 2025

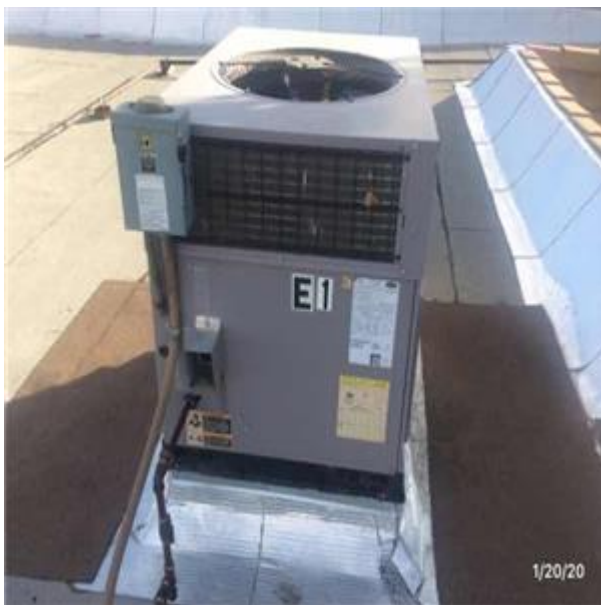
It should be noted, most of the packaged rooftop units were installed in 2002 and operate on R-22 refrigerant, which as of January 2020 is no longer available in the United States. The estimated useful life (EUL) for this type of equipment is usually 20-years and therefore the units are not due to exceed their EUL until 2022. As they operate on R-22 refrigerant, proactive replacement of these units is recommended early in the study period to ensure continuous operation at the building.

View of Packaged Rooftop A/C With Heat, Under 20 Tons - E-1

- + D Services: Replace Packaged Rooftop A/C With Heat, Under 20 Tons - W-7 at an estimated cost of \$7,887 in year 2020
- + D Services: Replace Packaged Rooftop A/C With Heat, Under 20 Tons - E-1 at an estimated cost of \$9,464 in year 2020

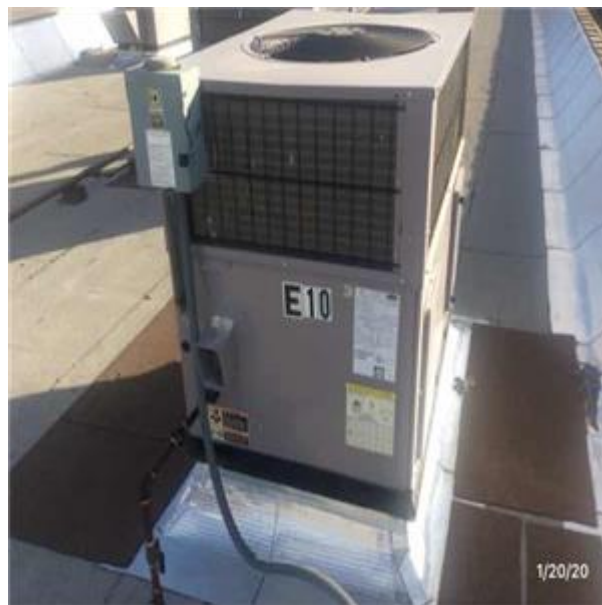
D3052 Package Units :-
View of Packaged Rooftop A/C With Heat, Under 20 Tons - E-10

- + D Services: Replace Packaged Rooftop A/C With Heat, Under 20 Tons - E-10 at an estimated cost of \$7,887 in year 2020
- + D Services: Replace Packaged Rooftop A/C With Heat, Under 20 Tons - W-6 at an estimated cost of \$7,887 in year 2020

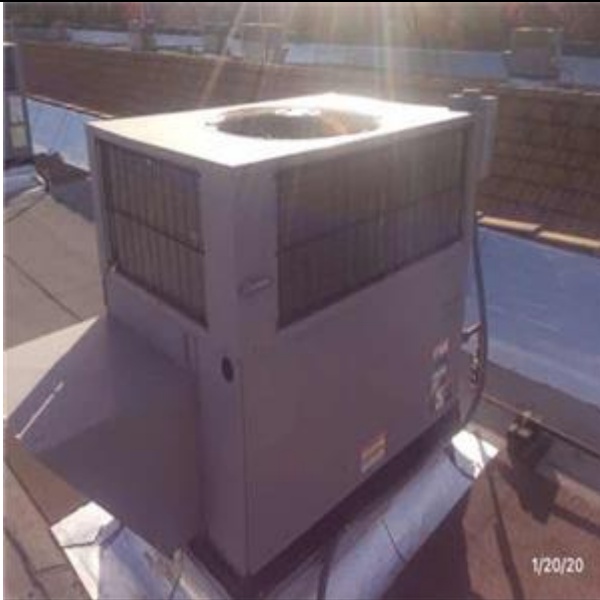
View of Packaged Rooftop A/C With Heat, Under 20 Tons - E-11

- + D Services: Replace Packaged Rooftop A/C With Heat, Under 20 Tons - W-2 at an estimated cost of \$9,464 in year 2020
- + D Services: Replace Packaged Rooftop A/C With Heat, Under 20 Tons - E-11 at an estimated cost of \$7,887 in year 2020

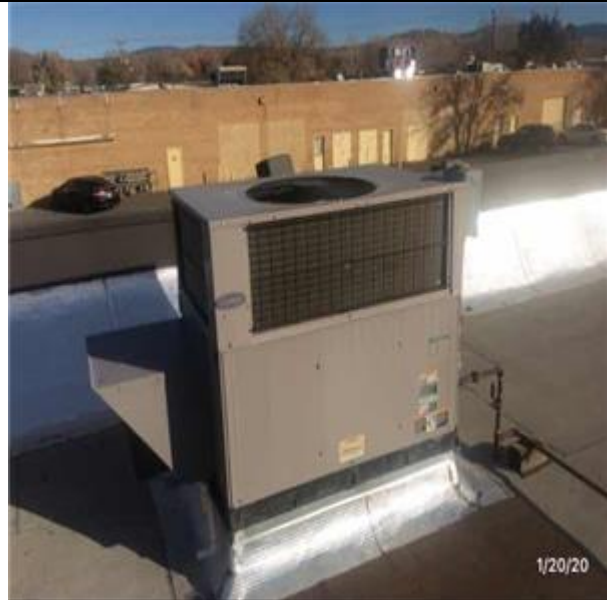
D3052 Package Units :-
View of Packaged Rooftop A/C With Heat, Under 20 Tons - E-12

- + D Services: Replace Packaged Rooftop A/C With Heat, Under 20 Tons - W-9 at an estimated cost of \$7,887 in year 2020
- + D Services: Replace Packaged Rooftop A/C With Heat, Under 20 Tons - E-12 at an estimated cost of \$7,887 in year 2020

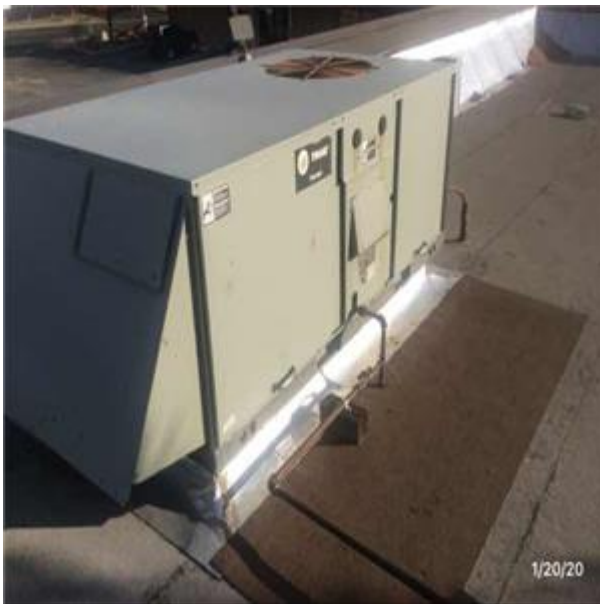
View of Packaged Rooftop A/C With Heat, Under 20 Tons - E-2

- + D Services: Replace Packaged Rooftop A/C With Heat, Under 20 Tons - E-2 at an estimated cost of \$9,464 in year 2020
- + D Services: Replace Packaged Rooftop A/C With Heat, Under 20 Tons - E-9 at an estimated cost of \$7,887 in year 2020

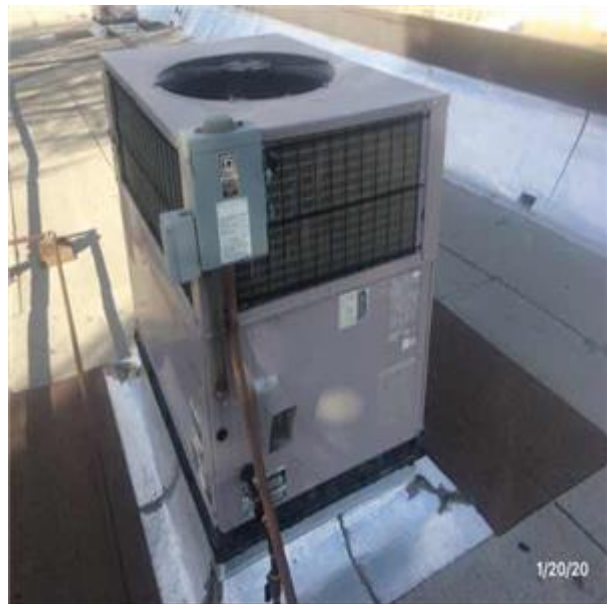
D3052 Package Units :-
View of Packaged Rooftop A/C With Heat, Under 20 Tons - E-3

- + D Services: Replace Packaged Rooftop A/C With Heat, Under 20 Tons - W-10 at an estimated cost of \$7,887 in year 2020
- + D Services: Replace Packaged Rooftop A/C With Heat, Under 20 Tons - E-3 at an estimated cost of \$7,887 in year 2020

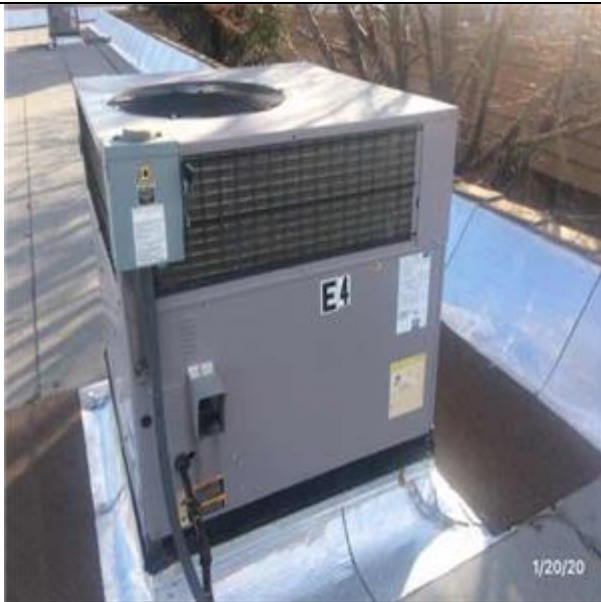
View of Packaged Rooftop A/C With Heat, Under 20 Tons - E-4

- + D Services: Replace Packaged Rooftop A/C With Heat, Under 20 Tons - E-4 at an estimated cost of \$11,041 in year 2020
- + D Services: Replace Packaged Rooftop A/C With Heat, Under 20 Tons - W-8 at an estimated cost of \$7,887 in year 2020

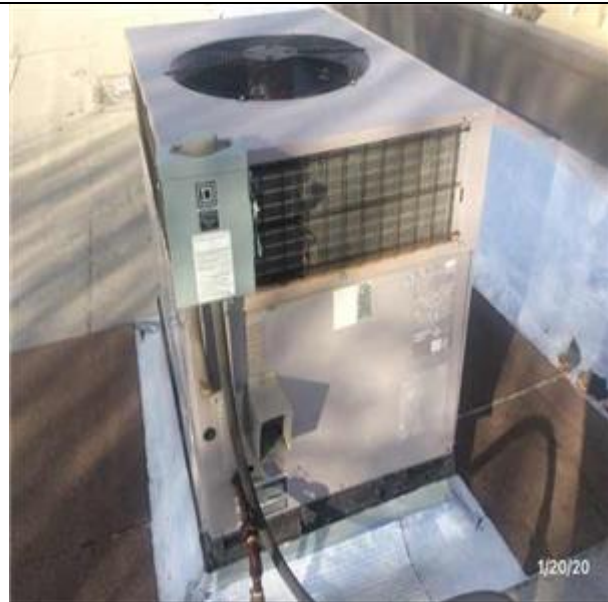
D3052 Package Units :-
View of Packaged Rooftop A/C With Heat, Under 20 Tons - E-5

- + D Services: Replace Packaged Rooftop A/C With Heat, Under 20 Tons - W-3 at an estimated cost of \$9,464 in year 2020
- + D Services: Replace Packaged Rooftop A/C With Heat, Under 20 Tons - E-5 at an estimated cost of \$7,887 in year 2020

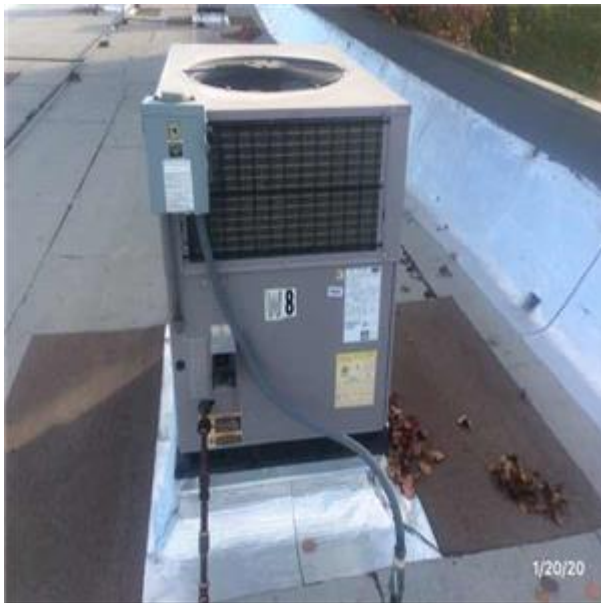
View of Packaged Rooftop A/C With Heat, Under 20 Tons - W-8

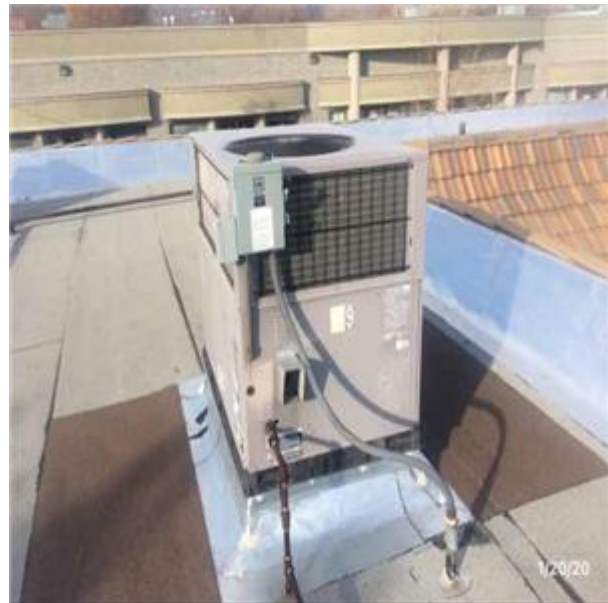
D3052 Package Units :-
View of Packaged Rooftop A/C With Heat, Under 20 Tons - W-9

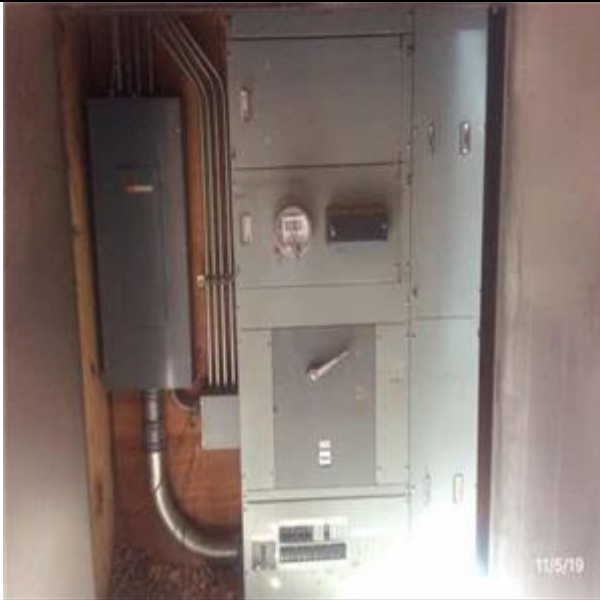
View of Switchboard - 120/208volts, 400 to 2000amp

- + D Services: Replace Flood Lights - Metal Halide Fixtures at an estimated cost of \$10,305 in year 2022
- + D Services: Replace Switchboard - 120/208volts, 400 to 2000amp at an estimated cost of \$17,664 in year 2022

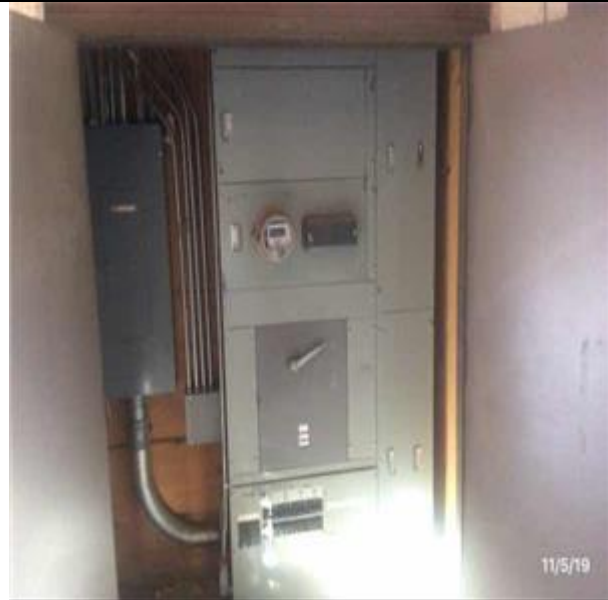
D5012 Low Tension Service & Dist :-
View of Switchboard - 120/208volts, 400 to 2000amp

- + D Services: Replace Switchboard - 120/208volts, 400 to 2000amp at an estimated cost of \$17,664 in year 2022
- + D Services: Replace Switchboard - 120/208volts, 400 to 2000amp at an estimated cost of \$17,664 in year 2022

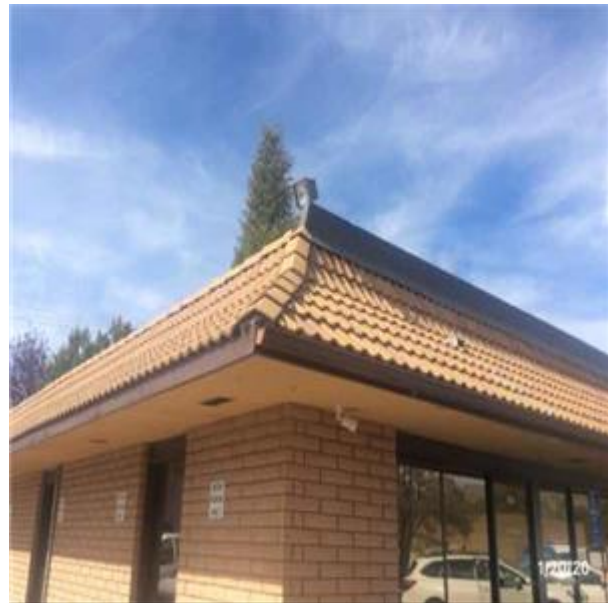
D5022 Lighting Equipment :-
View of Flood Lights - Metal Halide Fixtures

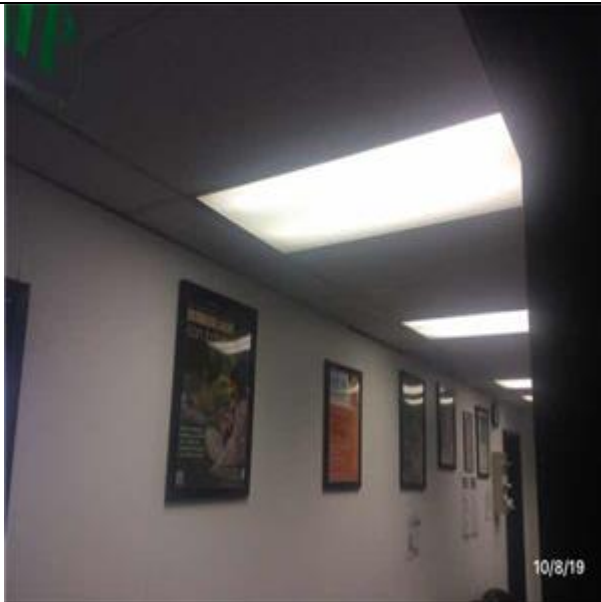
An LED energy efficient upgrade is recommended for all lighting that is scheduled to be replaced in the 10-year study period. A like-for-like replacement for the lighting has been included within the 10-year capital expenditure for this building, with an independent Energy Conservation Measures (ECM) capital expenditure report providing the energy efficient lighting upgrade costs.

View of Interior Light Fixtures – Fluorescent

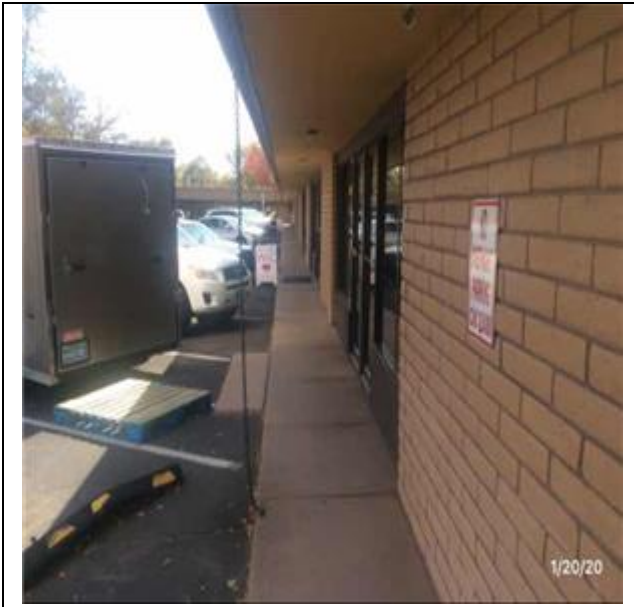
View of Concrete 3' - 4' Wide
