The purpose of this Memo is to present the preliminary results and mitigation associated with the hydraulic analysis of Ash Canyon Creek in support of the FEMA Conditional Letter of Map Revision (CLOMR) to be submitted in association of the proposed Andersen Ranch West development. The proposed development is located within a Zone AE flood zone without a regulatory floodway, which includes Base Flood Elevations (BFEs) that have been determined by detailed methods, as shown on the effective FEMA Flood Insurance Rate Map (FIRM) panel #3200010091F, dated 2/19/2014. Additionally, a LOMR (20-09-0437P) that includes the Andersen Ranch West parcel was completed by House Moran and became effective 2/18/2021. The LOMR revised the existing conditions FEMA model and mapping. The site boundary and effective FEMA mapping are illustrated on Figure 1 below.

Andersen Ranch Development
(AKA The Vintage at King's Canyon)
VICINITY MAP

The Vintage at King's Canyon

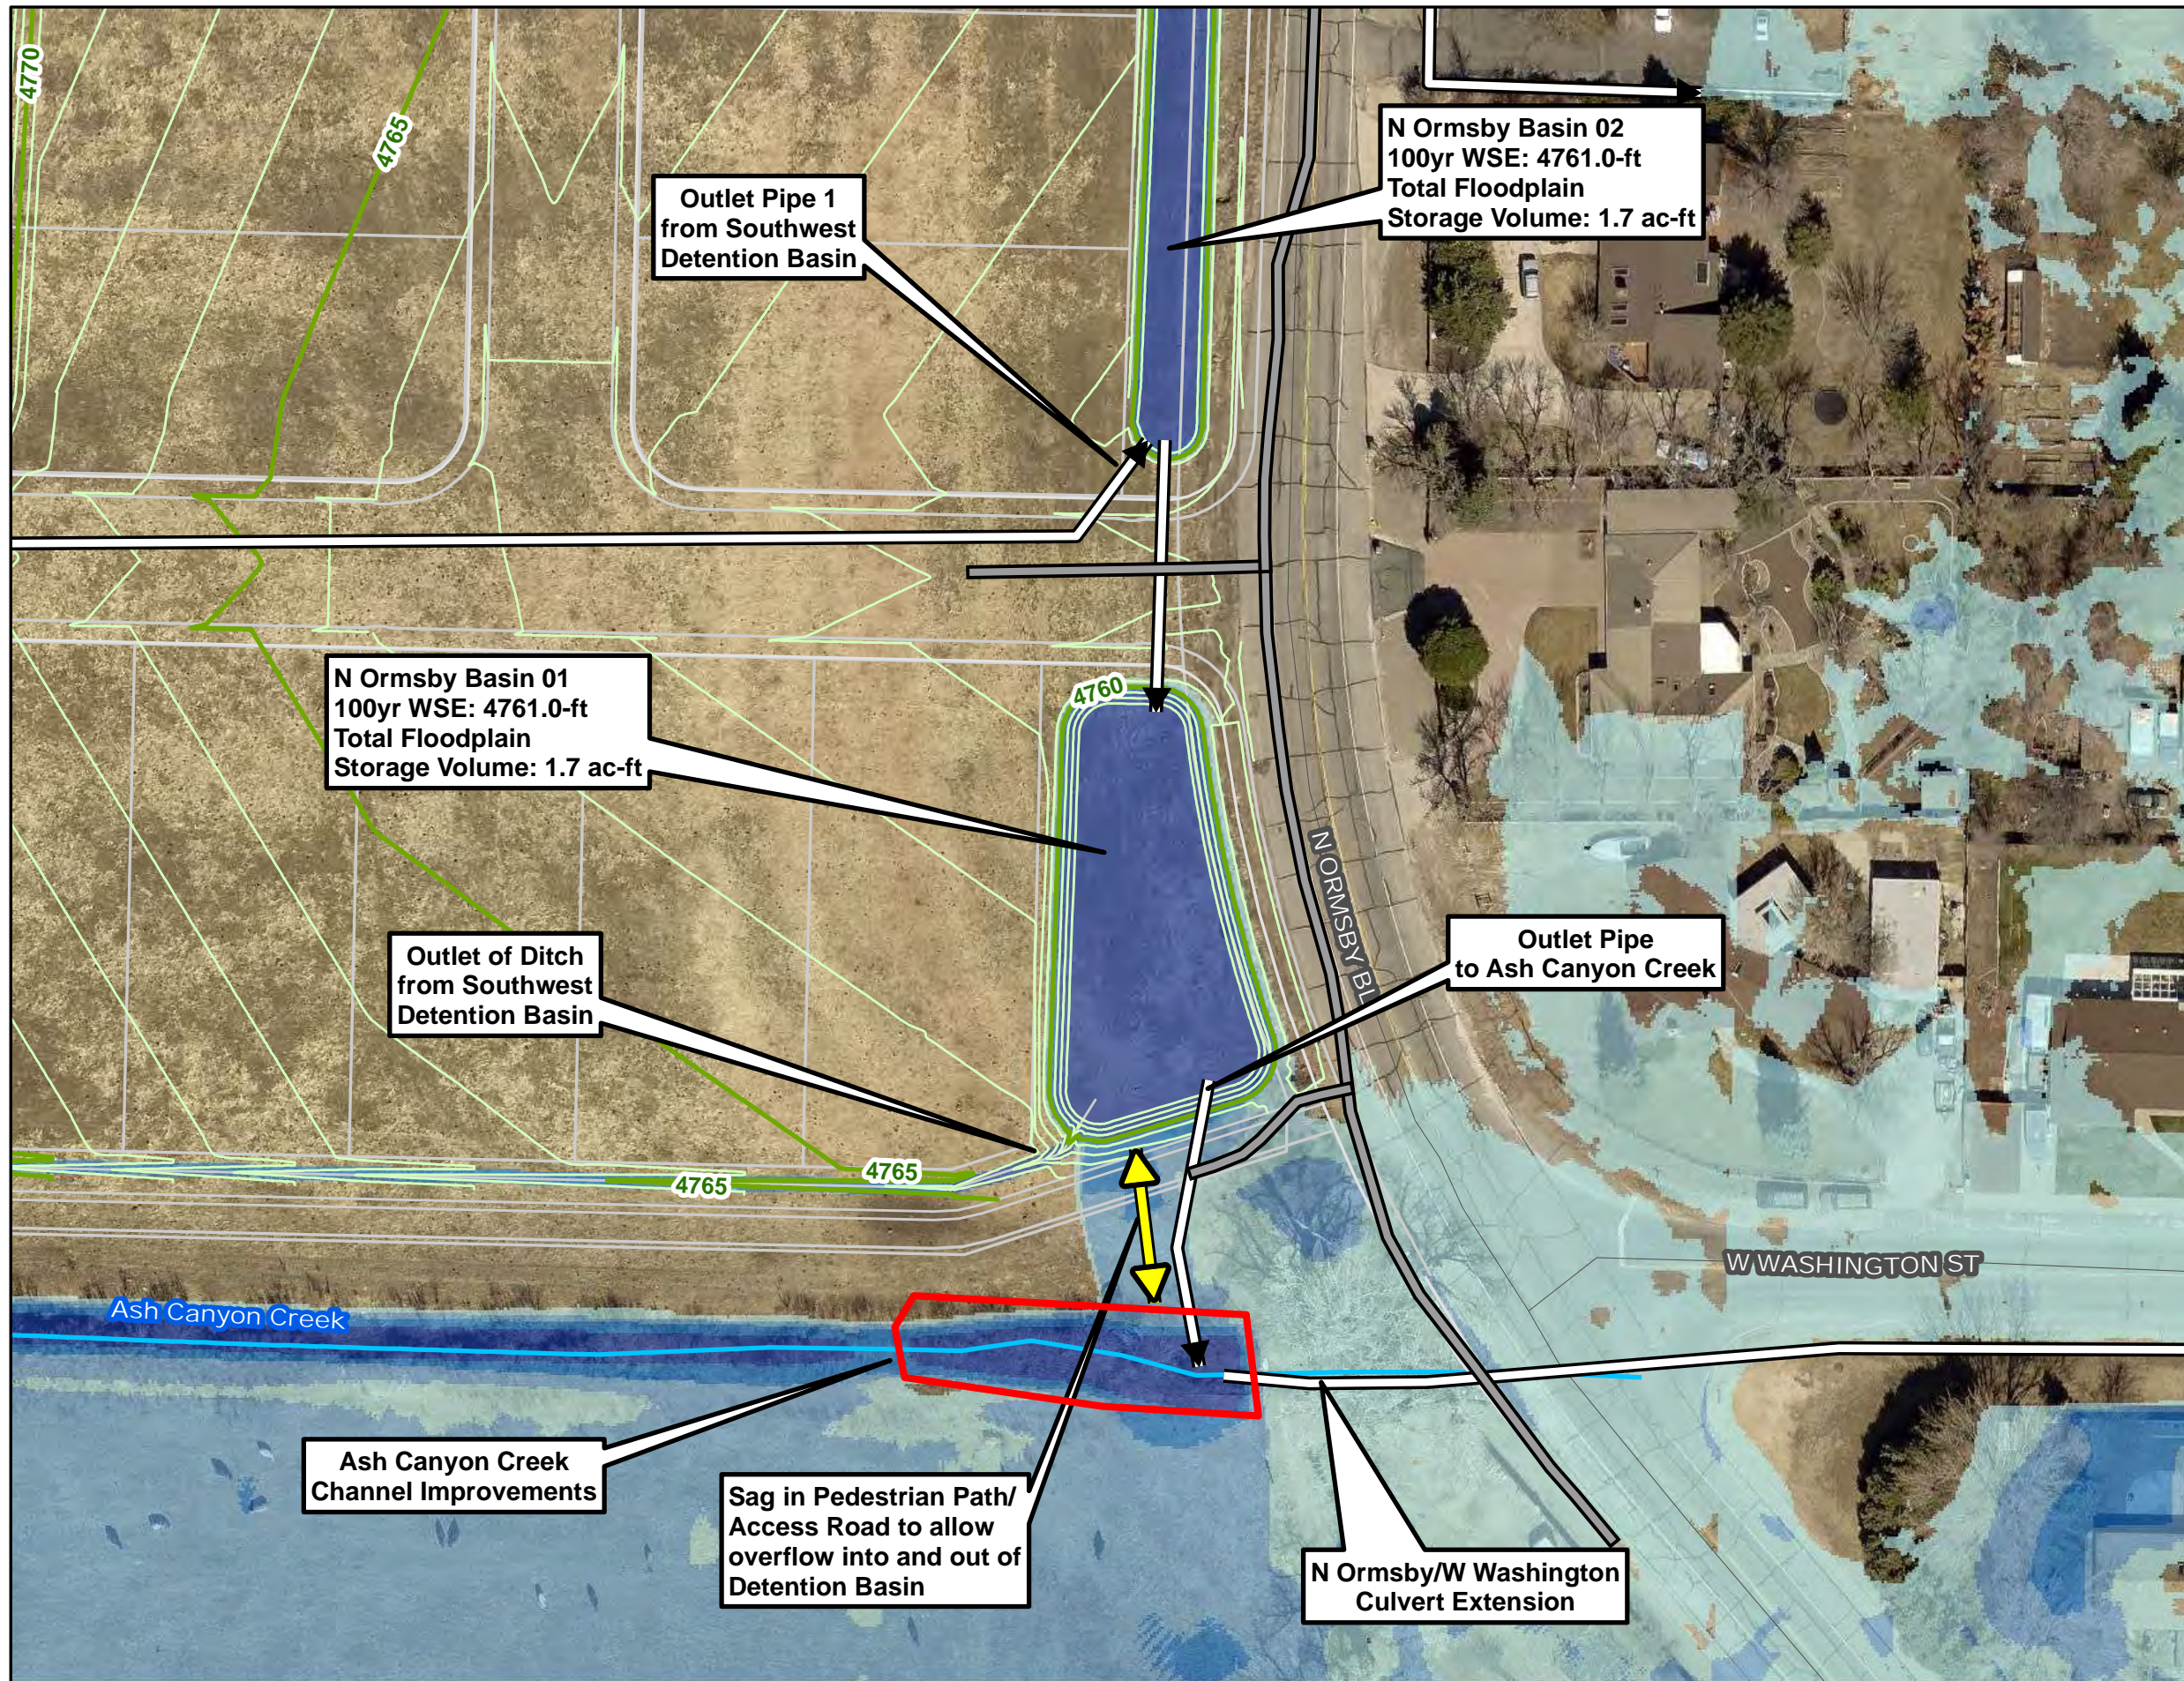
The details of North Ormsby detention basin system and the North Ormsby/West Washington culvert extension are illustrated on Exhibit 2 included in the attachments. As stated in the approach description, the purpose of basin system is to maintain floodplain storage similar to existing conditions. Table 2 below contains the floodplain storage volume calculated in existing and proposed conditions at Water Surface Elevation (WSE) 4761-ft.

The North Ormsby/West Washington culvert will be extended approximately 80 feet upstream and replace the existing culvert under the small dirt road. Approximately 100 feet of the Ash Canyon Creek channel will be improved upstream of the extended culvert to lower the channel and improve the transition into the entrance of the extended culvert.

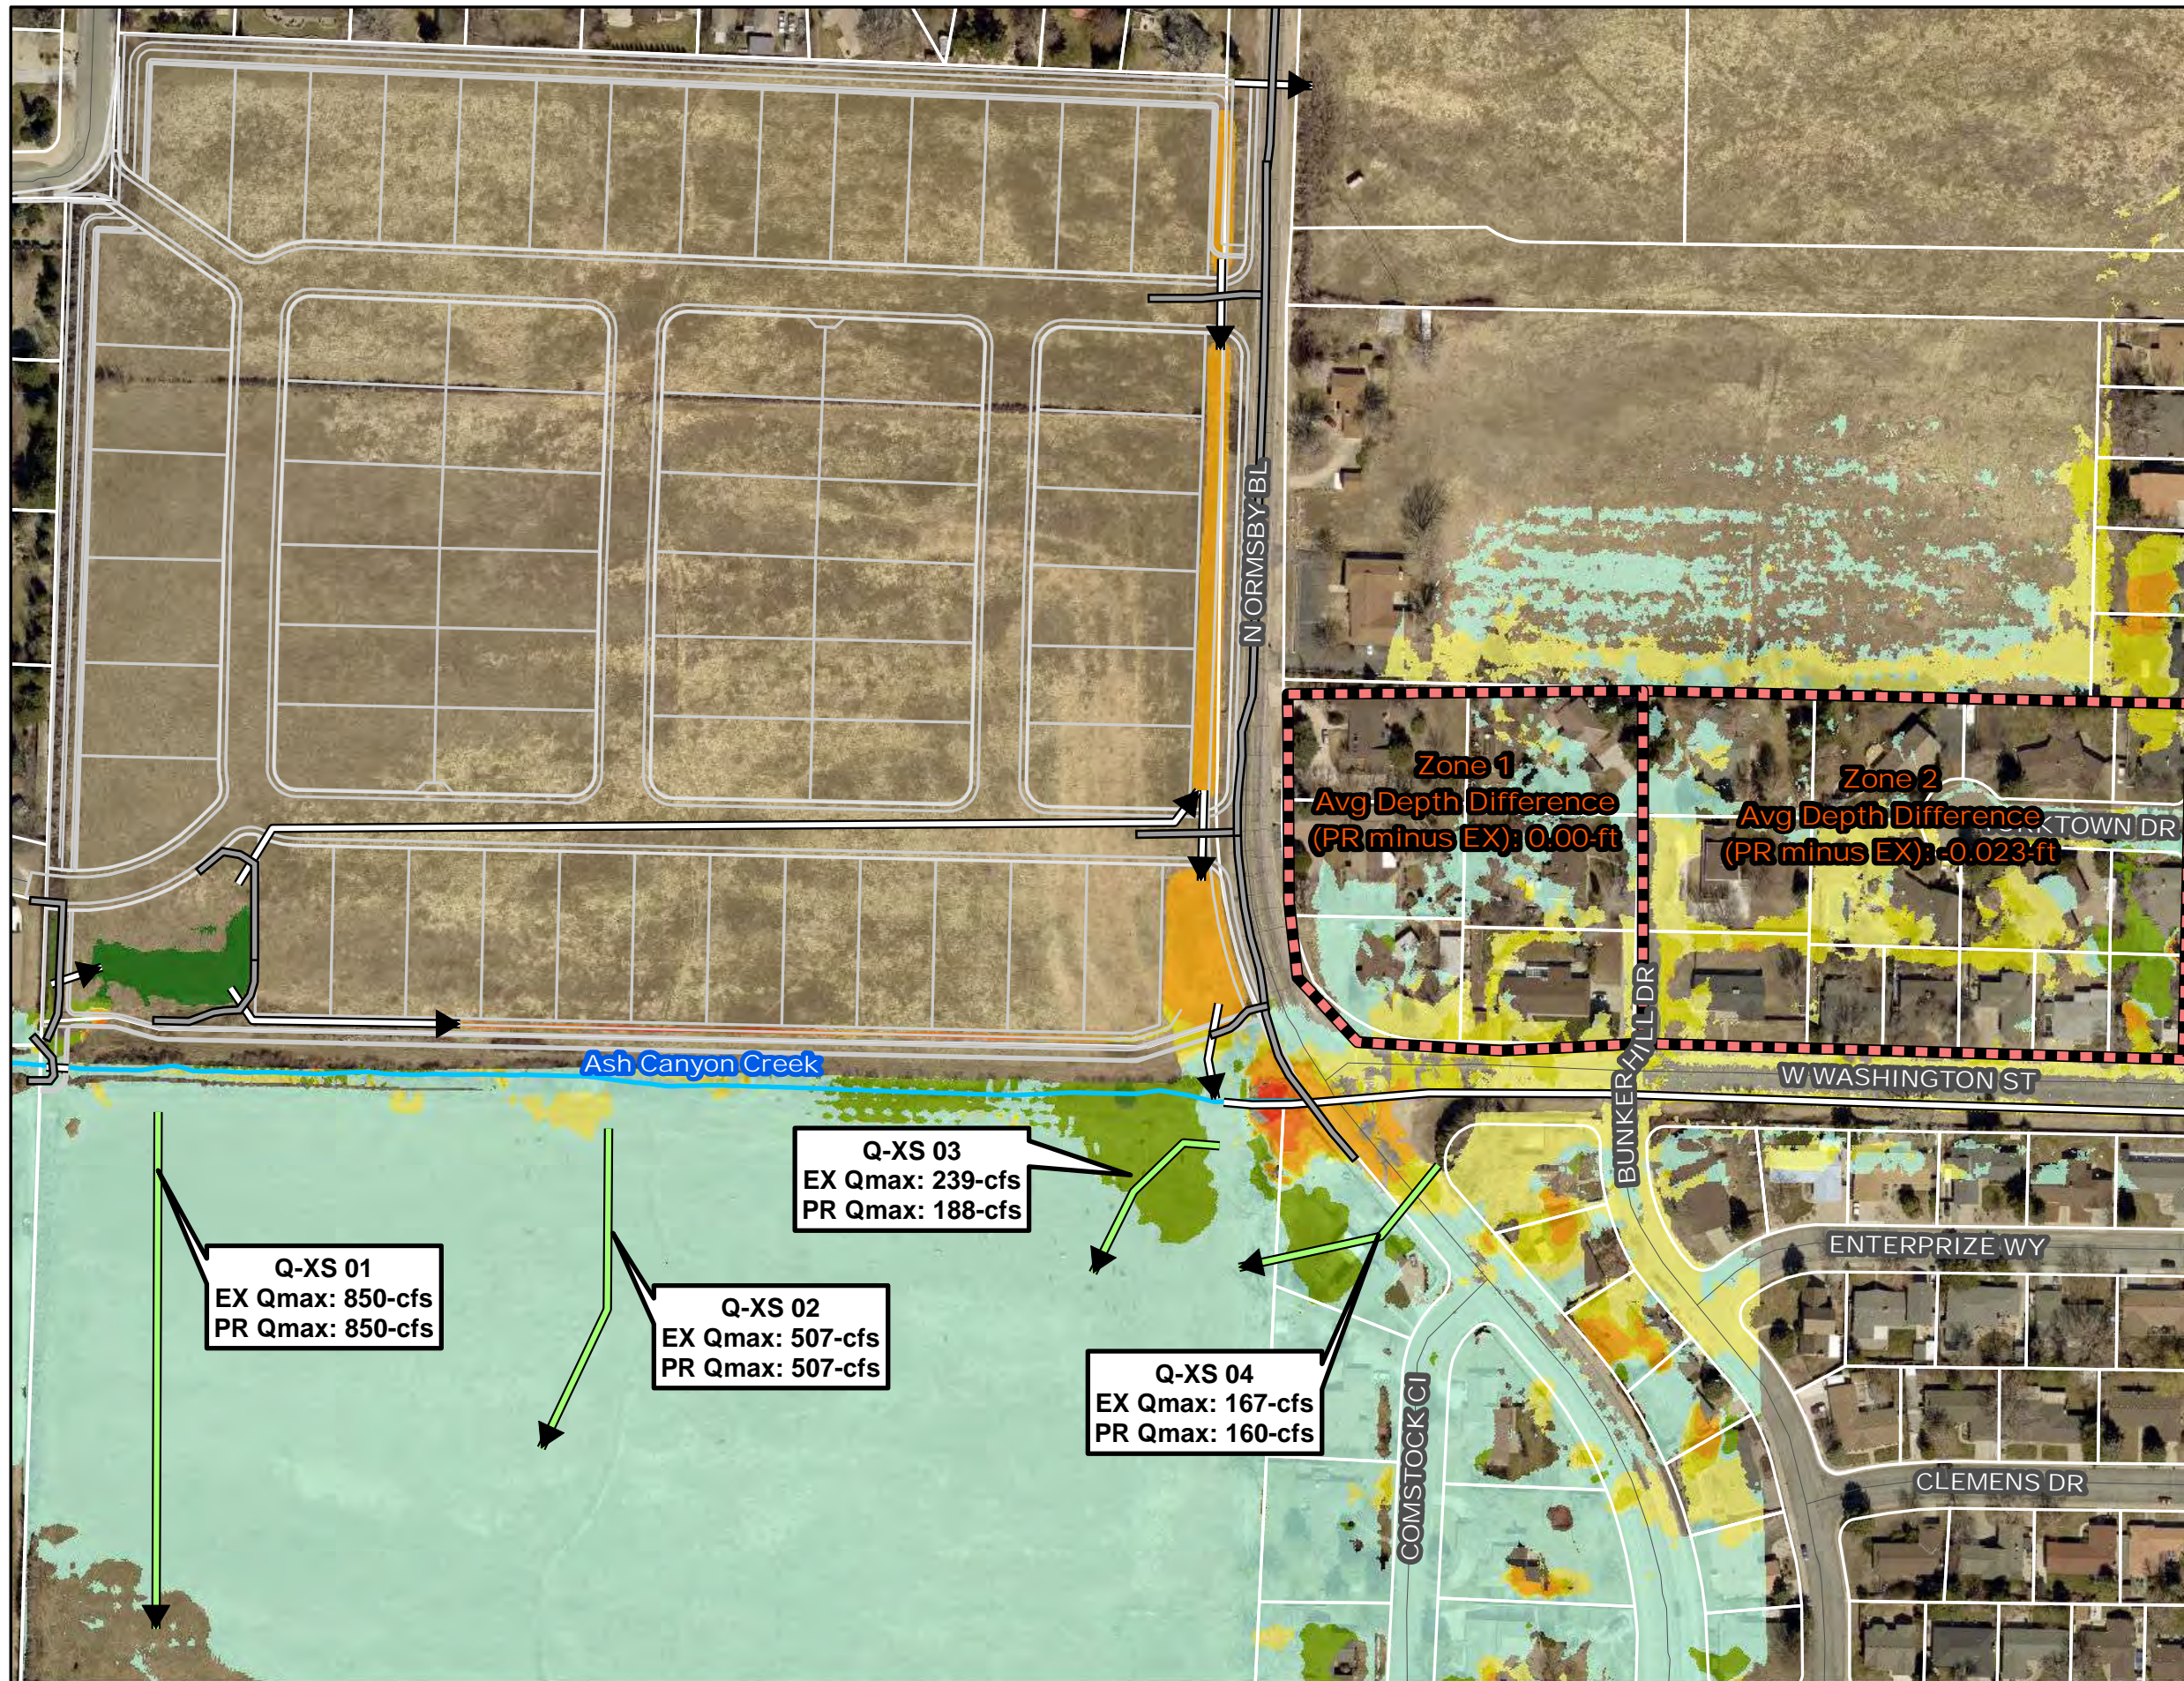
To ensure the proposed Andersen Ranch Development does not adversely impact flooding to surrounding areas maximum WSE's, average depths, and peak flows from the HEC-RAS 2D Existing and Proposed Conditions model will be analyzed. The attached Exhibit 3 illustrates the different evaluation methods and locations. The different methods are necessary due to the variety of flow directions and types of flooding that occur in this area. Along the main channel of Ash Canyon Creek, a comparison of WSE's is appropriate. South of Ash Canyon Creek, flow that enters the right overbank splits away from Ash Canyon Creek and flows south towards Kings Canyon Creek. In this region floodplain cross-sections are used to ensure the peak flow leaving Ash Canyon Creek has not increased. Existing and proposed conditions peak flows taken at four floodplain cross-sections are included in Table 3 below.

To the east of North Ormsby Blvd, the surface flow transitions to shallow flooding. Due to the small variations in model results between the two scenarios (Existing Conditions vs Proposed Conditions) caused by minor differences in the 2D mesh, variable time steps, and other model parameters that are variable, it is advisable to use an average depth method to evaluate regions affected by shallow flooding. The average depth zonal method was used to divide the regions affected by shallow flooding into

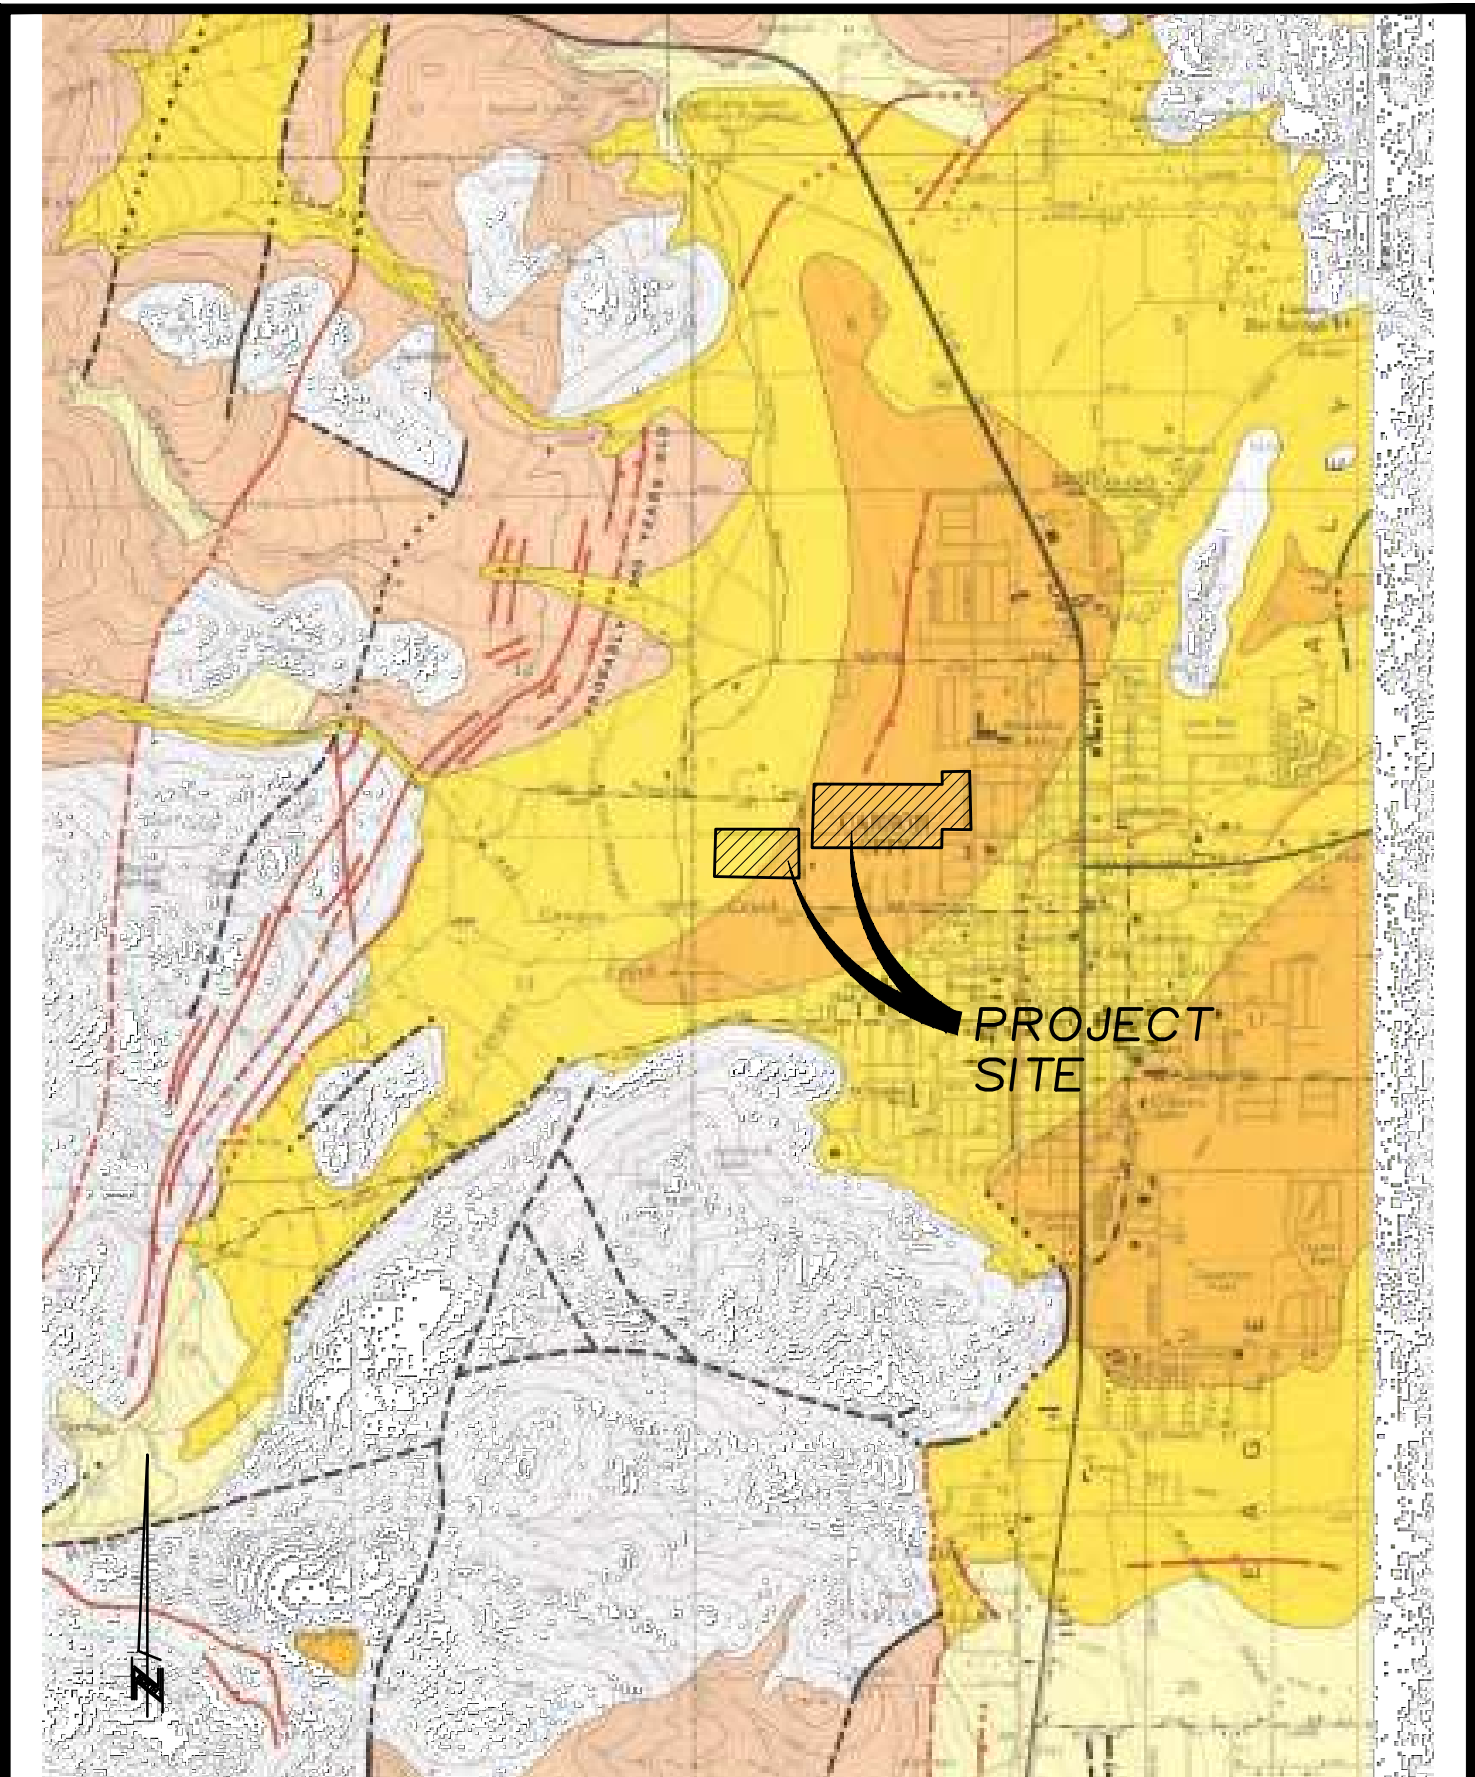
FAULT MAP

According to the Carson City Quadrangle Earthquake Hazards Map by Trexler and Bell (1979) a north/south trending fault is approximately 500-1000 feet north of the site (Plate 5). The fault is mapped as a Holocene, which is <12,000 years old, which is considered potentially active. However, no active Holocene (<12,000 years) age faulting is known to cross the site, nor has any direct evidence of on-site faulting been observed in the field during the current investigation.

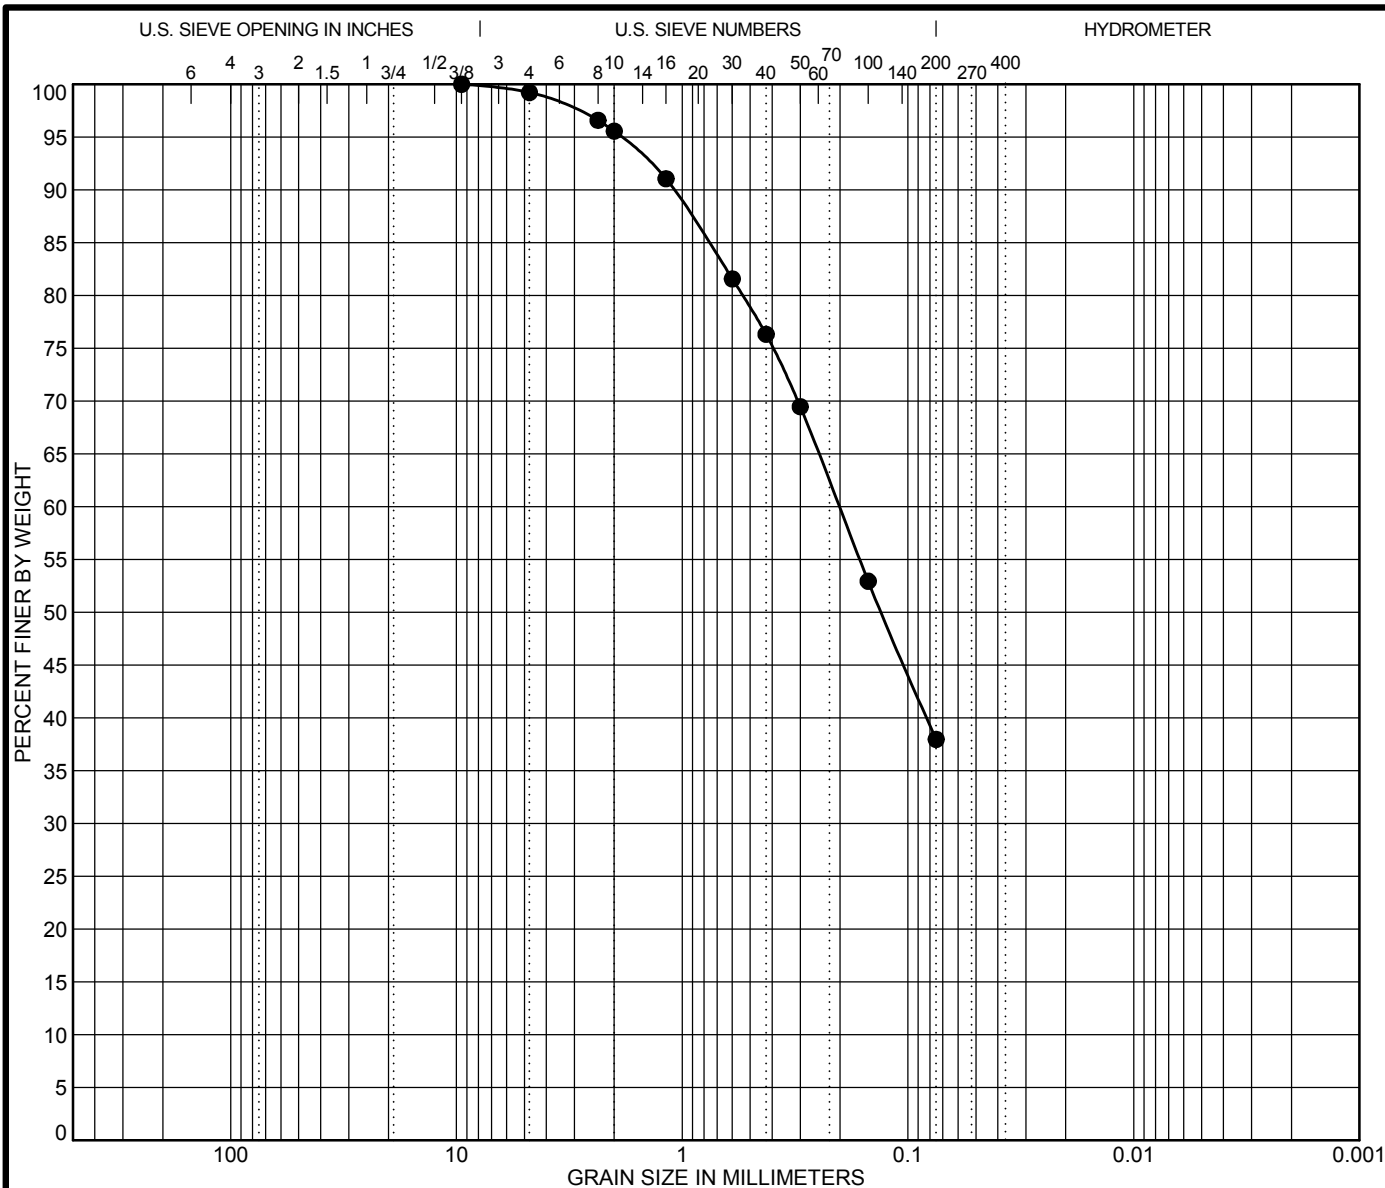
PLATE
B-1.1

Specimen Identification		Date: 5-6-2016									
B-01		Classification					LL	PL	PI	Cc	Cu
Depth: 0		Clayey SAND (SC)					36	23	13		
Sample Location		Comb. Samp. B-1, 2, 3, & 5 from 0'-3'									
USCS		SC									
AASHTO											
Specimen Identification											
B-01		D100	D60	D30	D10	%Gravel	%Sand	%Silt	%Clay		
Depth: 0		9.5	0.202			0.8	61.3	38.0			
Natural Moisture		6.7 %		S.E.		Absorption %					
R-Value		43		Durability Index		Soundness					
Percentage of Wear (500 rev)		%		Specific Gravity		Direct Shear		35

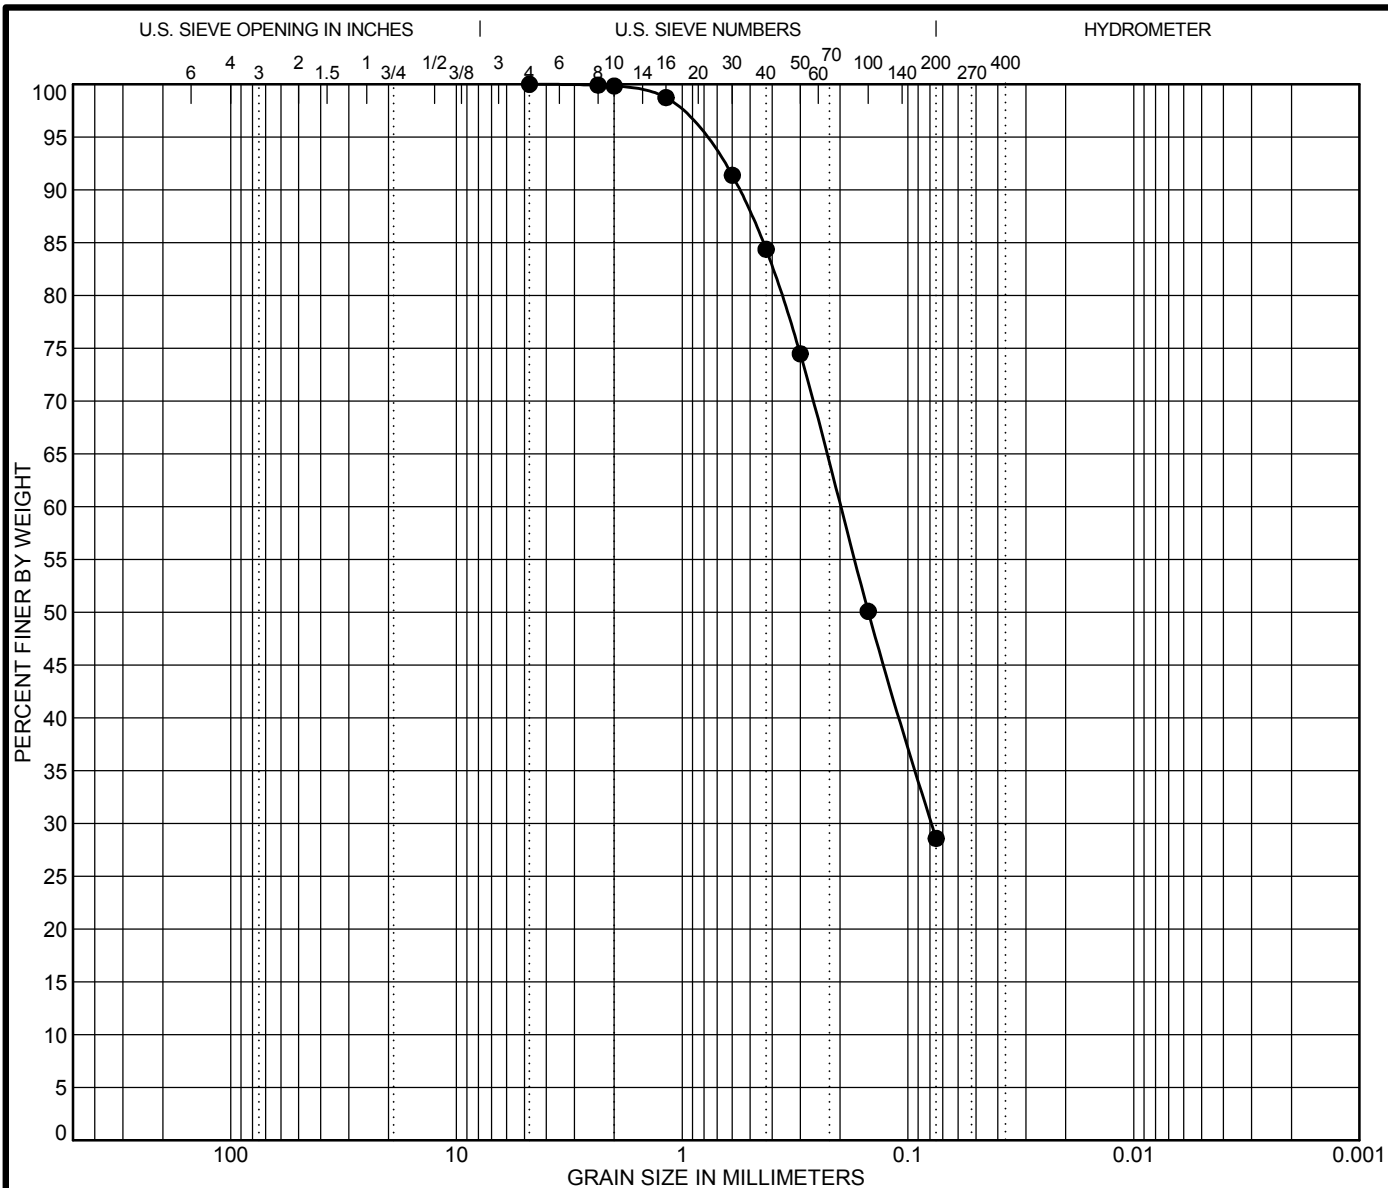
PLATE
B-1.2

Specimen Identification		Date: 5-2-2016					LL	PL	PI	Cc	Cu
●	B-01	Classification					34	16	18		
	Depth: 5	Clayey SAND (SC)									
	Sample Location	Boring 1 from 5' - 6.5'									
	USCS	SC									
	AASHTO										
Specimen Identification		D100	D60	D30	D10	%Gravel	%Sand	%Silt	%Clay		
●	B-01	4.75	0.199	0.079		0.0	71.4	28.6			
	Depth: 5										
	Natural Moisture	14.1 %		S.E.		Absorption %					
	R-Value			Durability Index		Soundness					
	Percentage of Wear (500 rev)	%		Specific Gravity		Direct Shear

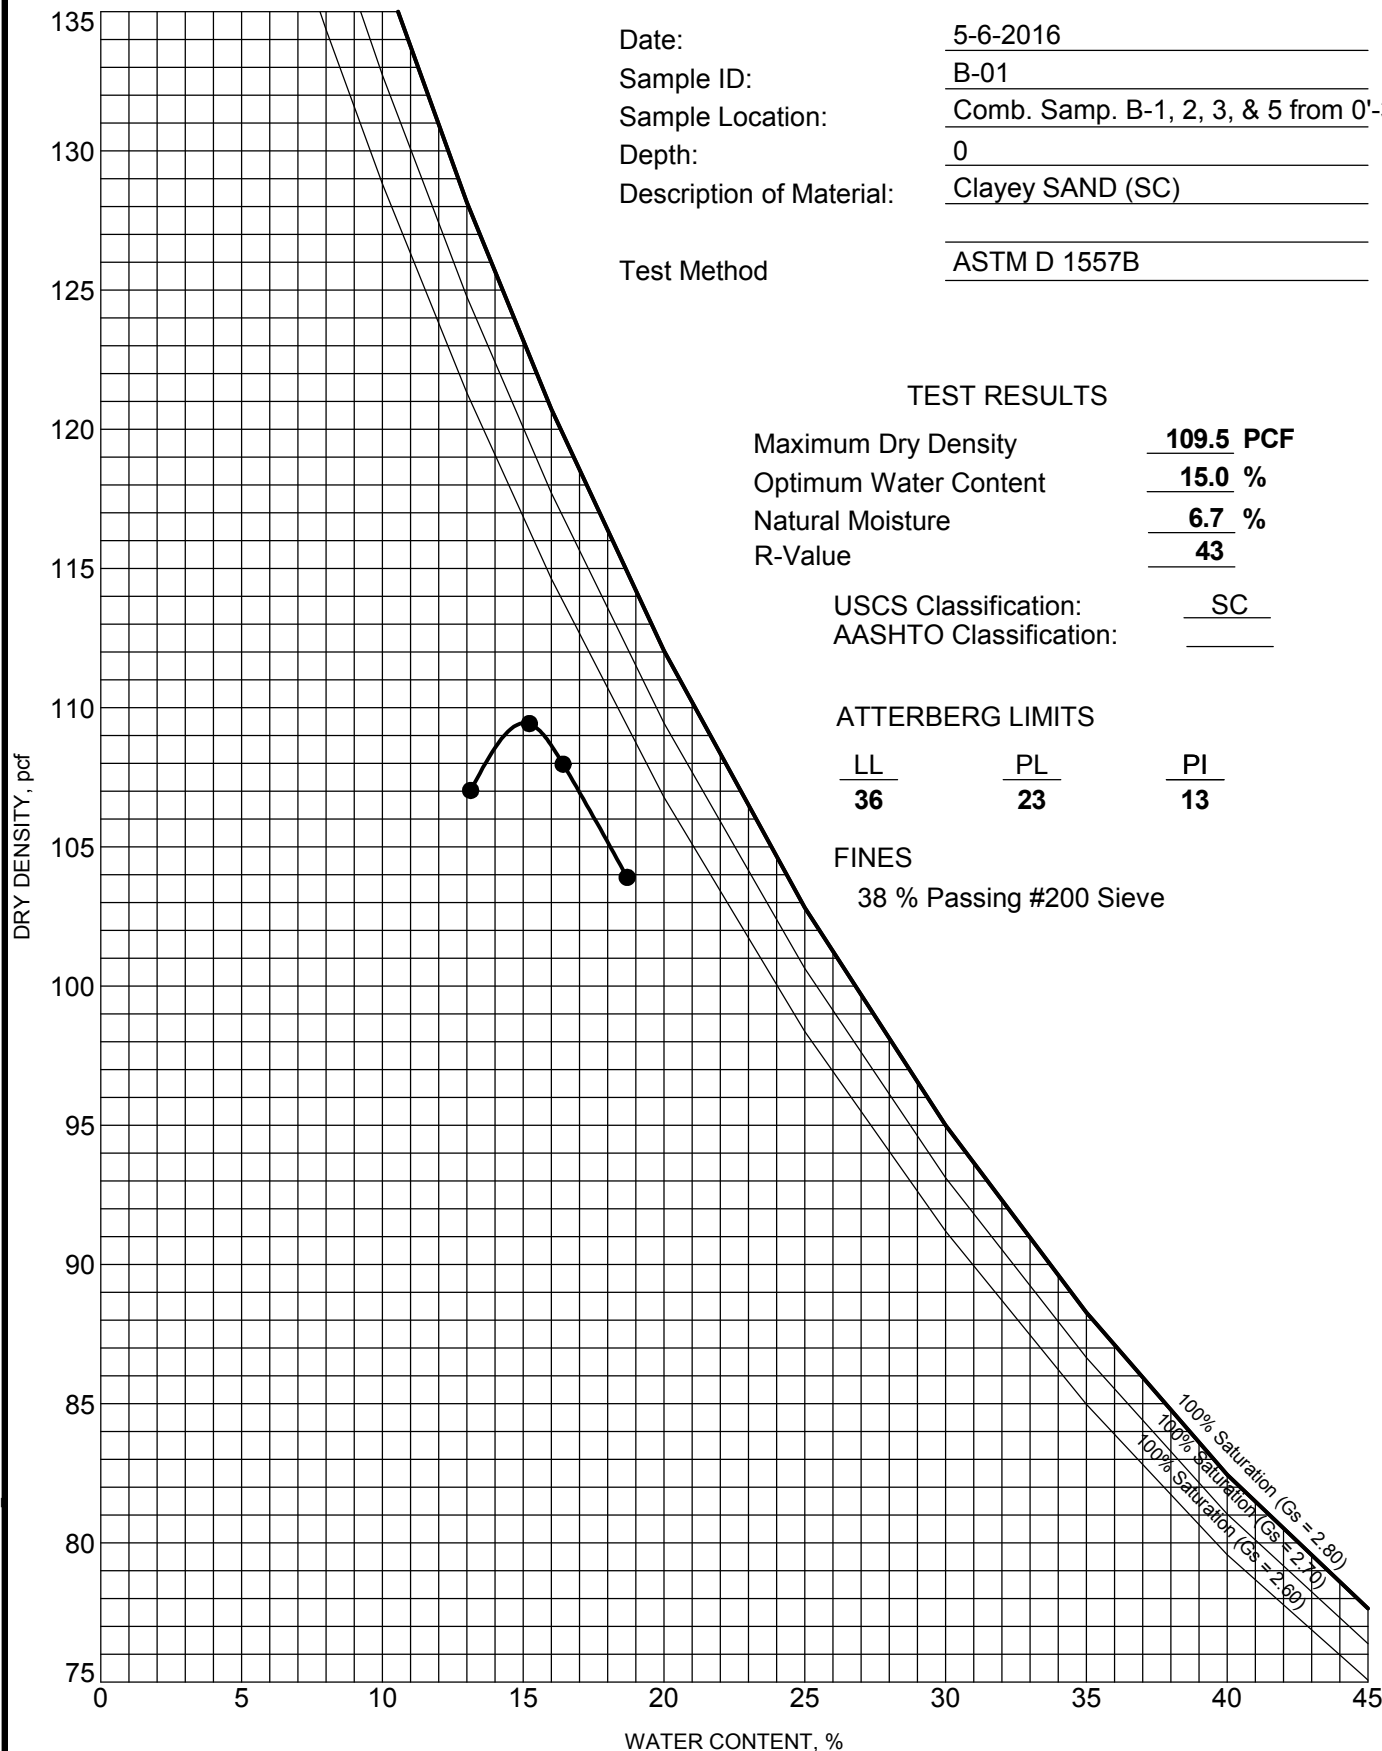
Date: 5-6-2016
 Sample ID: B-01
 Sample Location: Comb. Samp. B-1, 2, 3, & 5 from 0'-3'
 Depth: 0
 Description of Material: Clayey SAND (SC)
 Test Method: ASTM D 1557B

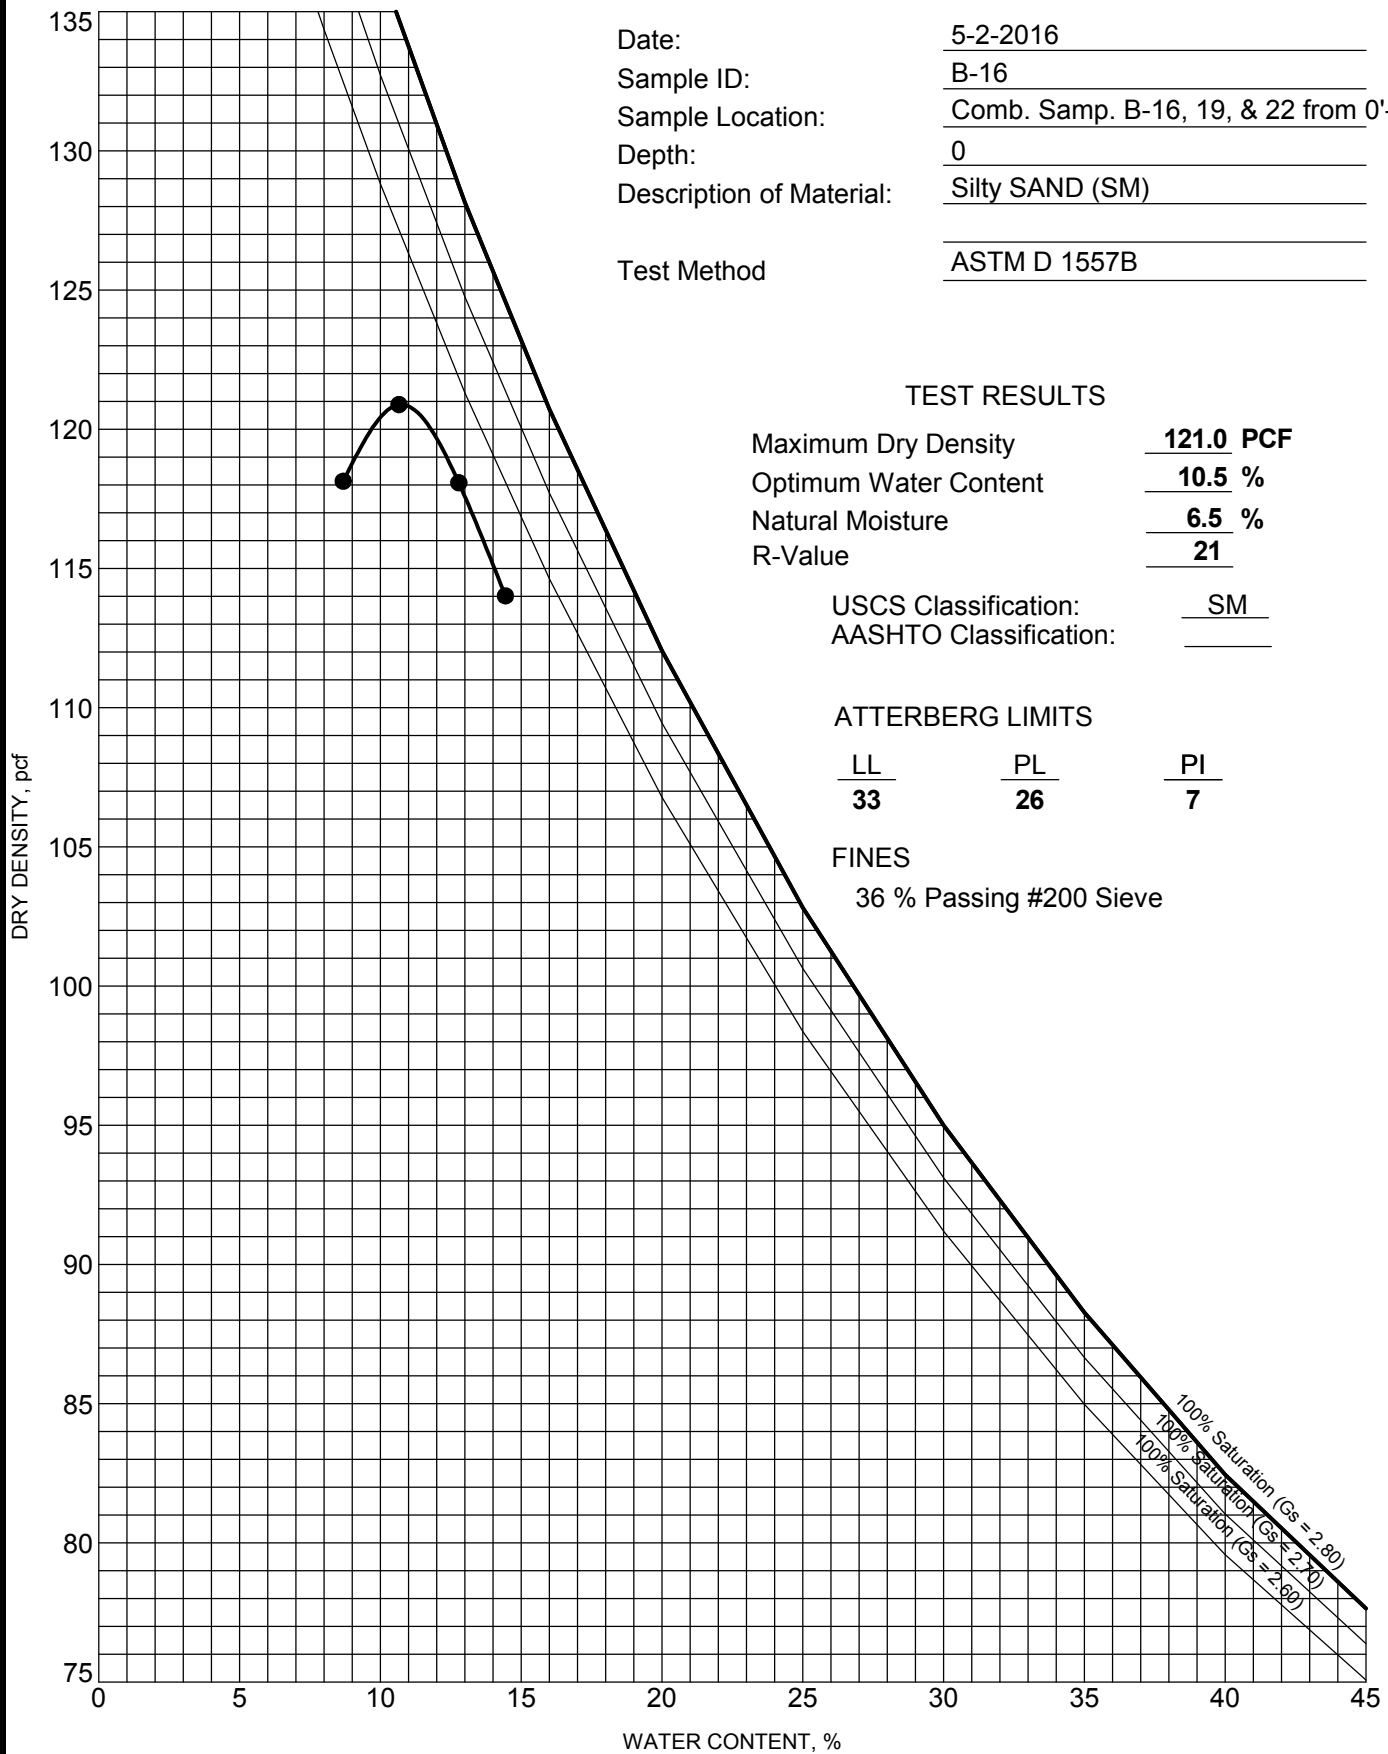
PLATE
B-3.2

Date: 5-2-2016
 Sample ID: B-16
 Sample Location: Comb. Samp. B-16, 19, & 22 from 0'-8"
 Depth: 0
 Description of Material: Silty SAND (SM)
 Test Method: ASTM D 1557B

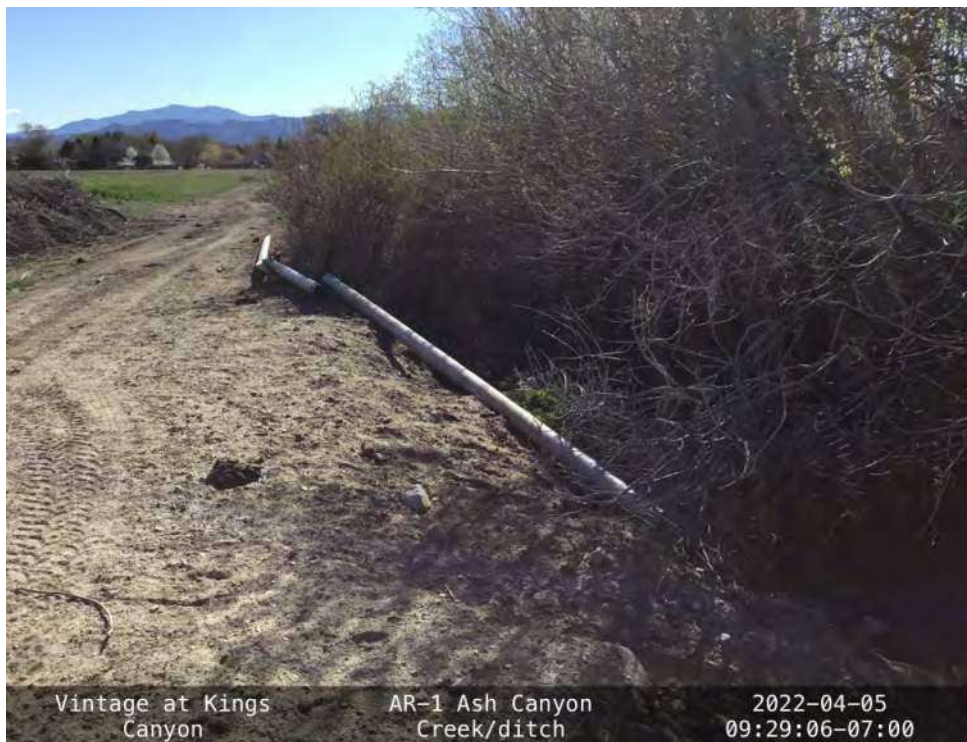
Photo 4. Overview of Ash Canyon Creek (AR-1). View looking east on north bank.

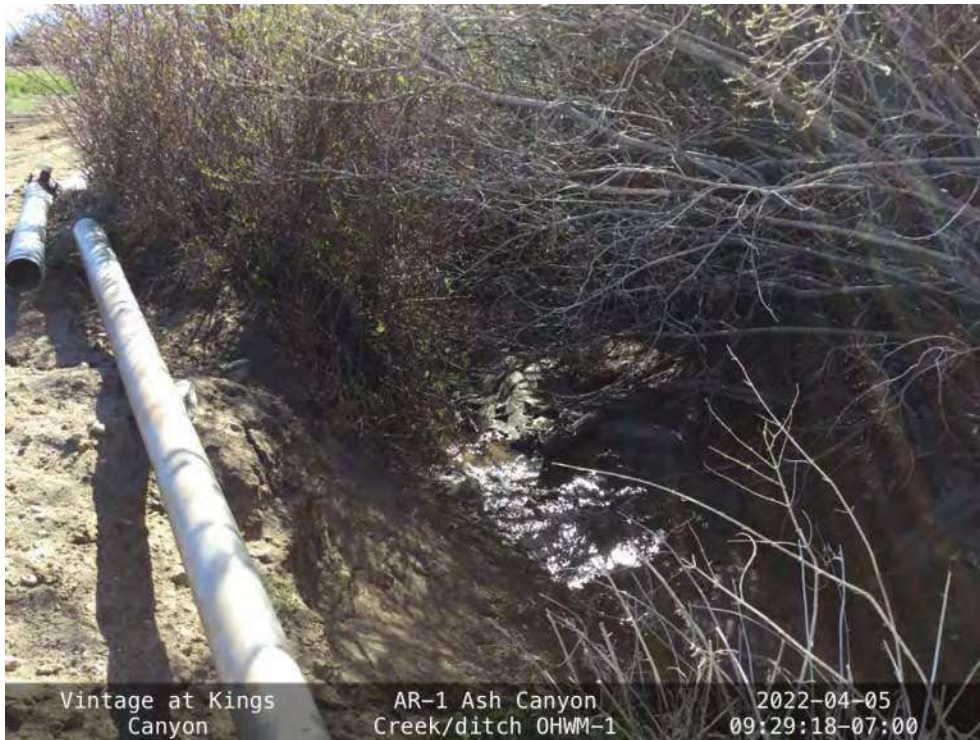
Photo 5. OHWM-1: picture showing approximately 2-4 inches of water in Ash Canyon Creek (AR-1). Exposed/partially excavated left bank with disconnected irrigation line. View looking southeast.

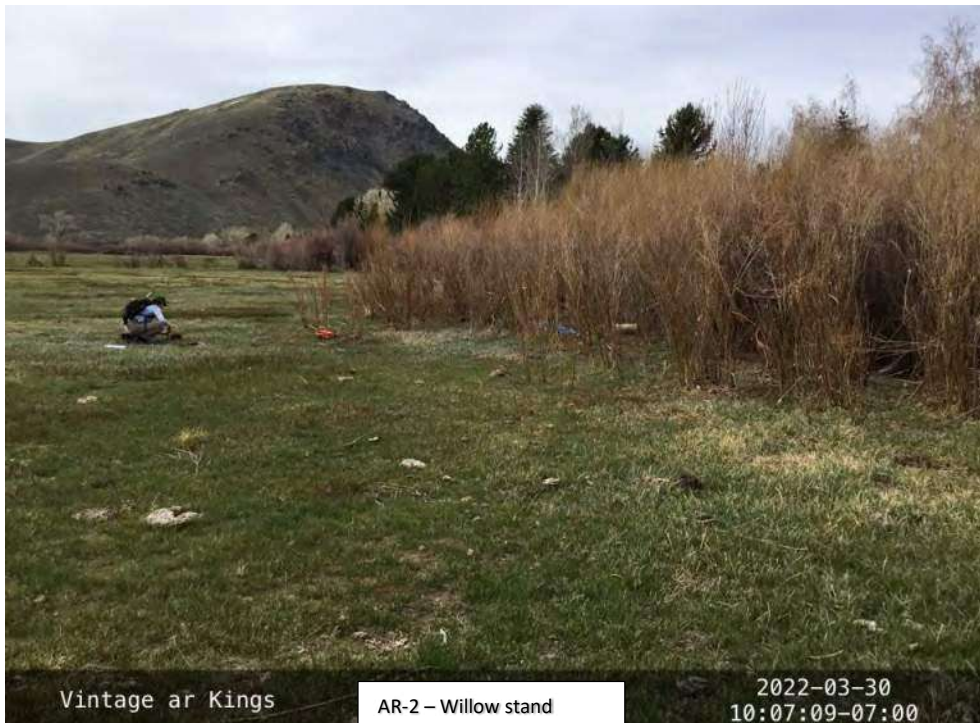
Photo 6. AR-2: Irrigation ditch running along the western boundary of Survey Area, flows south to north then terminates at northwest corner. Water from AR-2 flood irrigates pasture visible in picture. View looking south.

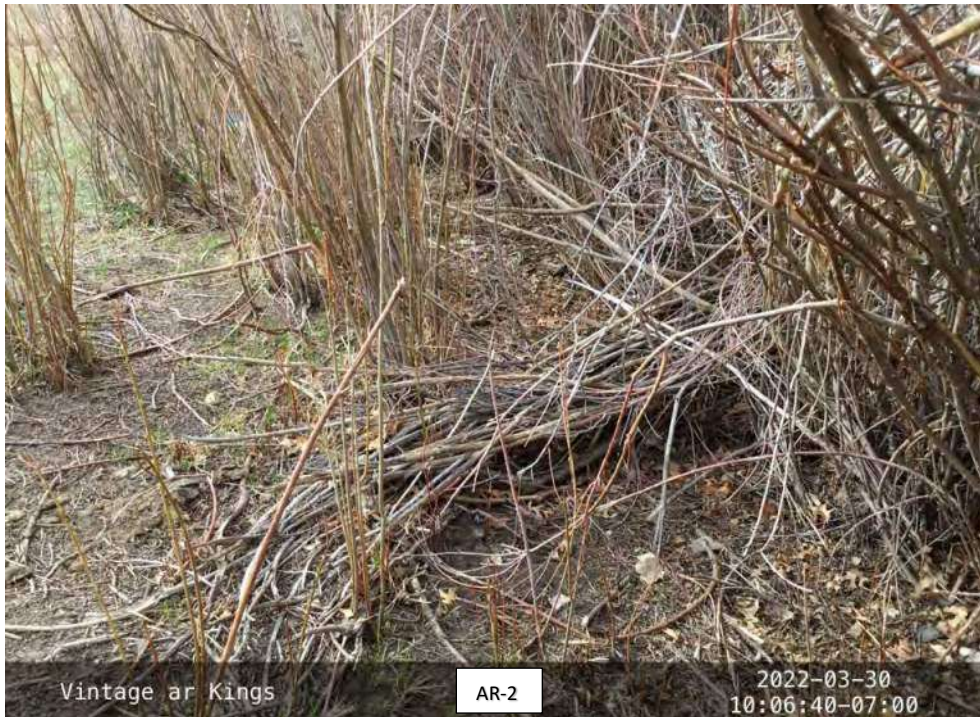
Photo 7. OHWM-2: AR-2 irrigation ditch at western boundary of Survey Area. Thick willow obscuring view of channel. Average channel width approximately 5 feet. View looking southwest.
