The purpose of this Memo is to present the preliminary results and mitigation associated with the hydraulic analysis of Ash Canyon Creek in support of the FEMA Conditional Letter of Map Revision (CLOMR) to be submitted in association of the proposed Andersen Ranch West development. The proposed development is located within a Zone AE flood zone without a regulatory floodway, which includes Base Flood Elevations (BFEs) that have been determined by detailed methods, as shown on the effective FEMA Flood Insurance Rate Map (FIRM) panel #3200010091F, dated 2/19/2014. Additionally, a LOMR (20-09-0437P) that includes the Andersen Ranch West parcel was completed by House Moran and became effective 2/18/2021. The LOMR revised the existing conditions FEMA model and mapping. The site boundary and effective FEMA mapping are illustrated on Figure 1 below.

Andersen Ranch Development
(AKA The Vintage at King's Canyon)
VICINITY MAP

The Vintage at King's Canyon

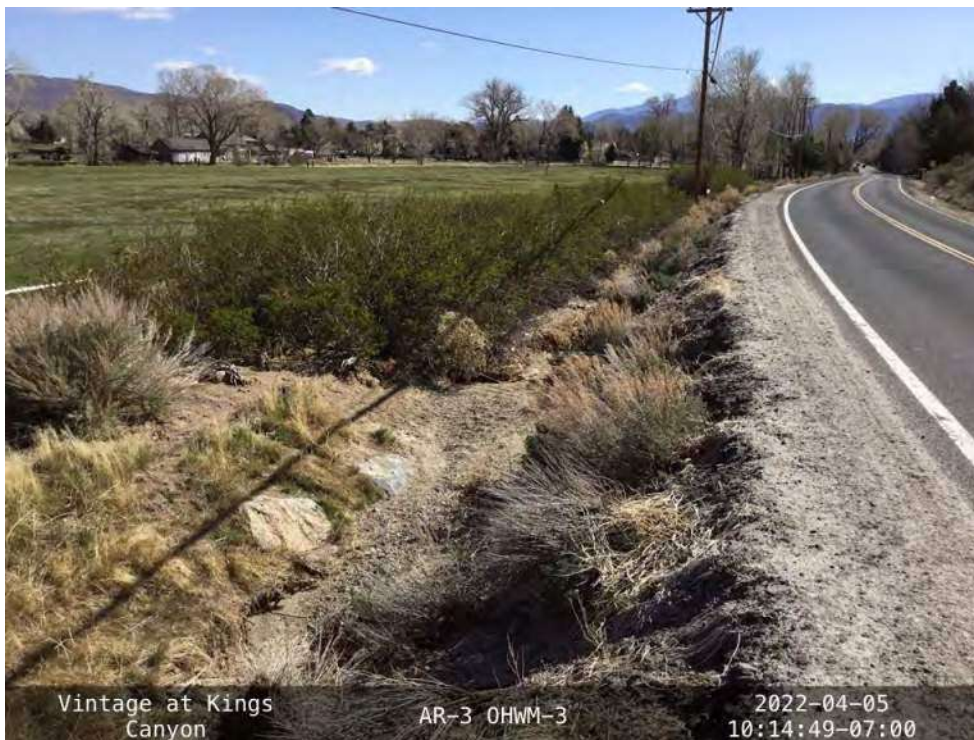
Photo 8. OHWM-3: AR-3 excavated roadside ditch capturing storm water from road. When present, water flow from west to east into storm drain at southeast corner of Survey Area. View looking east.

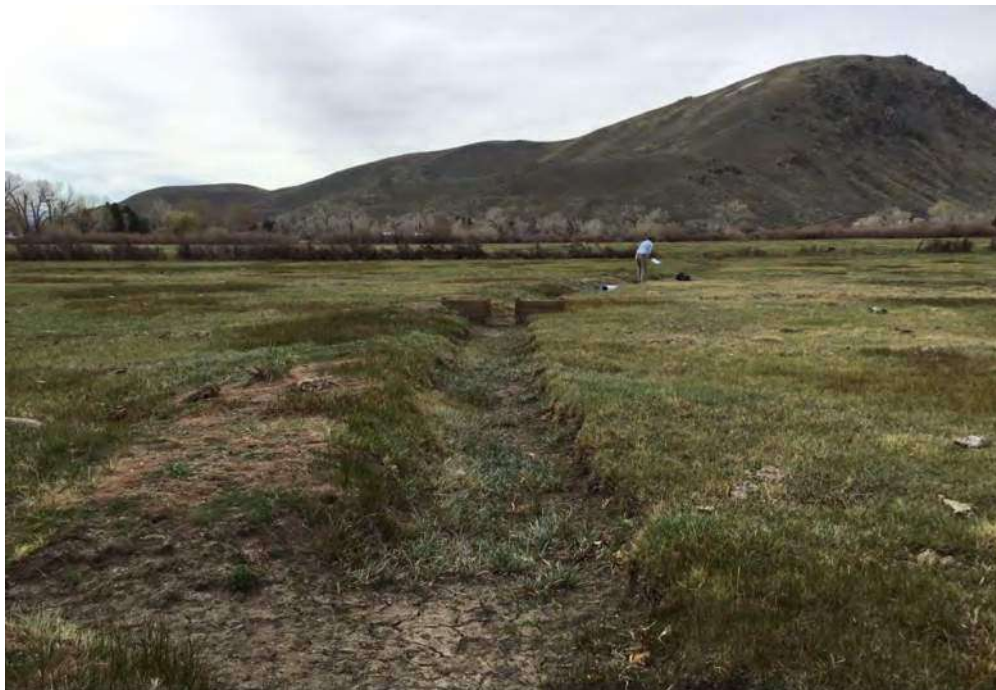
Photo 12. AR-4a: Southern end of AR-4 excavated irrigation ditch. Old irrigation ditch capturing sheet flow across pasture. Small weir visible in picture no longer operating. View looking south.
