APPENDIX L
FACILITIES REPORTS – TRANSIT STOPS

City of Carson City
ADA Self-Evaluation and Transition Plan Update
Transit Stop Projection Summary
2/13/2015

Route: No Route Listed on Sign GPS ID: 1
 Project Name: Hot Springs Rd - South (East of Roop St)
 City: Carson City

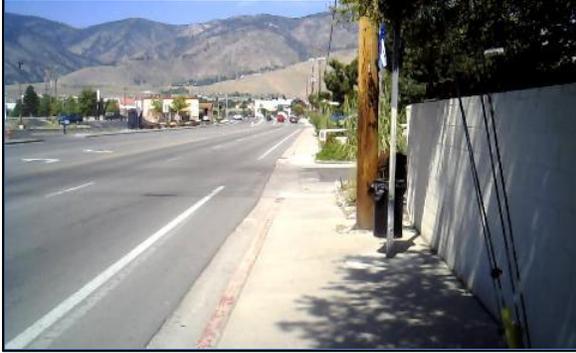
Boarding/Alighting Area

Boarding Area Issues	Issue Exists	Recommendations
Boarding area does not exist		
Boarding area length is less than 96"	X	Increase boarding area size
Boarding area width is less than 60"		
Boarding area running slope is greater than 2%	X	
Boarding area cross slope is greater than adjacent street grade		
Heaving/Sinking/Cracking present in the boarding area		Remove and replace boarding area
Ponding present in the boarding area		
Permanent obstruction (>0.25") in boarding area		
Temporary obstruction (>0.25") in boarding area		
Transition at connection to the curb is greater than 0.25"	X	Fix connection transition
Boarding area is missing a connection to the street or sidewalk network		
Adjacent Sidewalk Network Issues	Issue Exists	Recommendations
Sidewalk network width is less than 48"		
Sidewalk network cross slope is greater than 2%		
Heaving/Sinking/Cracking present in the sidewalk network		
Ponding present in the sidewalk network

Comment:
 Transit stop sign covered by tree limbs; remove temporary obstruction.

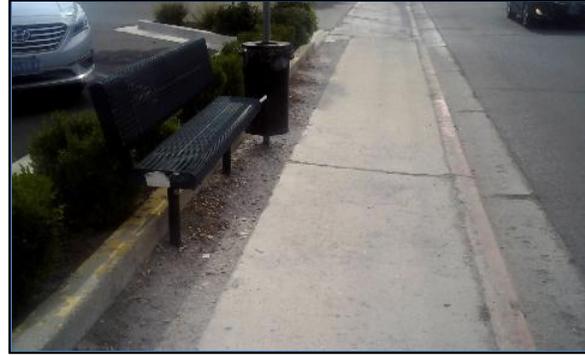
Boarding/Alighting Area

Boarding Area Issues	Issue Exists	Recommendations
Boarding area does not exist		
Boarding area length is less than 96"	X	Increase boarding area size
Boarding area width is less than 60"		
Boarding area running slope is greater than 2%	X	
Boarding area cross slope is greater than adjacent street grade		
Heaving/Sinking/Cracking present in the boarding area	X	Remove and replace boarding area
Ponding present in the boarding area		
Permanent obstruction (>0.25") in boarding area		
Temporary obstruction (>0.25") in boarding area		
Transition at connection to the curb is greater than 0.25"	X	Fix connection transition
Boarding area is missing a connection to the street or sidewalk network		
Adjacent Sidewalk Network Issues	Issue Exists	Recommendations
Sidewalk network width is less than 48"		
Sidewalk network cross slope is greater than 2%		
Heaving/Sinking/Cracking present in the sidewalk network		
Ponding present in the sidewalk network

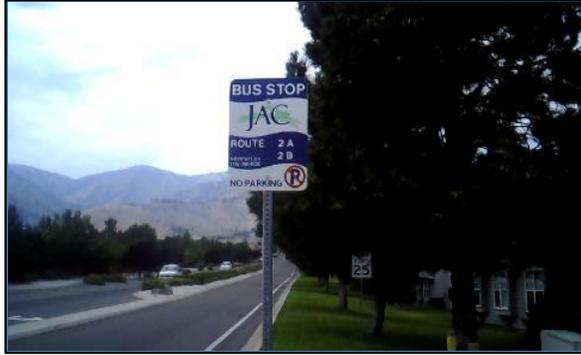
Boarding/Alighting Area

Boarding Area Issues	Issue Exists	Recommendations
Boarding area does not exist		
Boarding area length is less than 96"		
Boarding area width is less than 60"	X	Increase boarding area size
Boarding area running slope is greater than 2%		
Boarding area cross slope is greater than adjacent street grade	X	
Heaving/Sinking/Cracking present in the boarding area		Remove and replace boarding area
Ponding present in the boarding area		
Permanent obstruction (>0.25") in boarding area		
Temporary obstruction (>0.25") in boarding area		
Transition at connection to the curb is greater than 0.25"		
Boarding area is missing a connection to the street or sidewalk network		
Adjacent Sidewalk Network Issues		
Sidewalk network width is less than 48"		
Sidewalk network cross slope is greater than 2%		
Heaving/Sinking/Cracking present in the sidewalk network		
Ponding present in the sidewalk network		
Permanent obstruction (>0.25") in sidewalk network

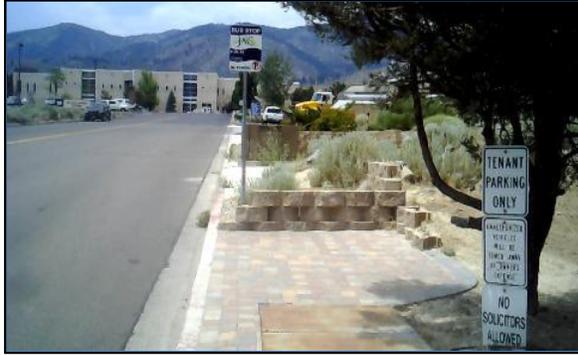
Boarding/Alighting Area

Comment:
 Brick pavers present in boarding area. Cost estimate includes concrete base for boarding area without brickpaver overlay. No sidewalk network present; boarding area connects directly to driveway.

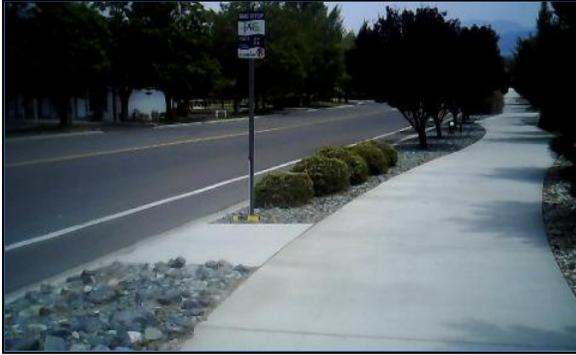
Boarding/Alighting Area

Boarding Area Issues	Issue Exists	Recommendations
Boarding area does not exist		
Boarding area length is less than 96"		
Boarding area width is less than 60"		
Boarding area running slope is greater than 2%	X	
Boarding area cross slope is greater than adjacent street grade		Remove and replace boarding area
Heaving/Sinking/Cracking present in the boarding area		
Ponding present in the boarding area		
Permanent obstruction (>0.25") in boarding area		
Temporary obstruction (>0.25") in boarding area		
Transition at connection to the curb is greater than 0.25"	X	Fix connection transition
Boarding area is missing a connection to the street or sidewalk network		
Adjacent Sidewalk Network Issues	Issue Exists	Recommendations
Sidewalk network width is less than 48"		
Sidewalk network cross slope is greater than 2%		
Heaving/Sinking/Cracking present in the sidewalk network		
Ponding present in the sidewalk network

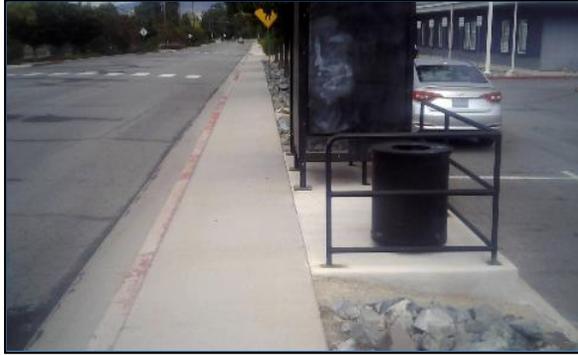
Boarding/Alighting Area

Boarding Area Issues	Issue Exists	Recommendations
Boarding area does not exist		
Boarding area length is less than 96"		
Boarding area width is less than 60"		
Boarding area running slope is greater than 2%	X	
Boarding area cross slope is greater than adjacent street grade		
Heaving/Sinking/Cracking present in the boarding area		Remove and replace boarding area
Ponding present in the boarding area		
Permanent obstruction (>0.25") in boarding area		
Temporary obstruction (>0.25") in boarding area		
Transition at connection to the curb is greater than 0.25"		
Boarding area is missing a connection to the street or sidewalk network		
Adjacent Sidewalk Network Issues		
Sidewalk network width is less than 48"		
Sidewalk network cross slope is greater than 2%		
Heaving/Sinking/Cracking present in the sidewalk network		
Ponding present in the sidewalk network		
Permanent obstruction (>0.25") in sidewalk network

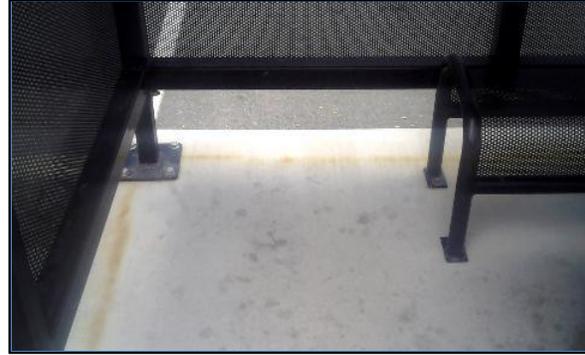
Shelter/Clear Space

No clear space under shelter		
Shelter clear space length is less than 48"		
Shelter clear space width is less than 30"		
Shelter clear space cross slope is greater than 2%		
Shelter clear space running slope is greater than 2%	X	
Shelter opening clear width is less than 32"

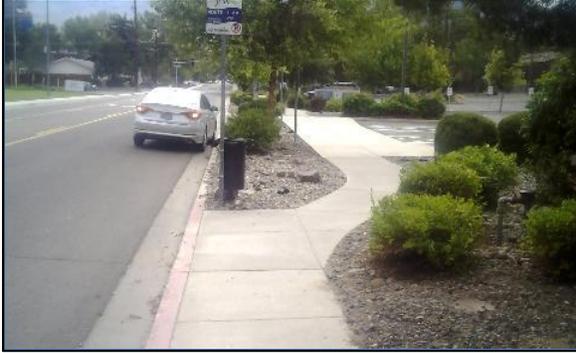
Boarding/Alighting Area

Boarding Area Issues	Issue Exists	Recommendations
Boarding area does not exist		
Boarding area length is less than 96"	X	Increase boarding area size
Boarding area width is less than 60"		
Boarding area running slope is greater than 2%	X	
Boarding area cross slope is greater than adjacent street grade		Remove and replace boarding area
Heaving/Sinking/Cracking present in the boarding area		
Ponding present in the boarding area		
Permanent obstruction (>0.25") in boarding area		
Temporary obstruction (>0.25") in boarding area		
Transition at connection to the curb is greater than 0.25"	X	Fix connection transition
Boarding area is missing a connection to the street or sidewalk network		
Adjacent Sidewalk Network Issues	Issue Exists	Recommendations
Sidewalk network width is less than 48"		
Sidewalk network cross slope is greater than 2%		
Heaving/Sinking/Cracking present in the sidewalk network		
Ponding present in the sidewalk network

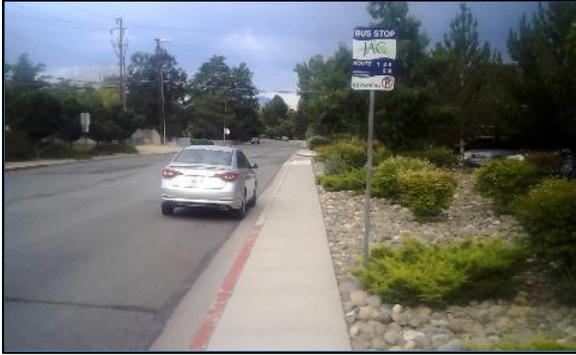
Boarding/Alighting Area

Boarding Area Issues	Issue Exists	Recommendations
Boarding area does not exist		
Boarding area length is less than 96"	X	Increase boarding area size
Boarding area width is less than 60"		
Boarding area running slope is greater than 2%	X	
Boarding area cross slope is greater than adjacent street grade		
Heaving/Sinking/Cracking present in the boarding area	X	Remove and replace boarding area
Ponding present in the boarding area		
Permanent obstruction (>0.25") in boarding area		
Temporary obstruction (>0.25") in boarding area		
Transition at connection to the curb is greater than 0.25"		
Boarding area is missing a connection to the street or sidewalk network		
Adjacent Sidewalk Network Issues		
Sidewalk network width is less than 48"		
Sidewalk network cross slope is greater than 2%		
Heaving/Sinking/Cracking present in the sidewalk network		
Ponding present in the sidewalk network		
Permanent obstruction (>0.25") in sidewalk network

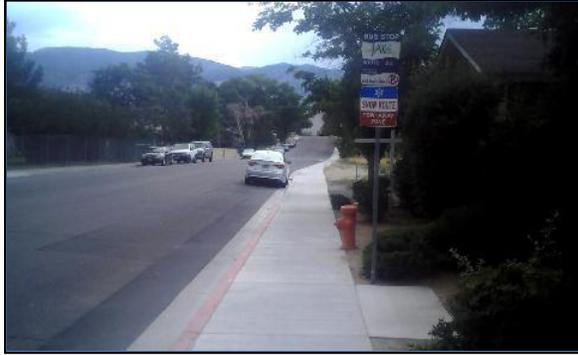
Boarding/Alighting Area

Boarding Area Issues	Issue Exists	Recommendations
Boarding area does not exist		
Boarding area length is less than 96"	X	Increase boarding area size
Boarding area width is less than 60"		
Boarding area running slope is greater than 2%		
Boarding area cross slope is greater than adjacent street grade		
Heaving/Sinking/Cracking present in the boarding area		
Ponding present in the boarding area		
Permanent obstruction (>0.25") in boarding area		
Temporary obstruction (>0.25") in boarding area		
Transition at connection to the curb is greater than 0.25"		
Boarding area is missing a connection to the street or sidewalk network		
Adjacent Sidewalk Network Issues		
Sidewalk network width is less than 48"		
Sidewalk network cross slope is greater than 2%		
Heaving/Sinking/Cracking present in the sidewalk network		
Ponding present in the sidewalk network		
Permanent obstruction (>0.25") in sidewalk network		
Temporary obstruction (>0.25") in sidewalk network

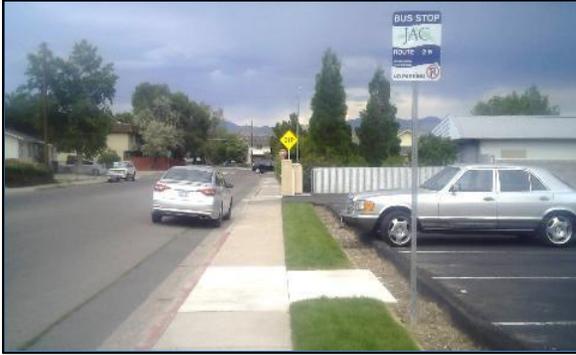
Boarding/Alighting Area

Boarding Area Issues	Issue Exists	Recommendations
Boarding area does not exist		
Boarding area length is less than 96"		
Boarding area width is less than 60"		
Boarding area running slope is greater than 2%	X	
Boarding area cross slope is greater than adjacent street grade		Remove and replace boarding area
Heaving/Sinking/Cracking present in the boarding area		
Ponding present in the boarding area		
Permanent obstruction (>0.25") in boarding area		
Temporary obstruction (>0.25") in boarding area		
Transition at connection to the curb is greater than 0.25"	X	Fix connection transition
Boarding area is missing a connection to the street or sidewalk network		
Adjacent Sidewalk Network Issues	Issue Exists	Recommendations
Sidewalk network width is less than 48"		
Sidewalk network cross slope is greater than 2%		
Heaving/Sinking/Cracking present in the sidewalk network		
Ponding present in the sidewalk network

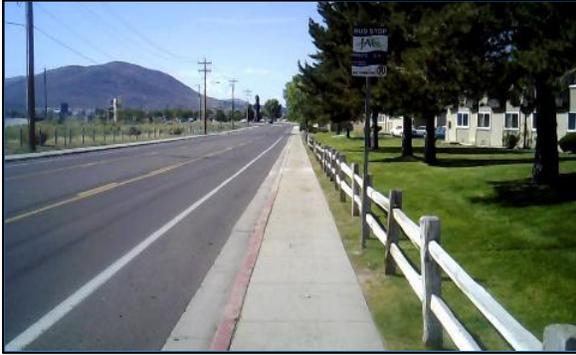
Boarding/Alighting Area

Boarding Area Issues	Issue Exists	Recommendations
Boarding area does not exist		
Boarding area length is less than 96"	X	Increase boarding area size
Boarding area width is less than 60"		
Boarding area running slope is greater than 2%		
Boarding area cross slope is greater than adjacent street grade		
Heaving/Sinking/Cracking present in the boarding area		
Ponding present in the boarding area		
Permanent obstruction (>0.25") in boarding area		
Temporary obstruction (>0.25") in boarding area		
Transition at connection to the curb is greater than 0.25"		
Boarding area is missing a connection to the street or sidewalk network		
Adjacent Sidewalk Network Issues		
Sidewalk network width is less than 48"		
Sidewalk network cross slope is greater than 2%		
Heaving/Sinking/Cracking present in the sidewalk network		
Ponding present in the sidewalk network		
Permanent obstruction (>0.25") in sidewalk network		
Temporary obstruction (>0.25") in sidewalk network

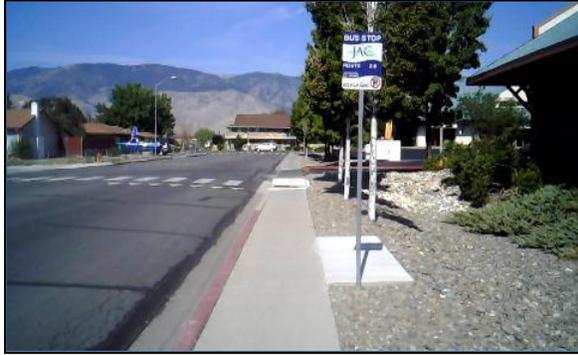
Boarding/Alighting Area

Boarding Area Issues	Issue Exists	Recommendations
Boarding area does not exist		
Boarding area length is less than 96"	X	Increase boarding area size
Boarding area width is less than 60"		
Boarding area running slope is greater than 2%	X	
Boarding area cross slope is greater than adjacent street grade		Remove and replace boarding area
Heaving/Sinking/Cracking present in the boarding area		
Ponding present in the boarding area		
Permanent obstruction (>0.25") in boarding area		
Temporary obstruction (>0.25") in boarding area		
Transition at connection to the curb is greater than 0.25"	X	Fix connection transition
Boarding area is missing a connection to the street or sidewalk network		
Adjacent Sidewalk Network Issues	Issue Exists	Recommendations
Sidewalk network width is less than 48"		
Sidewalk network cross slope is greater than 2%		
Heaving/Sinking/Cracking present in the sidewalk network		
Ponding present in the sidewalk network

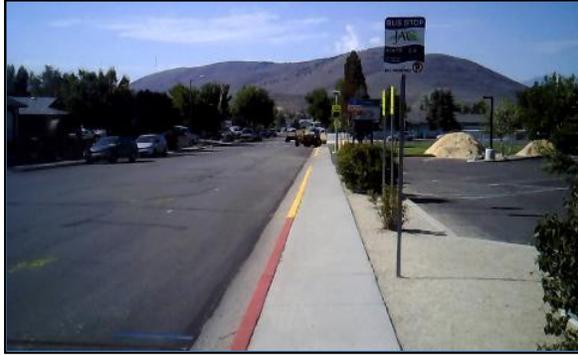
Boarding/Alighting Area

Boarding Area Issues	Issue Exists	Recommendations
Boarding area does not exist		
Boarding area length is less than 96"	X	Increase boarding area size
Boarding area width is less than 60"		
Boarding area running slope is greater than 2%	X	
Boarding area cross slope is greater than adjacent street grade		
Heaving/Sinking/Cracking present in the boarding area		Remove and replace boarding area
Ponding present in the boarding area		
Permanent obstruction (>0.25") in boarding area		
Temporary obstruction (>0.25") in boarding area		
Transition at connection to the curb is greater than 0.25"		
Boarding area is missing a connection to the street or sidewalk network		
Adjacent Sidewalk Network Issues		
Sidewalk network width is less than 48"		
Sidewalk network cross slope is greater than 2%		
Heaving/Sinking/Cracking present in the sidewalk network		
Ponding present in the sidewalk network		
Permanent obstruction (>0.25") in sidewalk network

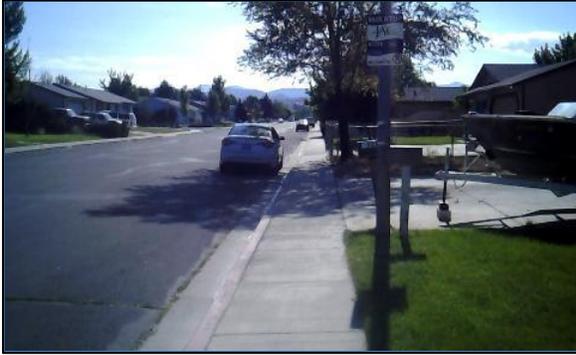
Boarding/Alighting Area

Boarding Area Issues	Issue Exists	Recommendations
Boarding area does not exist		
Boarding area length is less than 96"	X	Increase boarding area size
Boarding area width is less than 60"		
Boarding area running slope is greater than 2%	X	
Boarding area cross slope is greater than adjacent street grade		
Heaving/Sinking/Cracking present in the boarding area	X	Remove and replace boarding area
Ponding present in the boarding area		
Permanent obstruction (>0.25") in boarding area		
Temporary obstruction (>0.25") in boarding area		
Transition at connection to the curb is greater than 0.25"		
Boarding area is missing a connection to the street or sidewalk network		
Adjacent Sidewalk Network Issues		
Sidewalk network width is less than 48"		
Sidewalk network cross slope is greater than 2%		
Heaving/Sinking/Cracking present in the sidewalk network		
Ponding present in the sidewalk network		
Permanent obstruction (>0.25") in sidewalk network

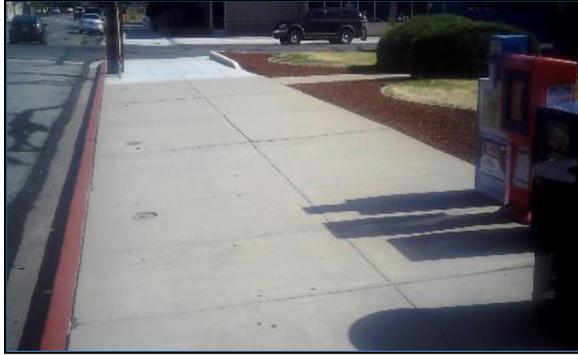
Boarding/Alighting Area

Boarding Area Issues	Issue Exists	Recommendations
Boarding area does not exist		
Boarding area length is less than 96"		
Boarding area width is less than 60"		
Boarding area running slope is greater than 2%	X	
Boarding area cross slope is greater than adjacent street grade		Remove and replace boarding area
Heaving/Sinking/Cracking present in the boarding area		
Ponding present in the boarding area		
Permanent obstruction (>0.25") in boarding area	X	Remove obstruction
Temporary obstruction (>0.25") in boarding area		
Transition at connection to the curb is greater than 0.25"	X	Fix connection transition
Boarding area is missing a connection to the street or sidewalk network		
Adjacent Sidewalk Network Issues	Issue Exists	Recommendations
Sidewalk network width is less than 48"		
Sidewalk network cross slope is greater than 2%		
Heaving/Sinking/Cracking present in the sidewalk network		
Ponding present in the sidewalk network

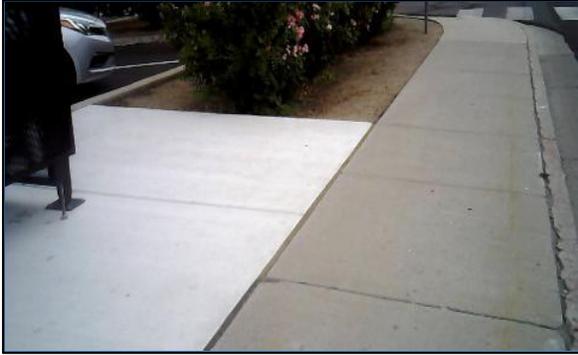
Boarding/Alighting Area

Boarding Area Issues	Issue Exists	Recommendations
Boarding area does not exist		
Boarding area length is less than 96"		
Boarding area width is less than 60"		
Boarding area running slope is greater than 2%	X	
Boarding area cross slope is greater than adjacent street grade		Remove and replace boarding area
Heaving/Sinking/Cracking present in the boarding area		
Ponding present in the boarding area		
Permanent obstruction (>0.25") in boarding area		
Temporary obstruction (>0.25") in boarding area		
Transition at connection to the curb is greater than 0.25"	X	Fix connection transition
Boarding area is missing a connection to the street or sidewalk network		
Adjacent Sidewalk Network Issues	Issue Exists	Recommendations
Sidewalk network width is less than 48"		
Sidewalk network cross slope is greater than 2%		
Heaving/Sinking/Cracking present in the sidewalk network		
Ponding present in the sidewalk network

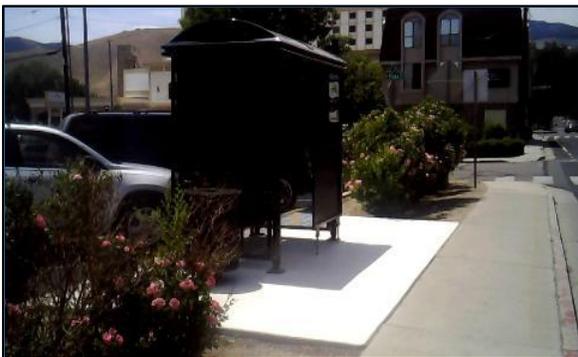
Shelter/Clear Space

Stand-alone bench clear space running slope is greater than 2%		
No clear space under shelter		
Shelter clear space length is less than 48"		
Shelter clear space width is less than 30"		
Shelter clear space cross slope is greater than 2%	X	
Shelter clear space running slope is greater than 2%		
Shelter opening clear width is less than 32"

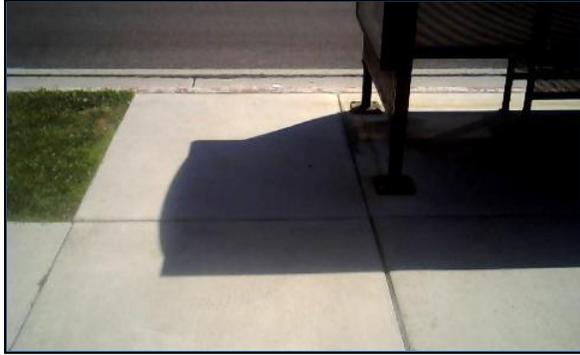
Boarding/Alighting Area

Temporary obstruction (>0.25") in sidewalk network		
Transition at connection to boarding area is greater than 0.25"	X	Fix connection transition
Transit Stop Sidewalk Issues	Issue Exists	Recommendations
Transit stop sidewalk cross slope is greater than 2%		
Heaving/Sinking/Cracking present in the transit stop sidewalk		
Ponding present in the transit stop sidewalk		
Permanent obstruction (>0.25") in transit stop sidewalk		
Temporary obstruction (>0.25") in transit stop sidewalk		
Transition at connection to sidewalk network is greater than 0.25"		
Transit Stop Amenity Issues	Issue Exists	Recommendations
No transit stop signage		
Transit stop signage is non-compliant	X	Remove and replace transit stop signage
No clear space adjacent to stand-alone bench		
Stand-alone bench clear space length is less than 48"		
Stand-alone bench clear space width is less than 30"		
Stand-alone bench clear space cross slope is greater than 2%

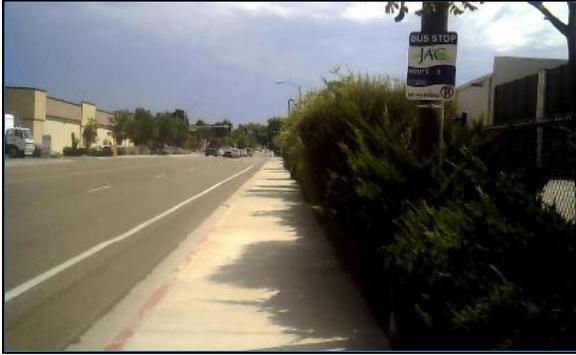
Boarding/Alighting Area

Boarding Area Issues	Issue Exists	Recommendations
Boarding area does not exist		
Boarding area length is less than 96"		
Boarding area width is less than 60"		
Boarding area running slope is greater than 2%	X	
Boarding area cross slope is greater than adjacent street grade		Remove and replace boarding area
Heaving/Sinking/Cracking present in the boarding area		
Ponding present in the boarding area		
Permanent obstruction (>0.25") in boarding area		
Temporary obstruction (>0.25") in boarding area		
Transition at connection to the curb is greater than 0.25"	X	Fix connection transition
Boarding area is missing a connection to the street or sidewalk network		
Adjacent Sidewalk Network Issues	Issue Exists	Recommendations
Sidewalk network width is less than 48"		
Sidewalk network cross slope is greater than 2%		
Heaving/Sinking/Cracking present in the sidewalk network		
Ponding present in the sidewalk network

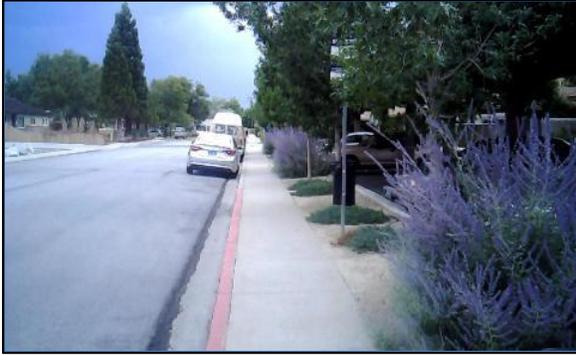
Boarding/Alighting Area

Boarding Area Issues	Issue Exists	Recommendations
Boarding area does not exist		
Boarding area length is less than 96"	X	Increase boarding area size
Boarding area width is less than 60"		
Boarding area running slope is greater than 2%	X	
Boarding area cross slope is greater than adjacent street grade		Remove and replace boarding area
Heaving/Sinking/Cracking present in the boarding area		
Ponding present in the boarding area		
Permanent obstruction (>0.25") in boarding area		
Temporary obstruction (>0.25") in boarding area		
Transition at connection to the curb is greater than 0.25"	X	Fix connection transition
Boarding area is missing a connection to the street or sidewalk network		
Adjacent Sidewalk Network Issues	Issue Exists	Recommendations
Sidewalk network width is less than 48"		
Sidewalk network cross slope is greater than 2%		
Heaving/Sinking/Cracking present in the sidewalk network		
Ponding present in the sidewalk network

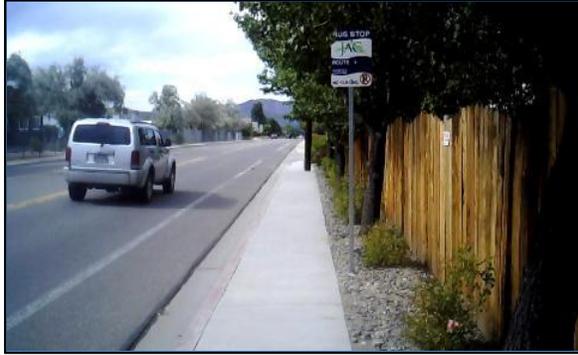
Boarding/Alighting Area

Boarding Area Issues	Issue Exists	Recommendations
Boarding area does not exist		
Boarding area length is less than 96"	X	Increase boarding area size
Boarding area width is less than 60"		
Boarding area running slope is greater than 2%	X	
Boarding area cross slope is greater than adjacent street grade		
Heaving/Sinking/Cracking present in the boarding area		Remove and replace boarding area
Ponding present in the boarding area		
Permanent obstruction (>0.25") in boarding area		
Temporary obstruction (>0.25") in boarding area		
Transition at connection to the curb is greater than 0.25"		
Boarding area is missing a connection to the street or sidewalk network		
Adjacent Sidewalk Network Issues	Issue Exists	Recommendations
Sidewalk network width is less than 48"		
Sidewalk network cross slope is greater than 2%		
Heaving/Sinking/Cracking present in the sidewalk network		
Ponding present in the sidewalk network

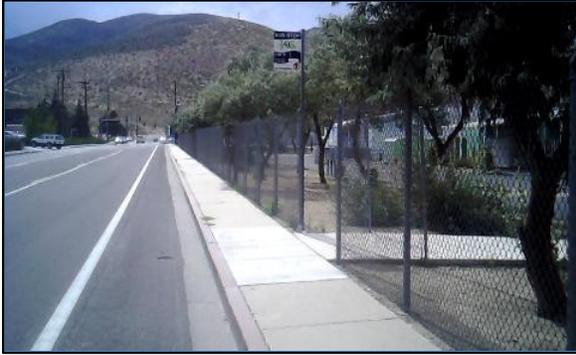
Boarding/Alighting Area

Boarding Area Issues	Issue Exists	Recommendations
Boarding area does not exist		
Boarding area length is less than 96"		
Boarding area width is less than 60"		
Boarding area running slope is greater than 2%	X	
Boarding area cross slope is greater than adjacent street grade		
Heaving/Sinking/Cracking present in the boarding area		Remove and replace boarding area
Ponding present in the boarding area		
Permanent obstruction (>0.25") in boarding area		
Temporary obstruction (>0.25") in boarding area		
Transition at connection to the curb is greater than 0.25"		
Boarding area is missing a connection to the street or sidewalk network		
Adjacent Sidewalk Network Issues		
Sidewalk network width is less than 48"		
Sidewalk network cross slope is greater than 2%		
Heaving/Sinking/Cracking present in the sidewalk network		
Ponding present in the sidewalk network		
Permanent obstruction (>0.25") in sidewalk network

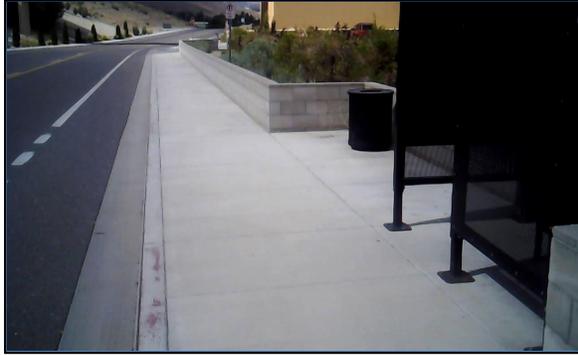
Boarding/Alighting Area

Boarding Area Issues	Issue Exists	Recommendations
Boarding area does not exist		
Boarding area length is less than 96"		
Boarding area width is less than 60"		
Boarding area running slope is greater than 2%		
Boarding area cross slope is greater than adjacent street grade		
Heaving/Sinking/Cracking present in the boarding area		
Ponding present in the boarding area		
Permanent obstruction (>0.25") in boarding area		
Temporary obstruction (>0.25") in boarding area		
Transition at connection to the curb is greater than 0.25"		
Boarding area is missing a connection to the street or sidewalk network		
Adjacent Sidewalk Network Issues	Issue Exists	Recommendations
Sidewalk network width is less than 48"		
Sidewalk network cross slope is greater than 2%		
Heaving/Sinking/Cracking present in the sidewalk network		
Ponding present in the sidewalk network		
Permanent obstruction (>0.25") in sidewalk network		
Temporary obstruction (>0.25") in sidewalk network

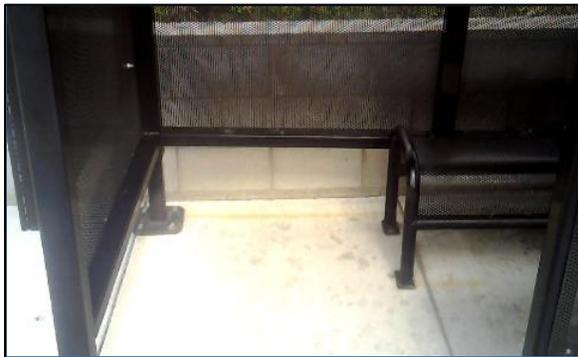
Shelter/Clear Space

No clear space under shelter		
Shelter clear space length is less than 48"		
Shelter clear space width is less than 30"		
Shelter clear space cross slope is greater than 2%	X	
Shelter clear space running slope is greater than 2%		
Shelter opening clear width is less than 32"

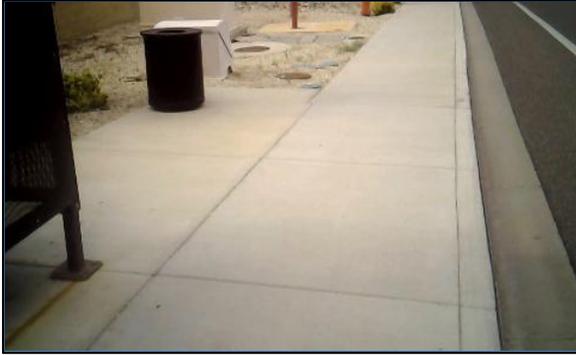
Boarding/Alighting Area

Boarding Area Issues	Issue Exists	Recommendations
Boarding area does not exist		
Boarding area length is less than 96"		
Boarding area width is less than 60"		
Boarding area running slope is greater than 2%	X	
Boarding area cross slope is greater than adjacent street grade		Remove and replace boarding area
Heaving/Sinking/Cracking present in the boarding area		
Ponding present in the boarding area		
Permanent obstruction (>0.25") in boarding area		
Temporary obstruction (>0.25") in boarding area		
Transition at connection to the curb is greater than 0.25"		
Boarding area is missing a connection to the street or sidewalk network		
Adjacent Sidewalk Network Issues		
Sidewalk network width is less than 48"		
Sidewalk network cross slope is greater than 2%		
Heaving/Sinking/Cracking present in the sidewalk network		
Ponding present in the sidewalk network		
Permanent obstruction (>0.25") in sidewalk network

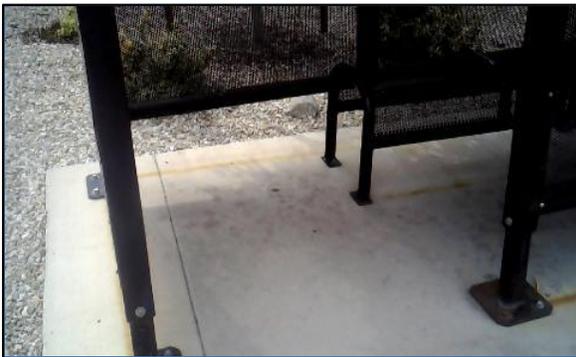
Shelter/Clear Space

No clear space under shelter		
Shelter clear space length is less than 48"		
Shelter clear space width is less than 30"		
Shelter clear space cross slope is greater than 2%	X	
Shelter clear space running slope is greater than 2%		
Shelter opening clear width is less than 32"

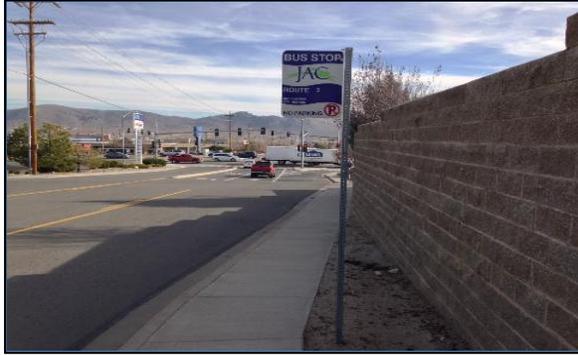
Boarding/Alighting Area

Boarding Area Issues	Issue Exists	Recommendations
Boarding area does not exist		
Boarding area length is less than 96"	X	Increase boarding area size
Boarding area width is less than 60"		
Boarding area running slope is greater than 2%	X	
Boarding area cross slope is greater than adjacent street grade		Remove and replace boarding area
Heaving/Sinking/Cracking present in the boarding area		
Ponding present in the boarding area		
Permanent obstruction (>0.25") in boarding area		
Temporary obstruction (>0.25") in boarding area		
Transition at connection to the curb is greater than 0.25"	X	Fix connection transition
Boarding area is missing a connection to the street or sidewalk network		
Adjacent Sidewalk Network Issues	Issue Exists	Recommendations
Sidewalk network width is less than 48"		
Sidewalk network cross slope is greater than 2%		
Heaving/Sinking/Cracking present in the sidewalk network		
Ponding present in the sidewalk network

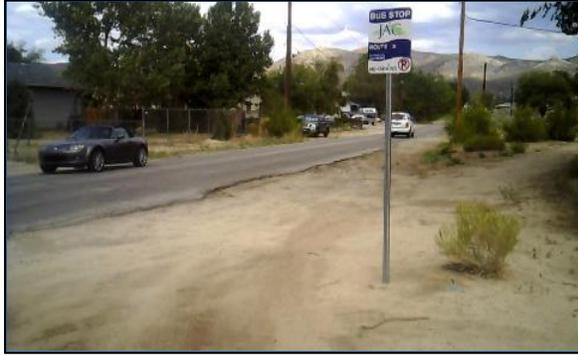
Boarding/Alighting Area

Boarding Area Issues	Issue Exists	Recommendations
Boarding area does not exist	X	Install boarding area
Boarding area length is less than 96"		
Boarding area width is less than 60"		
Boarding area running slope is greater than 2%		
Boarding area cross slope is greater than adjacent street grade		
Heaving/Sinking/Cracking present in the boarding area		
Ponding present in the boarding area		
Permanent obstruction (>0.25") in boarding area		
Temporary obstruction (>0.25") in boarding area		
Transition at connection to the curb is greater than 0.25"		
Boarding area is missing a connection to the street or sidewalk network		
Adjacent Sidewalk Network Issues		
Sidewalk network width is less than 48"	Issue Exists	Recommendations
Sidewalk network cross slope is greater than 2%		
Heaving/Sinking/Cracking present in the sidewalk network		
Ponding present in the sidewalk network		
Permanent obstruction (>0.25") in sidewalk network

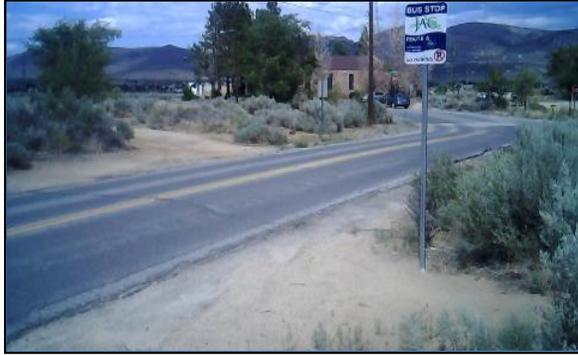
Boarding/Alighting Area

Boarding Area Issues	Issue Exists	Recommendations
Boarding area does not exist	X	Install boarding area
Boarding area length is less than 96"		
Boarding area width is less than 60"		
Boarding area running slope is greater than 2%		
Boarding area cross slope is greater than adjacent street grade		
Heaving/Sinking/Cracking present in the boarding area		
Ponding present in the boarding area		
Permanent obstruction (>0.25") in boarding area		
Temporary obstruction (>0.25") in boarding area		
Transition at connection to the curb is greater than 0.25"		
Boarding area is missing a connection to the street or sidewalk network		
Adjacent Sidewalk Network Issues		
Sidewalk network width is less than 48"	Issue Exists	Recommendations
Sidewalk network cross slope is greater than 2%		
Heaving/Sinking/Cracking present in the sidewalk network		
Ponding present in the sidewalk network		
Permanent obstruction (>0.25") in sidewalk network

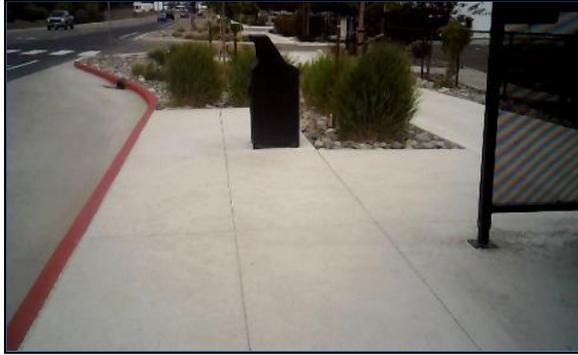
Boarding/Alighting Area

Boarding Area Issues	Issue Exists	Recommendations
Boarding area does not exist		
Boarding area length is less than 96"		
Boarding area width is less than 60"		
Boarding area running slope is greater than 2%		
Boarding area cross slope is greater than adjacent street grade		
Heaving/Sinking/Cracking present in the boarding area		
Ponding present in the boarding area		
Permanent obstruction (>0.25") in boarding area		
Temporary obstruction (>0.25") in boarding area		
Transition at connection to the curb is greater than 0.25"	X	Fix connection transition
Boarding area is missing a connection to the street or sidewalk network		
Adjacent Sidewalk Network Issues	Issue Exists	Recommendations
Sidewalk network width is less than 48"		
Sidewalk network cross slope is greater than 2%		
Heaving/Sinking/Cracking present in the sidewalk network		
Ponding present in the sidewalk network		
Permanent obstruction (>0.25") in sidewalk network

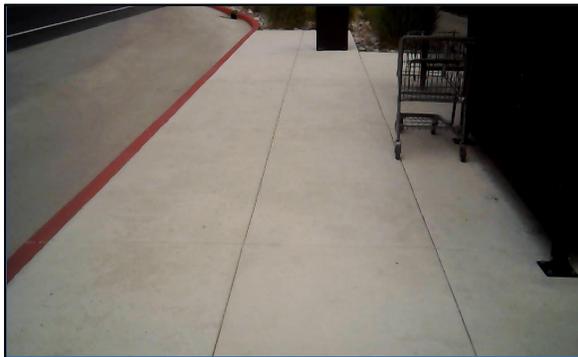
Temporary obstruction (>0.25") in sidewalk network		
Transition at connection to boarding area is greater than 0.25"		
Transit Stop Sidewalk Issues	Issue Exists	Recommendations
Transit stop sidewalk cross slope is greater than 2%	X	
Heaving/Sinking/Cracking present in the transit stop sidewalk		Remove and replace transit stop sidewalk
Ponding present in the transit stop sidewalk		
Permanent obstruction (>0.25") in transit stop sidewalk		
Temporary obstruction (>0.25") in transit stop sidewalk		
Transition at connection to sidewalk network is greater than 0.25"		
Transit Stop Amenity Issues	Issue Exists	Recommendations
No transit stop signage		
Transit stop signage is non-compliant	X	Remove and replace transit stop signage
No clear space adjacent to stand-alone bench		
Stand-alone bench clear space length is less than 48"		
Stand-alone bench clear space width is less than 30"		
Stand-alone bench clear space cross slope is greater than 2%

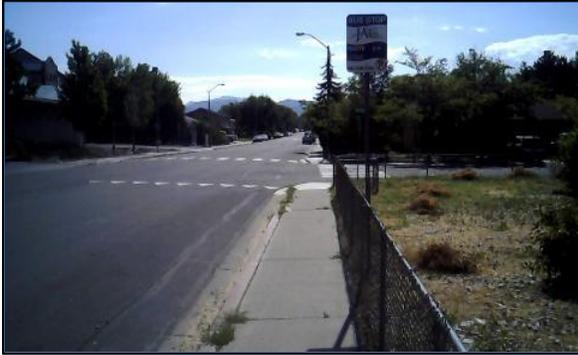
Boarding/Alighting Area

Boarding Area Issues	Issue Exists	Recommendations
Boarding area does not exist		
Boarding area length is less than 96"	X	Increase boarding area size
Boarding area width is less than 60"		
Boarding area running slope is greater than 2%	X	
Boarding area cross slope is greater than adjacent street grade		
Heaving/Sinking/Cracking present in the boarding area	X	Remove and replace boarding area
Ponding present in the boarding area		
Permanent obstruction (>0.25") in boarding area		
Temporary obstruction (>0.25") in boarding area	X	Remove temporary obstruction
Transition at connection to the curb is greater than 0.25"	X	Fix connection transition
Boarding area is missing a connection to the street or sidewalk network		
Adjacent Sidewalk Network Issues	Issue Exists	Recommendations
Sidewalk network width is less than 48"		
Sidewalk network cross slope is greater than 2%		
Heaving/Sinking/Cracking present in the sidewalk network

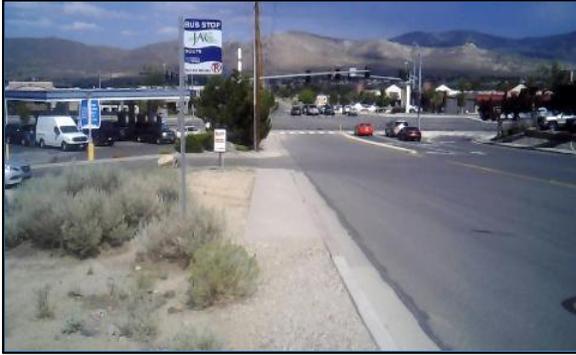
Boarding/Alighting Area

Boarding Area Issues	Issue Exists	Recommendations
Boarding area does not exist		
Boarding area length is less than 96"	X	Increase boarding area size
Boarding area width is less than 60"		
Boarding area running slope is greater than 2%		
Boarding area cross slope is greater than adjacent street grade		
Heaving/Sinking/Cracking present in the boarding area		
Ponding present in the boarding area		
Permanent obstruction (>0.25") in boarding area		
Temporary obstruction (>0.25") in boarding area		
Transition at connection to the curb is greater than 0.25"		
Boarding area is missing a connection to the street or sidewalk network		
Adjacent Sidewalk Network Issues		
Sidewalk network width is less than 48"		
Sidewalk network cross slope is greater than 2%		
Heaving/Sinking/Cracking present in the sidewalk network		
Ponding present in the sidewalk network		
Permanent obstruction (>0.25") in sidewalk network		
Temporary obstruction (>0.25") in sidewalk network
