SUBJECT: **HRC-14-029 – For Presentation and Discussion Only:** *The Future of the Nevada State Prison*, the Nevada State Prison Steering Committee's Final Report to the Nevada Legislature

The Future of the Nevada State Prison

Recommendations to the 2015 Legislature
Pursuant to 2013 Assembly Bill 356

Inventory of Existing Conditions

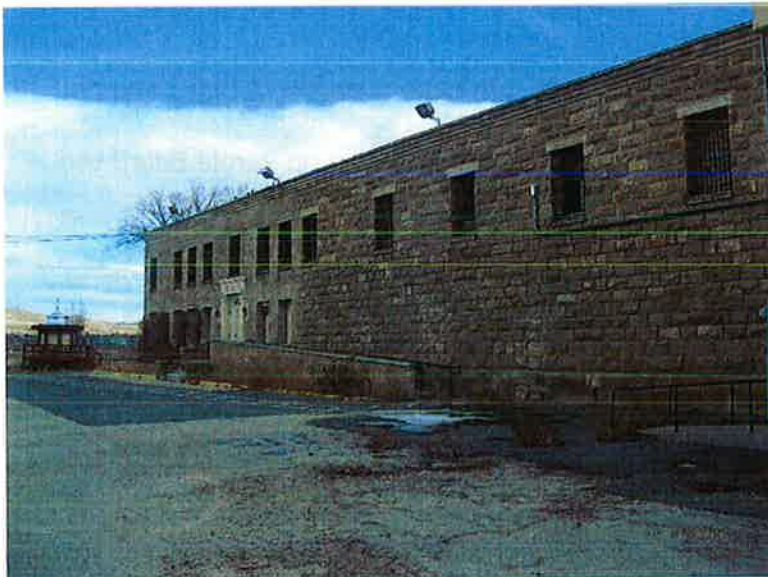
WEST WING (Administrative Wing)

- The western wing of the building is essentially given to administrative functions,
- On the southwest corner the building is attached to the chapel (former sally port).
- The lower level contains a large inmate visiting room that is open except for the rooms used for confidential attorney visits.
- The walls are dramatically decorated with murals painted by inmates.
- In the 1960's/70s, this area was the "weight room", a bare room filled with gym equipment.
- This lower level also contains the prison staff offices, central control room, and file room.
- The second floor of this wing houses the old education area.
- There are also rooms where minimum custody (shortline) inmates lived. It is believed that in the 19th century that these rooms were used for guard housing.

- The floor coverings in this building are in generally poor condition and have reached the end of their serviceable life.
- The carpeted areas are showing signs of traffic wear and the 12"x12" VCT is loose and separating from the substrate creating a potential tripping hazard.

- This area has a roof mounted packaged HVAC system.
- There are scattered evaporative coolers located in other areas that are in need of replacement.
- This building is in need of a major HVAC upgrade.

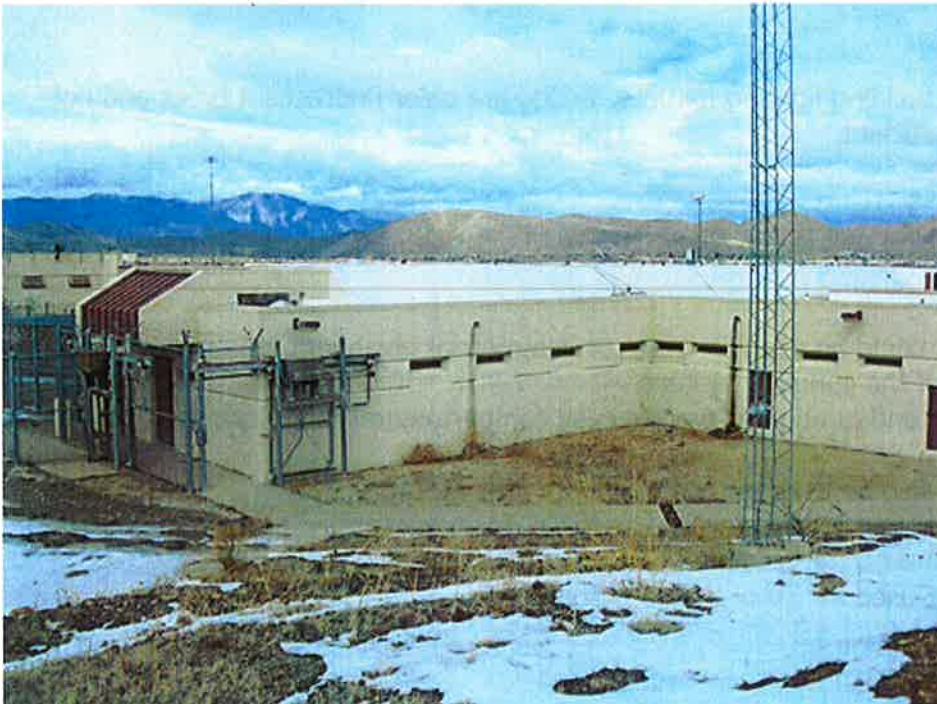
HOUSING UNIT 12

- Housing Unit 12, also known as a "Hill Unit" is a painted precast concrete structure with a single-ply membrane roof.
- It contains 40 cells, showers, visitor's area, a public restroom, mechanical rooms and a central control room.

- The unit could be used for State or commercial document storage with the closure of the sprinkler system.
- The cell configuration allows for easy compartmentalization and securing of items.
- It could also be used for commodity or bulk storage.
- It can be used for training by the NDOC for new staff.
- It can be used for incident training for other agencies.
- It can be used for TV or movie production.

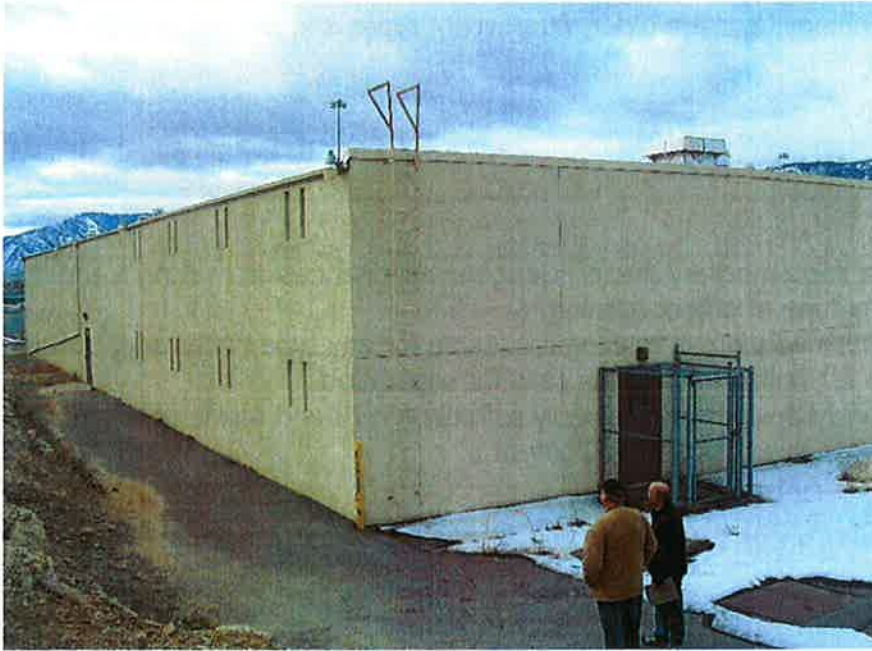
HOUSING UNIT 13

- Housing Unit 13, also known as a "Hill Unit" is a precast concrete structure covered with painted stucco and a single-ply membrane roof.
- It contains cells, showers and a central control room all on two levels.
- This housing unit is a "lockdown" unit for the prison.
- The structure is in fair shape.
- The unit has 11,888 sf of space and was constructed in 1988.

- This unit has a contemporary and efficient correctional design making it the most suitable for any type of officer training.
- The design is also very open, making it suitable for any type of storage, utilizing its open space for bulk items and its cells for separation.
- The contemporary design makes it very suitable for TV and movie production with great space for production equipment.

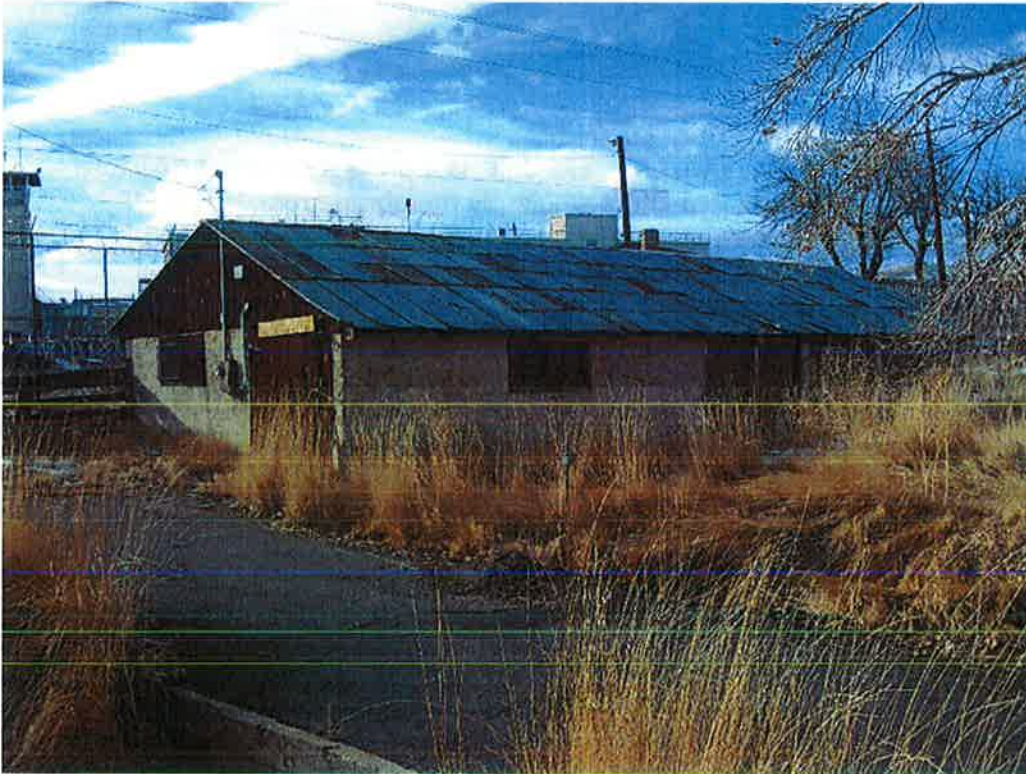
DOG KENNEL

- The Dog Kennel is a stone masonry structure with a corrugated metal gable roof.
- It is located on the north side of the prison area outside of the fence.
- The building is in poor shape and has not been used or occupied for years.
- It has 1,200 sf of space and was constructed after 1942.

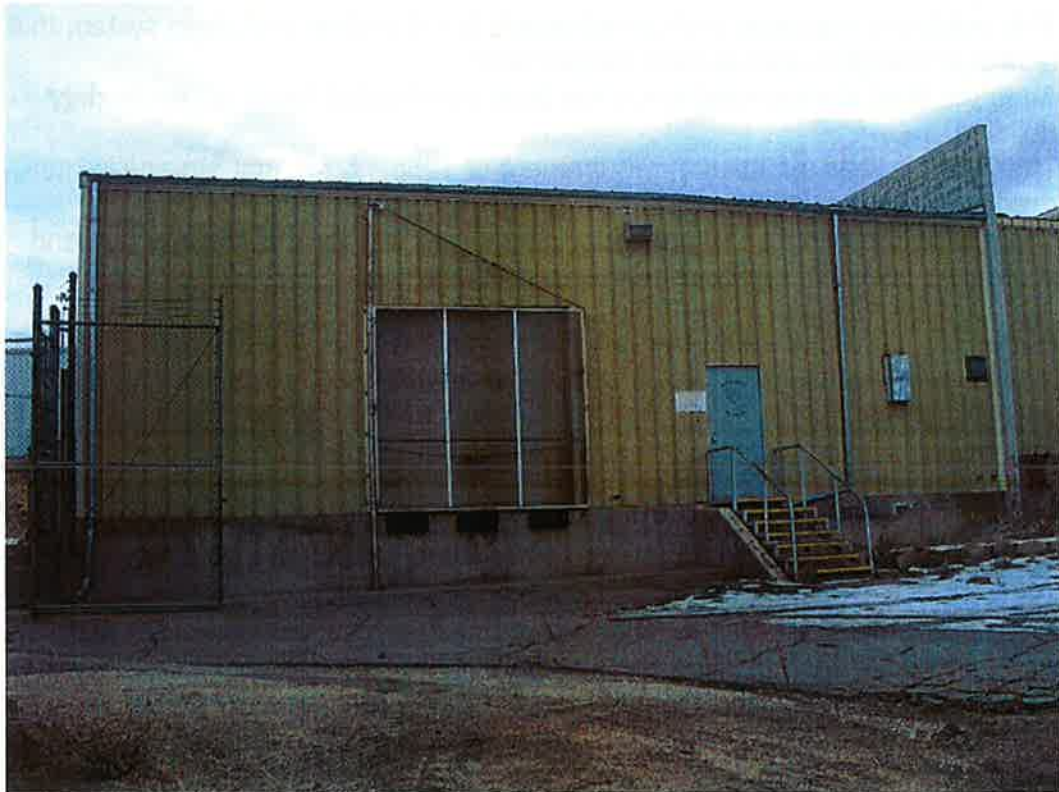
BOOKBINDARY

- The Book Bindery is an engineered, insulated, structural steel building with metal siding and roof.
- There is a mezzanine used for storage and printing accessed by a metal stairway.
- It has 4,137 sf of space, and was constructed in 1976.

- This building could be used for light industrial activities under lease to a private concern.
- Necessary repairs/upgrades could be an element of the lease.
- The building could be used as support space for proposed training, industrial, or storage uses in other areas of the institution

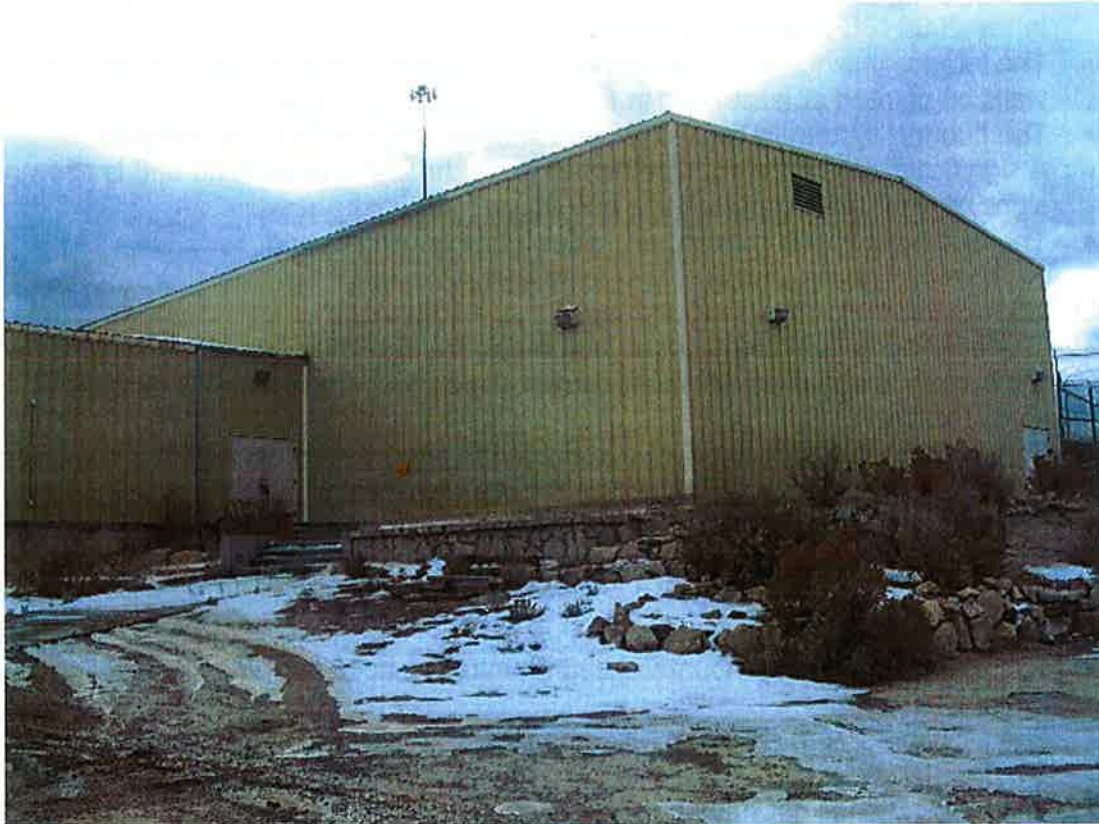
GYMNASIUM

- The Gymnasium is an insulated engineered steel structure with metal siding and roof.
- The building was used to allow inmates to play basketball, table tennis and lift weights.
- It has restrooms with showers, a couple of offices and storage areas and a large activity area with a concrete floor.
- The building has 7,980 sf of space and was constructed in 1976.

- The building could continue to serve its original purpose, but this would entail a substantial upgrade in its systems and structure
- With some work, it could be used for light industrial activities under lease to a private concern.
- Necessary repairs/upgrades could be an element of the lease.
- The building could be used as support space for proposed training, industrial, or storage uses in other areas of the institution

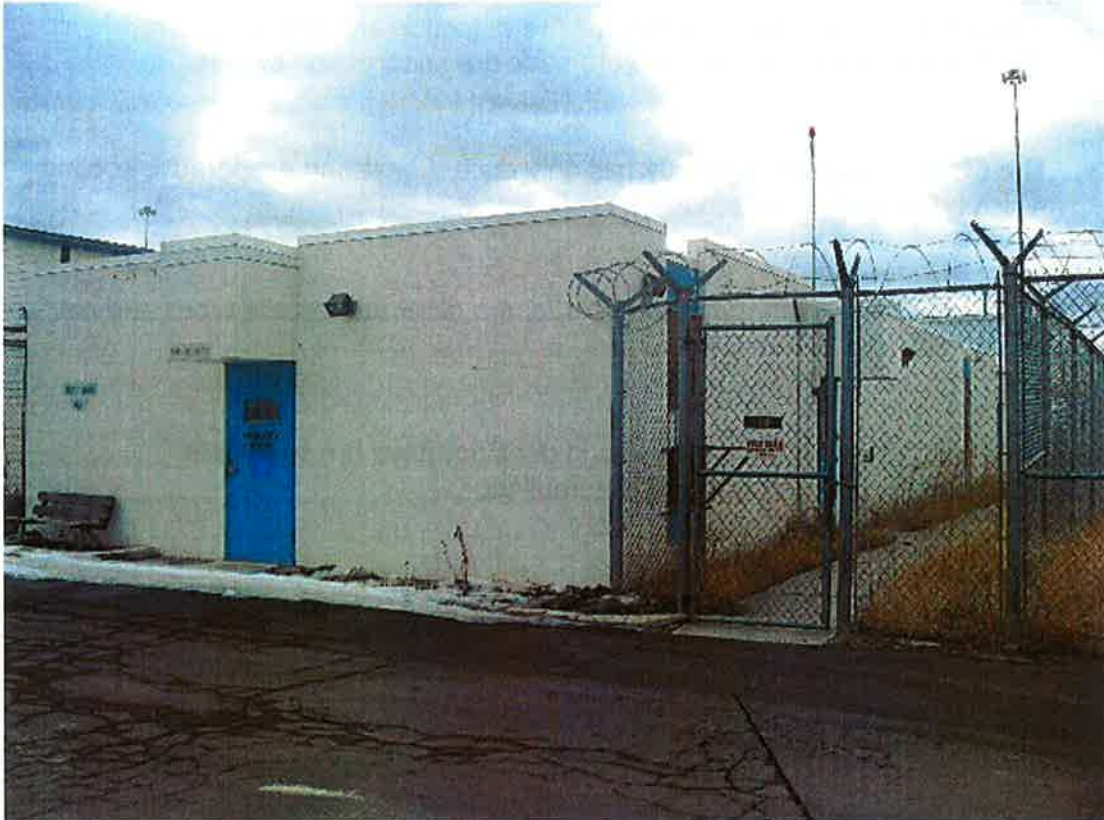
CHAPEL/6-POST

- The Chapel/Six Post is a concrete masonry unit (CMU) structure with a single-ply membrane roof and a concrete slab- on-grade foundation.
- The building contains the chapel, office area, restroom and Six Post.
- Gross Area (square feet): Year Constructed:
- It has 2,968 sf of space and was constructed in 1981.

- A proposed use for this structure has not been developed at this time.
- This is a substantial building that could be used as support space for proposed training, industrial, or storage uses as in other areas of the institution.

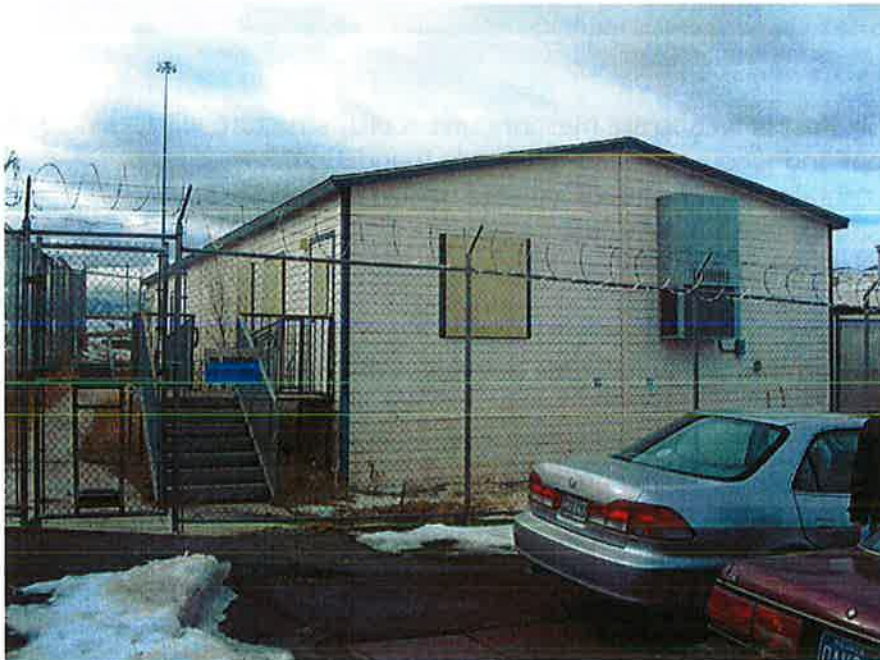
MODULAR EDUCATION BUILDING

- The Modular Education Building is a manufactured or modular style structure with painted Masonite siding, asphalt composition roof on an 8 point foundation.
- The facility contains two large classroom areas and restrooms.
- The current occupancy or use is for educational purposes and is classified as a B occupancy per the 2003 IBC.
- Constructed in 2002, 1680 sf.

- A use for this structure has not been put forward at this time.
- It is not a substantial structure and any purpose to which it is put would be considered temporary.

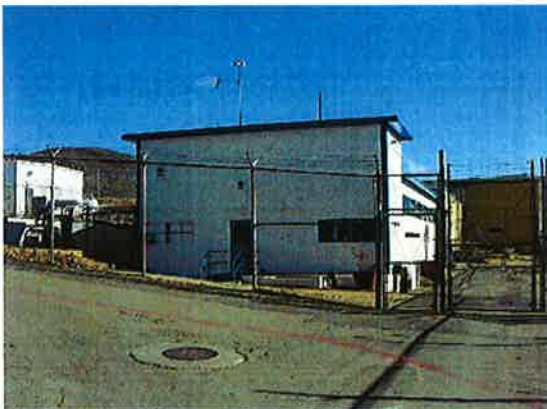
BOILER PLANT

- The Boiler Plant is a painted precast concrete structure with a single-ply membrane roof.
- This building contains three steam boilers and ancillary equipment for the heating of the prison housing units.
- There are a few small sleeping areas and a restroom for the inmate boiler maintenance technicians.
- It has 2688 sf of space and was constructed in 1958.

- This building would be continued in its current use.
- It would need to be maintained, regardless of the proposed use/s selected for the institution.
- It is proposed that the plant could be continued to be operated by the NDOC as in the past, using inmate labor in the manner of the Building & Grounds Section at the Capitol Complex.

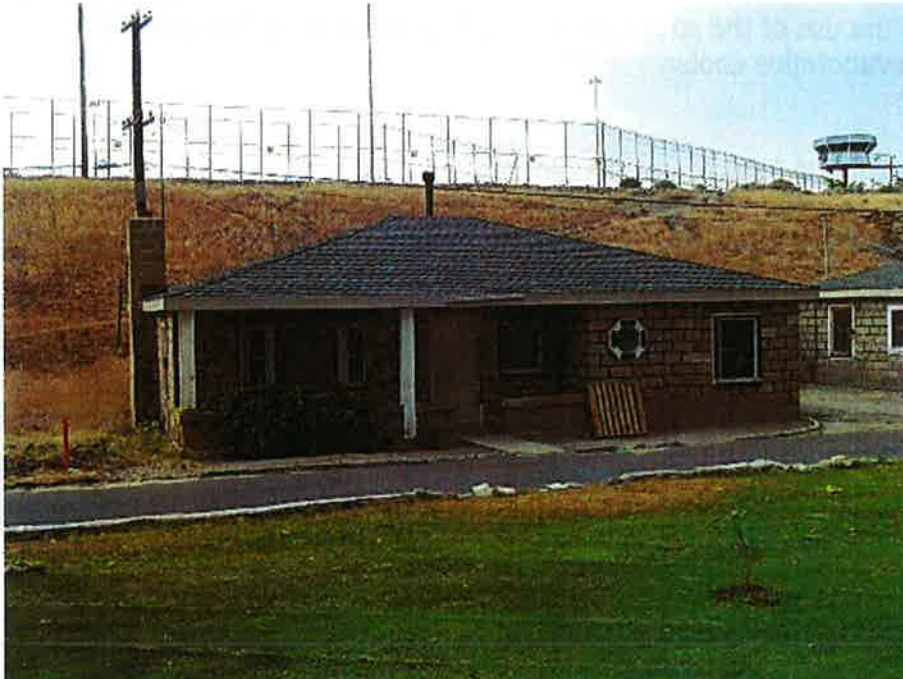
COTTAGE 1-6

- The cottages are located along the entrance road to Warm Springs Correctional Center east of NSP.
- They were constructed in 1957, using stone quarried from the prison.
- They were used to house prison staff until the mid-1970s.
- Since that time they have been variously used as storage and offices and female inmate housing.
- Cottage 1 is currently used for file storage by WSCC.
- They have 850 to 1,000 square feet of space and they were constructed in 1957.

- This building would be continued in its current use.
- It would need to be maintained, regardless of the proposed use/s selected for the institution.
- It is proposed that the plant could be continued to be operated by the NDOC as in the past, using inmate labor in the manner of the Building & Grounds Section at the Capitol Complex.

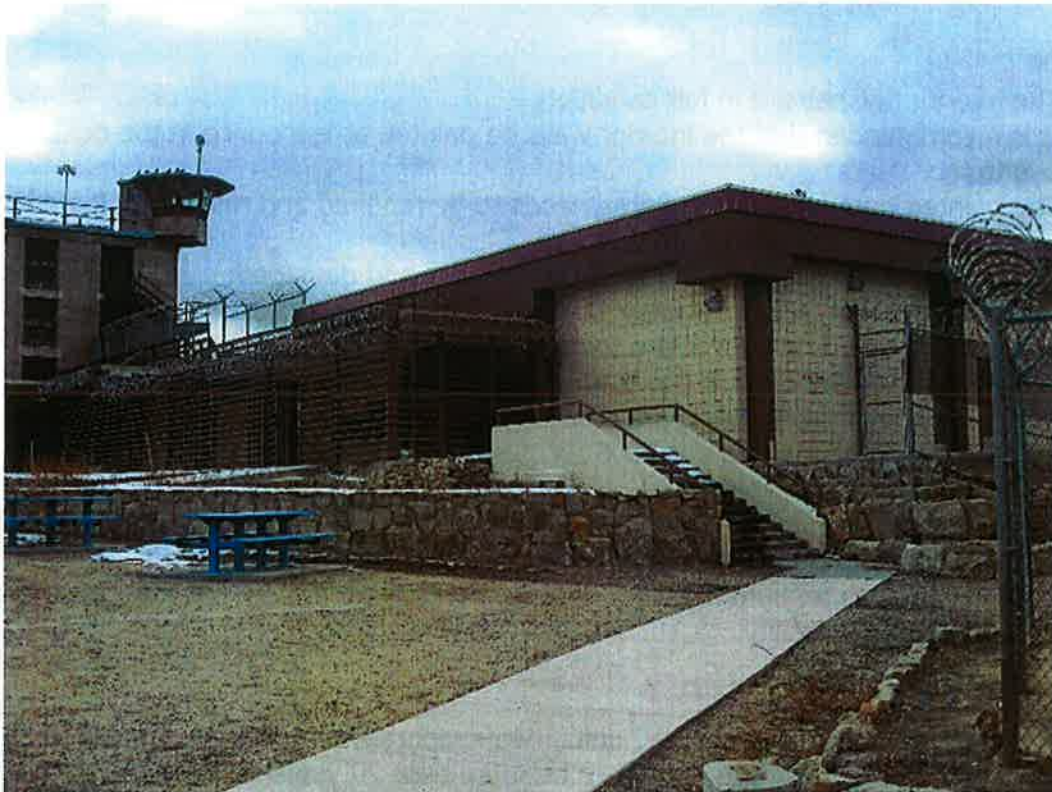
CULINARY/DINING HALL

- The Culinary / Dining Hall is a concrete masonry unit structure with a single-ply membrane roof.
- The building contains the food preparation, storage and dining services for the prison.
- The Culinary encloses the South side of the old prison yard,
- Dining room is filled with substantial table/seat systems that are bolted to the floor, consistent with current correctional practice.
- It is guarded by two interior gun posts.
- Gross Area (square feet): Year Constructed:
- The Culinary has 11,334 sf of space and was constructed in 1966.

- The Preservation Society sees this building as major stop on a museum route.
- The building could offer vending machines for visitors and use the seating in the dining area.
- Alternatively, the vendors operating food service areas in other State buildings might be interested in presenting a snack bar.
- The building can also be used for events.
- A less attractive alternative is to simply use all or portions of the building for bulk storage.

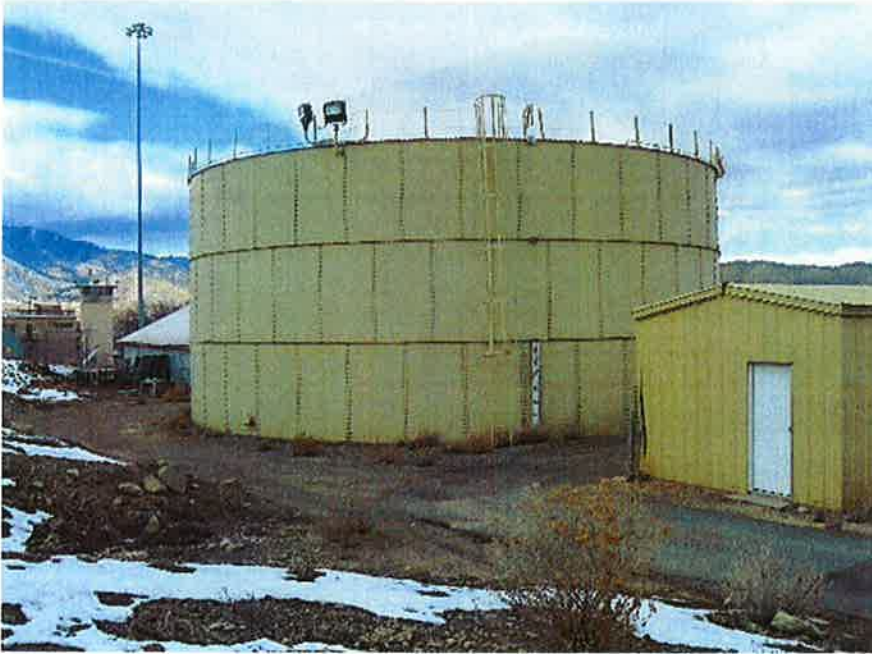
WATER TANK

- The Water tank is located on the North side of the institution, outside the secure perimeter.
- It was constructed in 1969, with 2,375 square feet.
- It was used to pressurize the prison water system before the institution was connected to the City water system.
- It has not been in used for water storage for some time.
- Two doors were cut into its side and it is used for maintenance storage

- No use for this structure has been presented by the planning group.
- It could continue as a storage resource, albeit, an inadequate structure.
- The SPWB estimated that it would cost approximately \$23,000 to demolish the tank.
- This would seem unnecessary at this time.

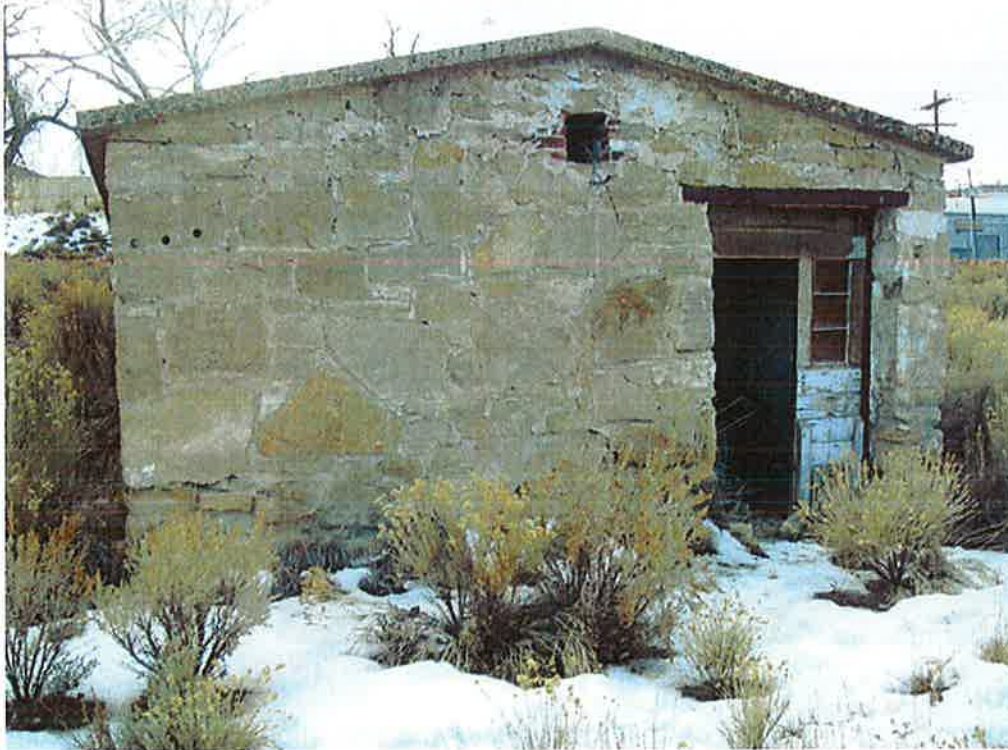
OLD BUTCHER SHOP

- The Old Butcher's Shop is a stone masonry structure with a concrete roof.
- It is located north of the main prison, outside the secure perimeter.
- It has 300 sf of space and was constructed in 1868.
- The Old Butchers Shop has code and safety issues including but not limited to rodent infestation, missing windows and doors, and possible structural deficiencies.
- Also, the building is located outside of the secure area of the prison and could be accessed by the public.

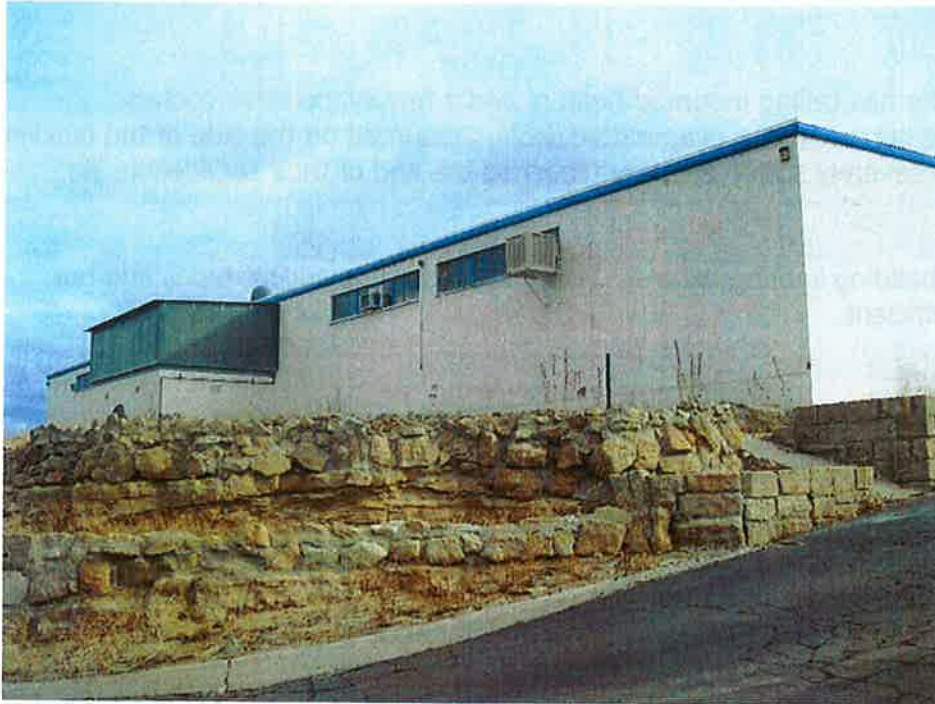
LICENSE PLATE FACTORY

- The windows are single pane, open inward which protrudes into the isles and are original to the building.
- Some of the units have several cracks, seals are broken, are difficult to operate and they have reached the end of their useful life.

- The interior finishes are in fair condition.
- The exit signs in this building are older types or painted on the walls. Illuminated exit signs shall be marked per 2006 IBC Section 1011.1.

- It is recommended that a fire detection and alarm system be installed depending on the identified use.

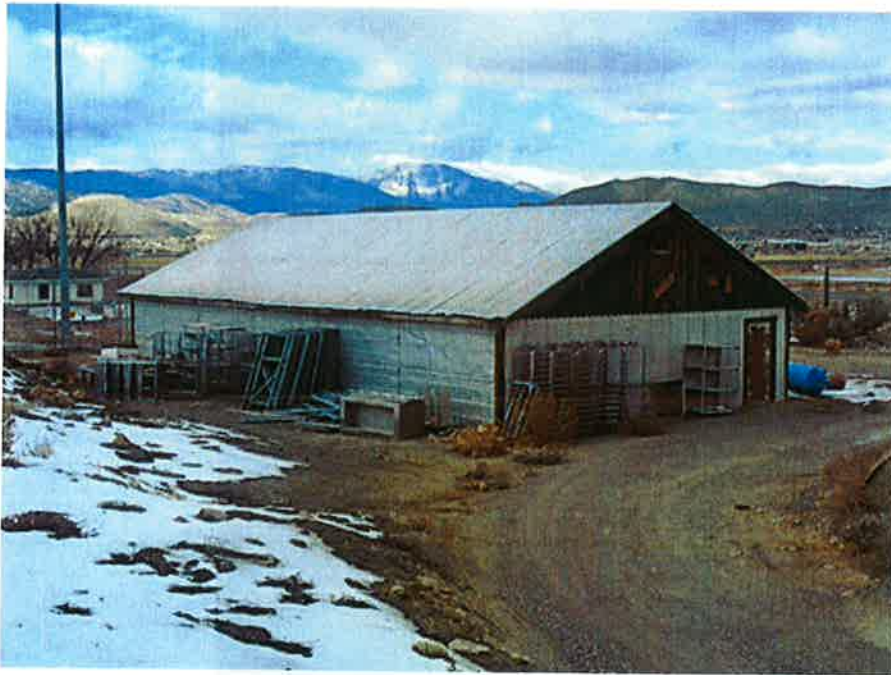
MAINTENANCE WAREHOUSE 2

- The Maintenance Warehouse 2 is a wood framed structure with metal siding and roof.
- It is located on the north side of the prison outside the fence.
- This structure is no longer in use.
- 1,288 sf.
- Constructed in 1950.

- Determine historical significance, recommend potential storage.

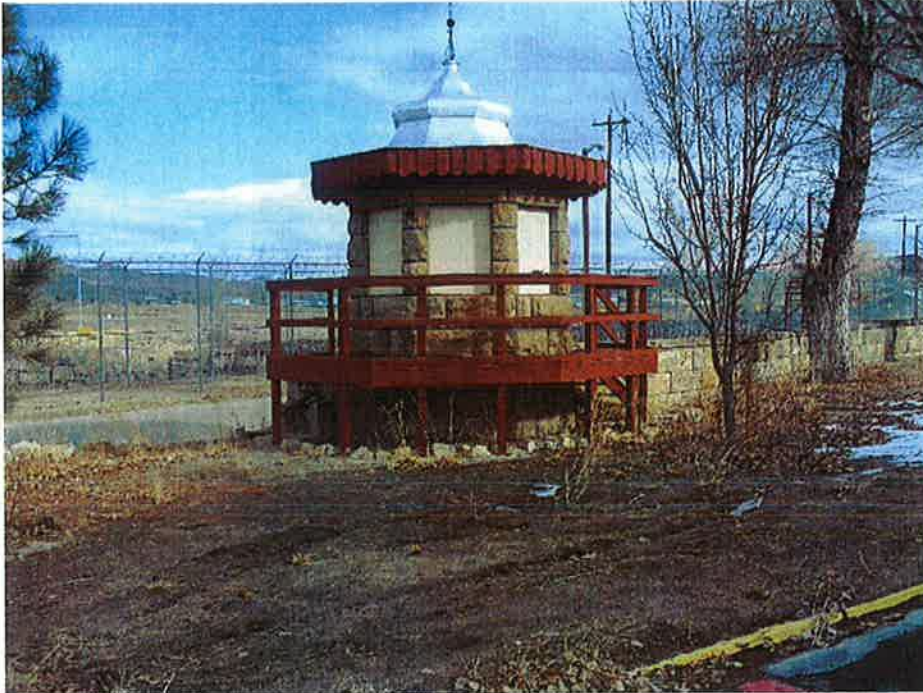
OLD FIFTH STREET TOWER

- The structure is in good shape for its age.
- The exterior paint is peeling; the caulking around the windows, flashing, fixtures and other penetrations is failing.
- It is recommended that the exterior be repaired in the next 2 years.

- The interior finishes are in fair to poor condition.

- It is recommended that maintenance action be taken to arrest the decay of this historic structure's interior.

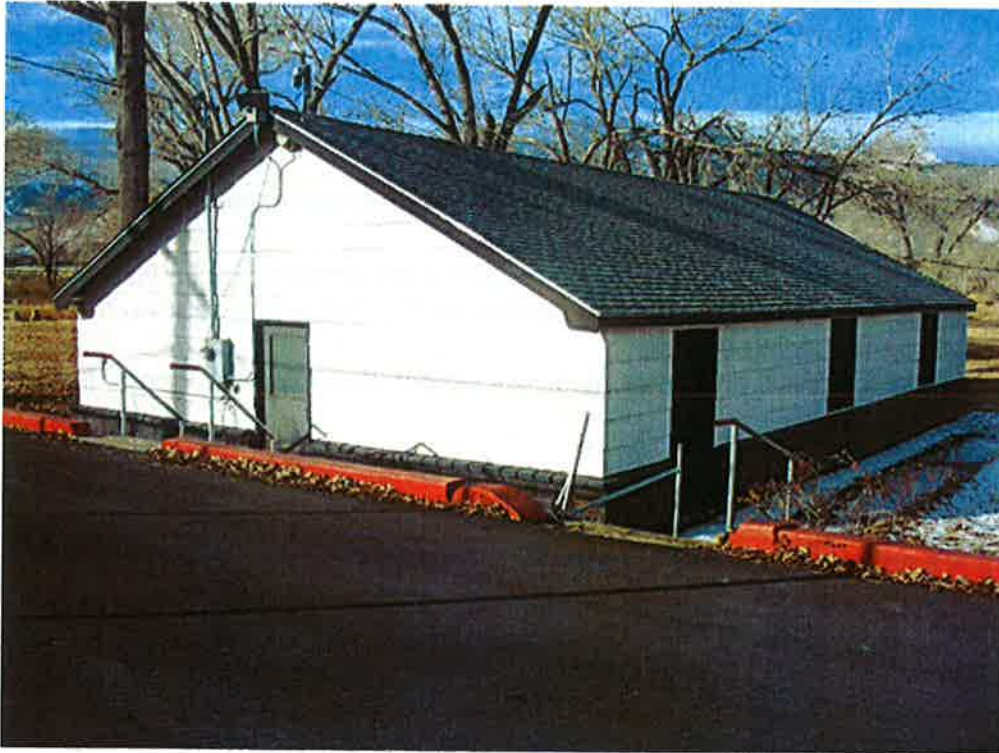
PROPERTY WAREHOUSE 1 / OLD ARMORY

- The building is in fair to good shape.
- If used, the exterior stairs and hand rails need to be addressed.
- It is recommended that the building be painted in the next 5-7 years.
- It has a new asphalt composition gable roof.

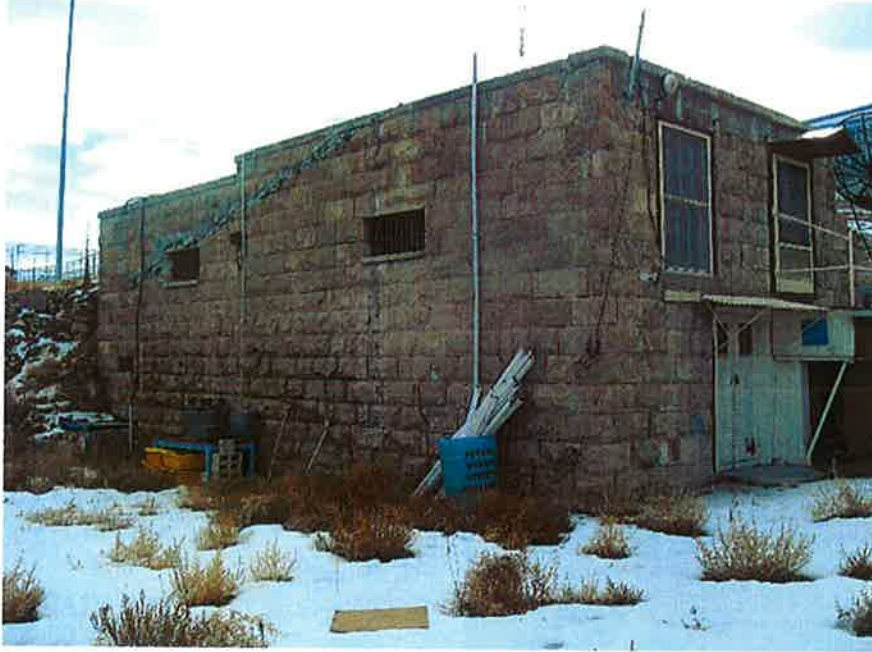
OLD ELECTRIC SHOP

- The building is in poor to fair shape.
- The Old Electric Shop is dilapidated and deteriorating.

- The facility does not have adequate ventilation, fire protection or restroom facilities.
- It contains numerous code and safety issues including, but not limited to rodent infestation, broken or missing doors and windows, non-code compliant entry stairs, possible asbestos contamination and broken or missing electrical fixtures.

- The SPWB recommends mothballing this building in accordance with the U. S. Department of Interior Recommended Guidelines in Preservation Brief 31.
- This Brief suggests:

- A use for this structure is not presented at this time.
- We believe that the structure should be maintained for a time when a use is identified

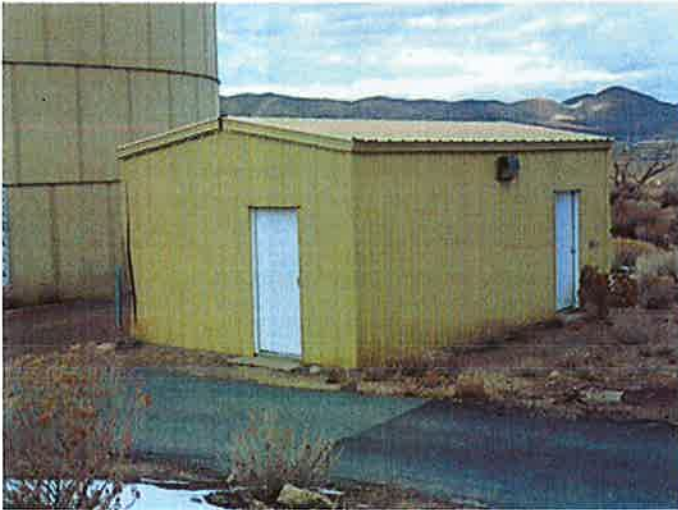
PUMP HOUSE

- The building is in good shape.
- It is recommended that the building be sealed and caulked in the next 5-7 years.

- Given the type, location, and age of this building, no recommendation is made for its use.

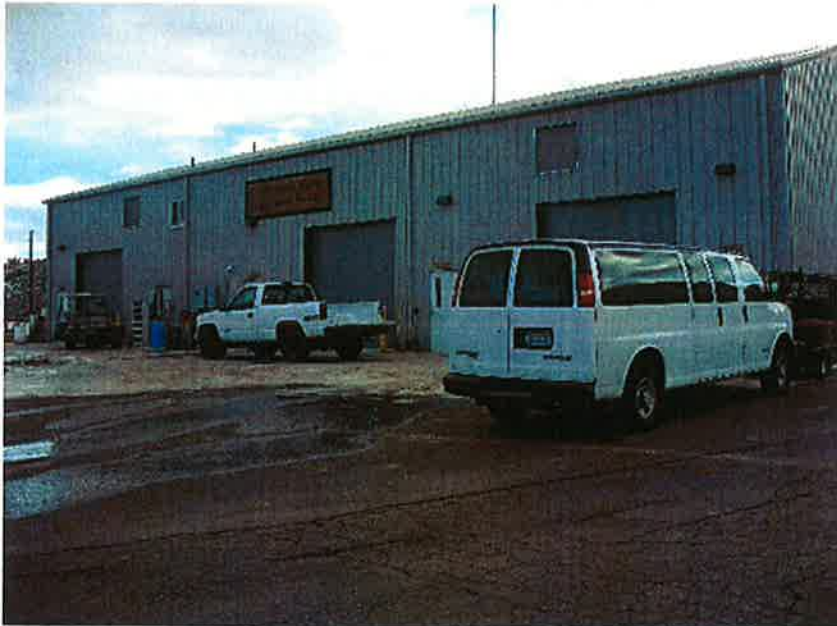
MAINTENANCE SHOP

- This structure is in good shape.
- It is recommended that the building be caulked and sealed in the next 5-7 years.

- The interior finishes are in fair condition.
- It is recommended that the interior walls be painted at least once in the next two to four years.
- The 2006 International Building Code 1009.11 requires handrails on each side of stairways.
- The building has a set of stairs to access the offices on the mezzanine above the cafeteria and restrooms.
- The stairway has only one handrail.

- This building currently supports the maintenance of the WSCC, and to some degree, NSP.
- It should continue in that role.

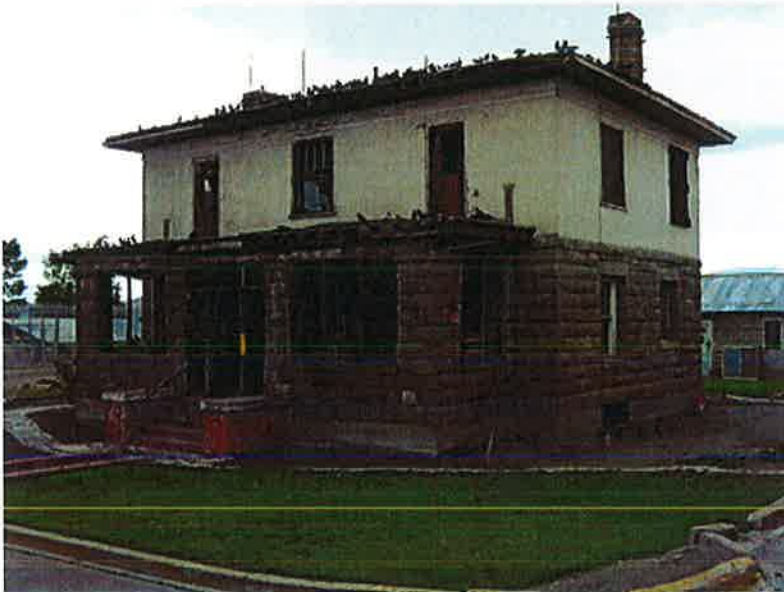
WARDEN'S HOUSE

- The old residence is in extremely poor shape with damage to the roof and roof framing, failing decks, broken or damaged doors and windows.
- The window and door openings have been sealed.

Broken or missing doors and windows;

Broken or missing electrical fixtures.

- The SPWB recommends mothballing this building in accordance with the U. S. Department of Interior Recommended Guidelines in Preservation Brief 31.
- This Brief suggests:

- This house should eventually be restored because of its historic nature and correctional context.
- We believe that the structure should be maintained until that restoration can be financed and accomplished and integrated into the proposed museum.

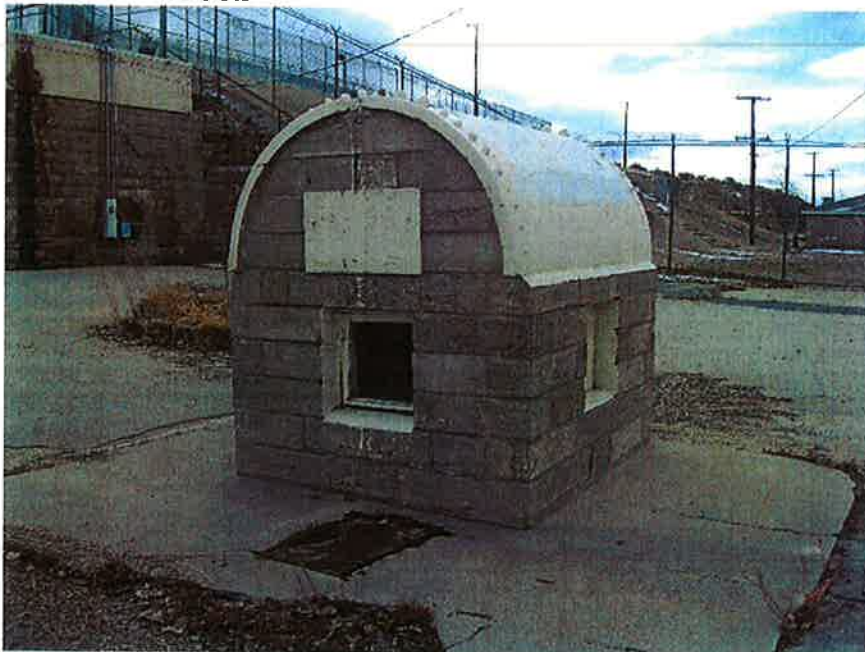
OLD PUMP HOUSE

- The Old Pump House is an old sandstone masonry building with an arched concrete roof.
- It used to serve as the pump house for the prison's old water system and is no longer in use.
- 64 sf of space and is one of the oldest, if not the oldest structure on the site.

- Recommend maintaining this structure for its historic and architectural value.
- The old plumbing mechanisms are still present in the pump house.
