### City of Carson City Agenda Report

**Subject Title**: <u>For Possible Action</u>: To accept the 2013 Monitoring Report for the Horsecreek Ranch Conservation Easement as recommended by the Open Space Advisory Committee. (Ann Bollinger)

**Date:** July 24, 2013

#### Conservation Easement, Exhibit C, Prohibited Uses and Practices

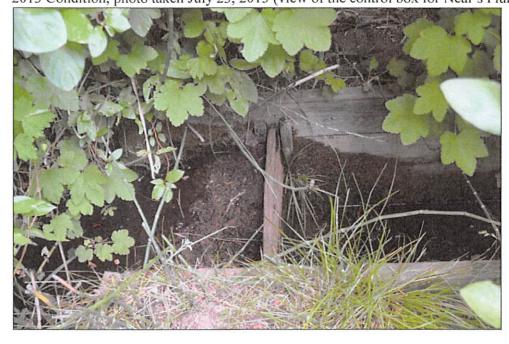
- <u>Stewardship Account:</u> There are no expenses to report. The account has a current balance of \$47,375.00.
- The irrigation ditch known as "Neal's Flume" was dry during this field monitoring. Mr. Fagen informed staff that the adjacent landowners (Jeff Schulz and John Schulz) had cleaned the flume in April/May 2013 and typically water is sent to the top of the meadow in early spring for at least one good surface flood. It should be noted that the Baseline Condition Report also commented that the ditch is not used during the minimum flow periods of the north fork of Clear Creek due to significant conveyance losses on the ditch. An inspection of the upper reach revealed water flow in the north fork of Clear Creek; however, the water level seemed low and it was certainly lower than the accumulated sediment behind the control box for Neal's Flume. While the upper meadow at Horsecreek Ranch was not currently receiving water from Neal's Flume, two other springs were flowing and providing water to nearby areas. Overall, the meadow was fairly green and productive.

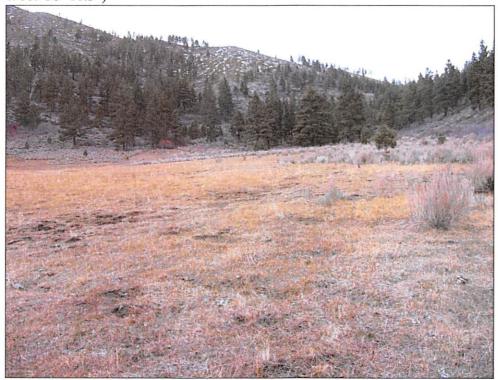
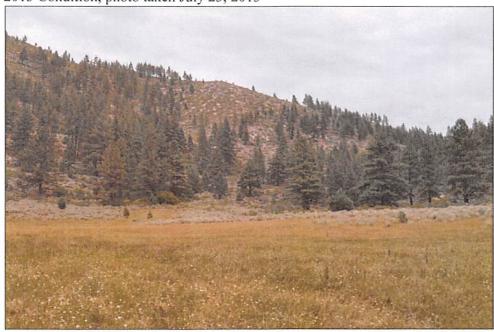
Photo Point 1A (view northeast): A photo point located at the edge of the shrub dominated granitic fan and the irrigated meadow. This would be used to monitor shrub invasion into the meadow area indicating irrigation problems.

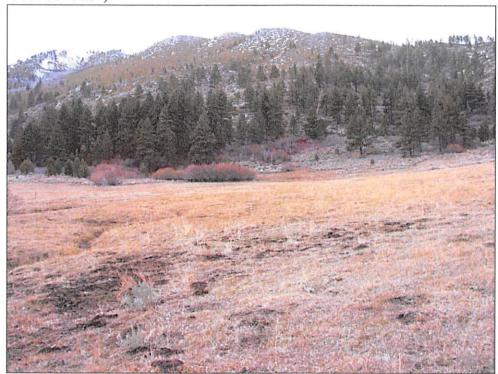
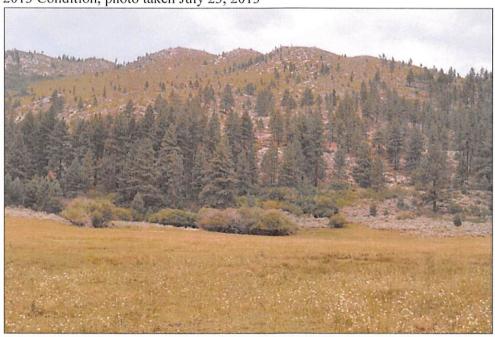
Photo Point 1B (view northwest): A photo point located at the edge of the shrub dominated granitic fan and the irrigated meadow. This would be used to monitor shrub invasion into the meadow area indicating irrigation problems.

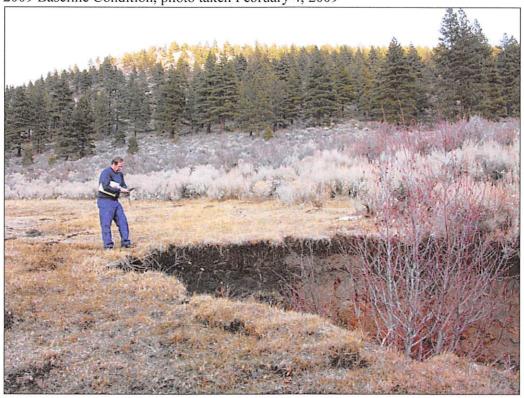
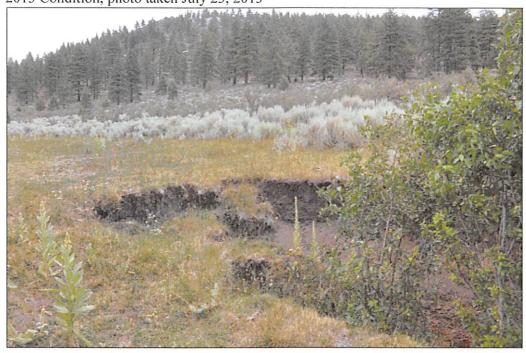
Photo Point 4A (view north): A photo point located at the most northern active headcut after required stabilization to monitor effectiveness.

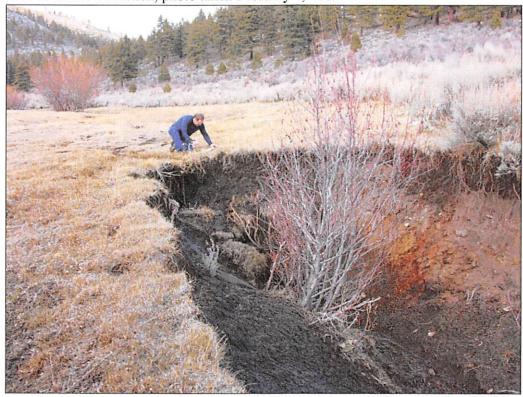
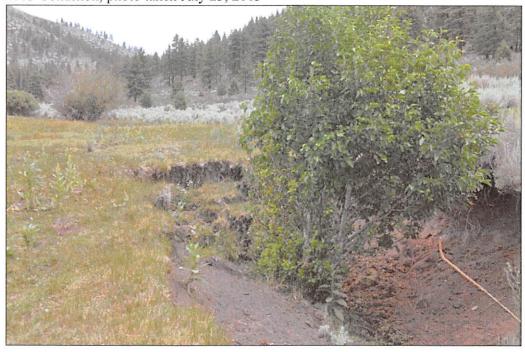
Photo Point 4B (detail): A photo point located at the most northern active headcut after required stabilization to monitor effectiveness.

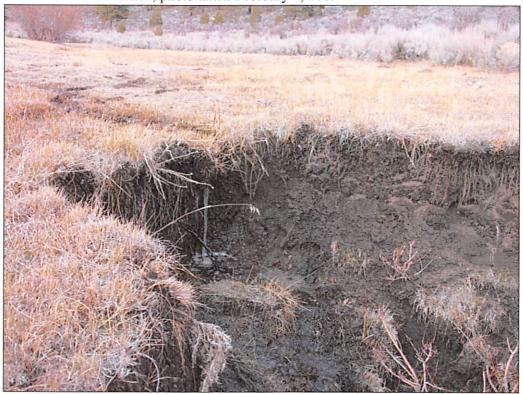
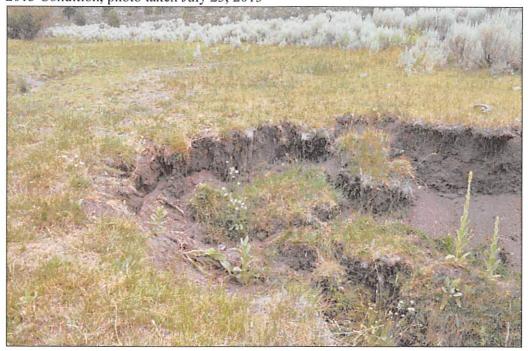
Photo Point 4C (detail): A photo point located at the most northern active headcut after required stabilization to monitor effectiveness.

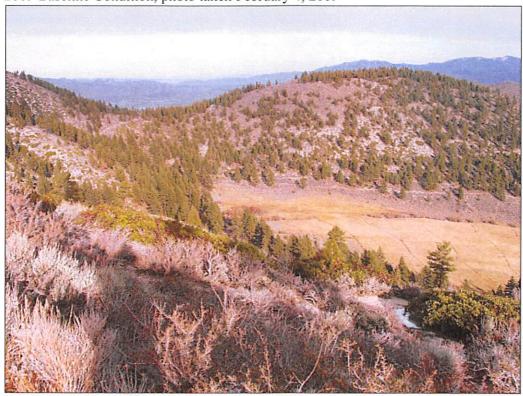
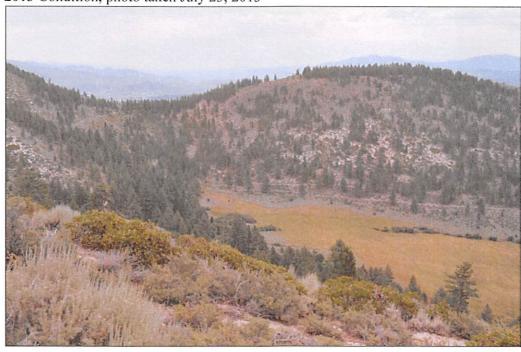
Photo Point 6A (view north): A photo point from the Kings Canyon Road that would provide panoramic views of the ranch from a west to east perspective.

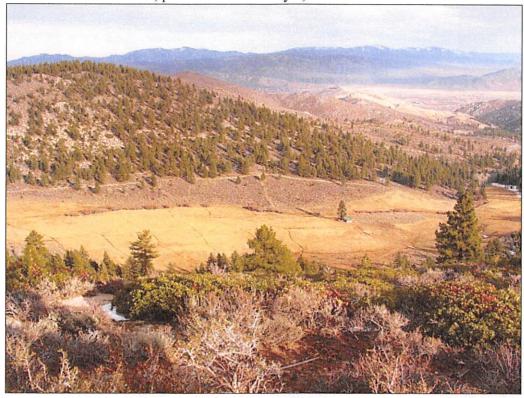
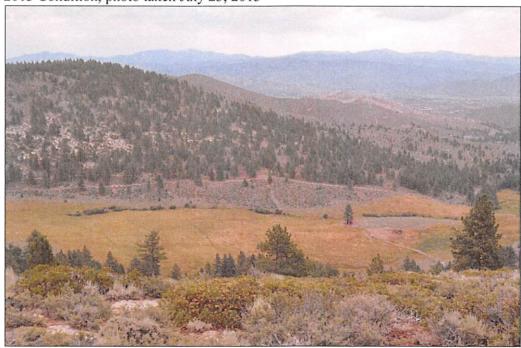
Photo Point 6B (view center): A photo point from the Kings Canyon Road that would provide panoramic views of the ranch from a west to east perspective.

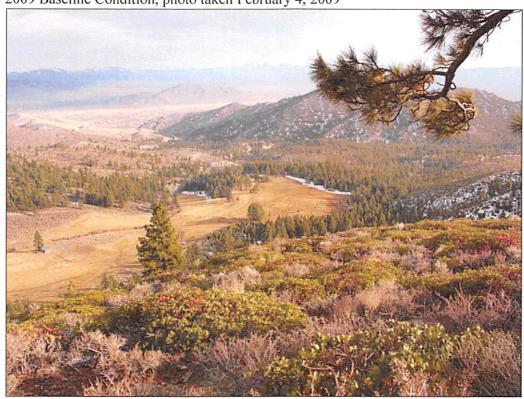
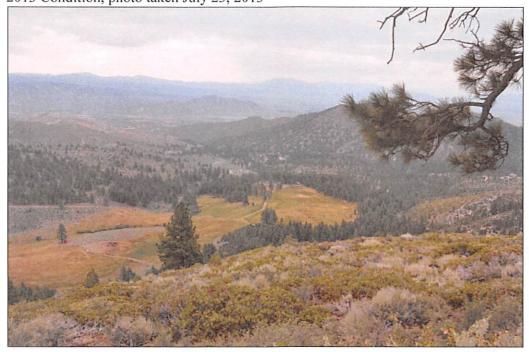
Photo Point 6C (view south): A photo point from the Kings Canyon Road that would provide panoramic views of the ranch from a west to east perspective.

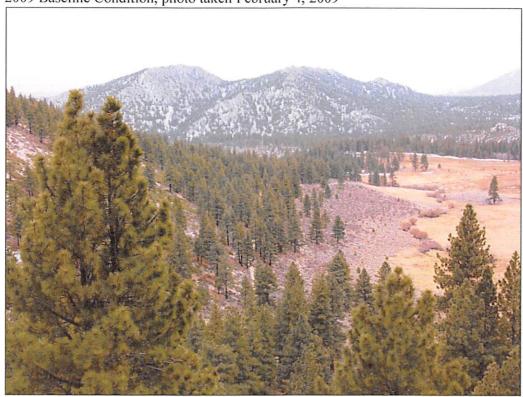
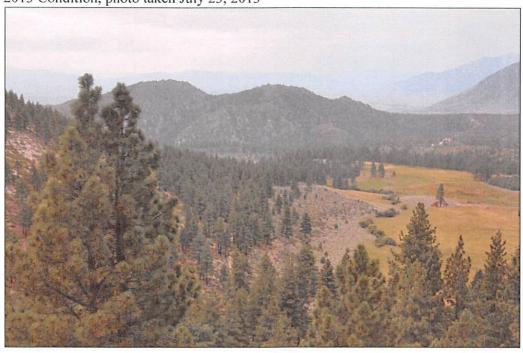
Photo Point 7A (view southeast): A photo point from Kings Canyon Road that would provide panoramic views of the ranch from a north to south perspective.

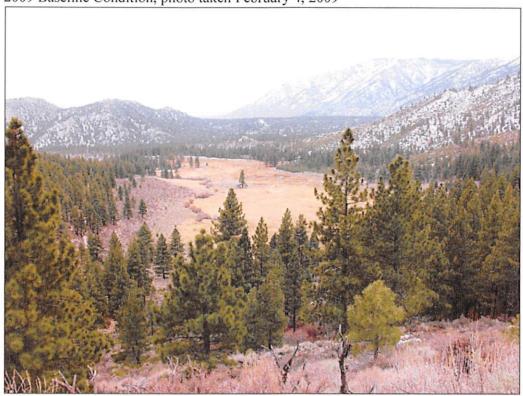
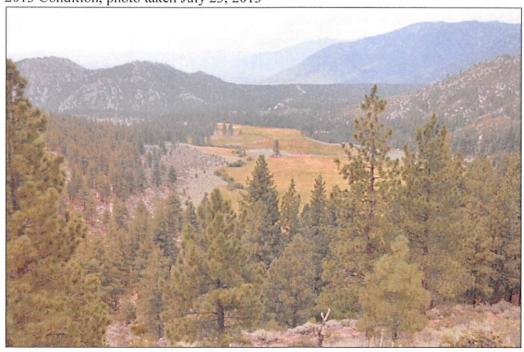
Photo Point 7B (view south): A photo point from Kings Canyon Road that would provide panoramic views of the ranch from a north to south perspective.

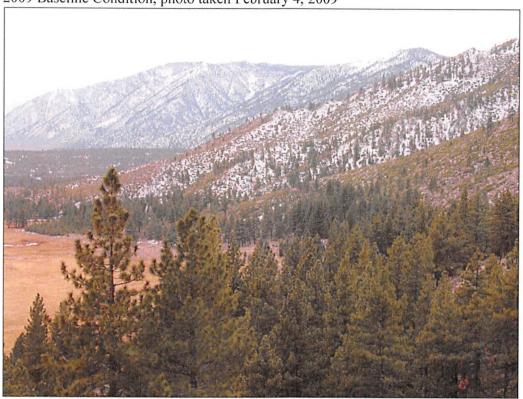
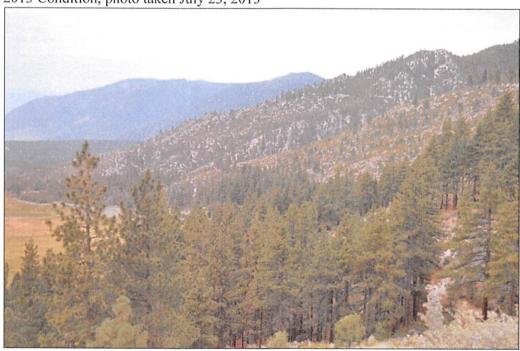
Photo Point 7C (view southwest): A photo point from Kings Canyon Road that would provide panoramic views of the ranch from a north to south perspective.

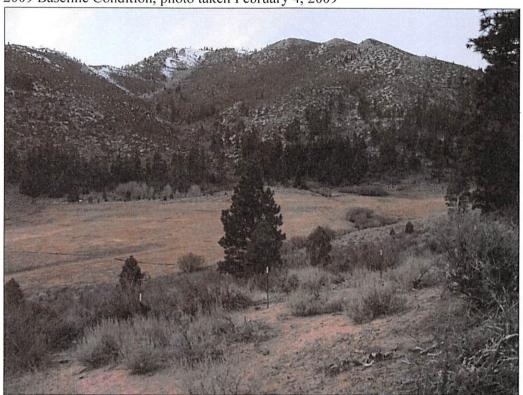
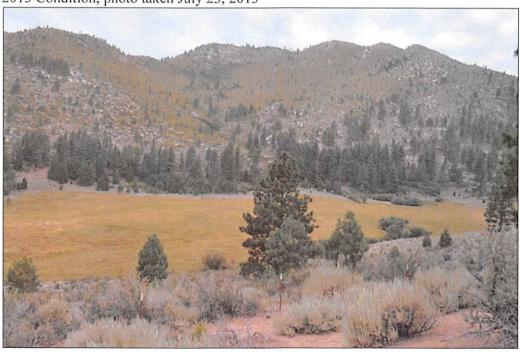
Photo Point 8A (view northwest): A photo point overlooking the meadow from the east to the west located next to the property corner along the new road.

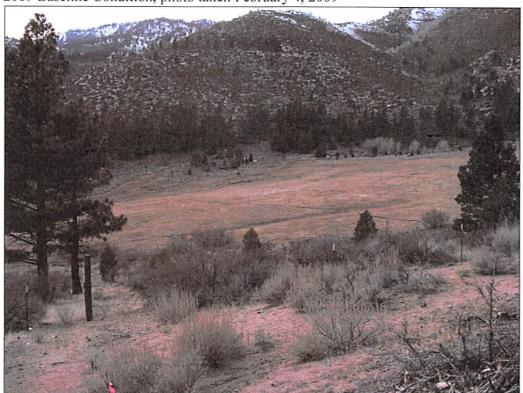
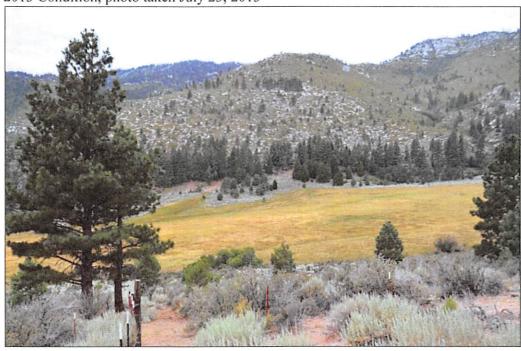
Photo Point 8B (view west): A photo point overlooking the meadow from the east to the west located next to the property corner along the new road.

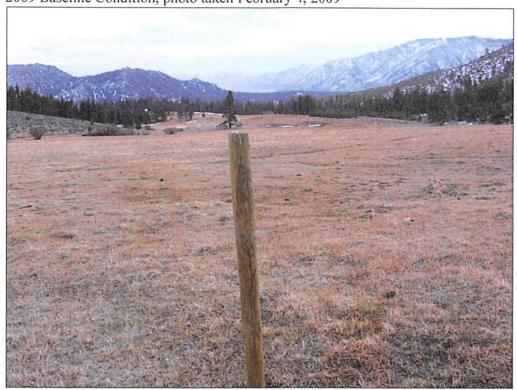
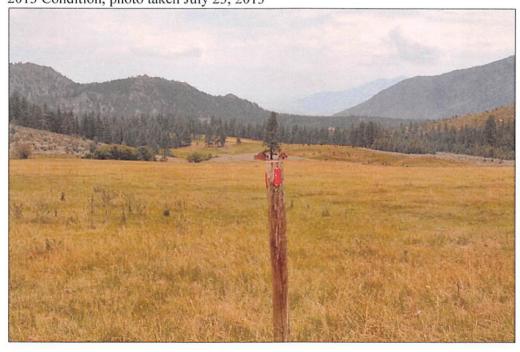
Photo Point 9: A permanently marked 100' x 100' area to monitor pasture condition. This annual inventory will be used to monitor not only pasture condition but irrigation efficiency, vegetative response to drought and appropriate livestock utilization.
