INFORMATIONAL TOPICS JULY 2012

From Asbestos to Zinc ROOFING FOR HISTORIC BUILDINGS

Technical Preservation Services

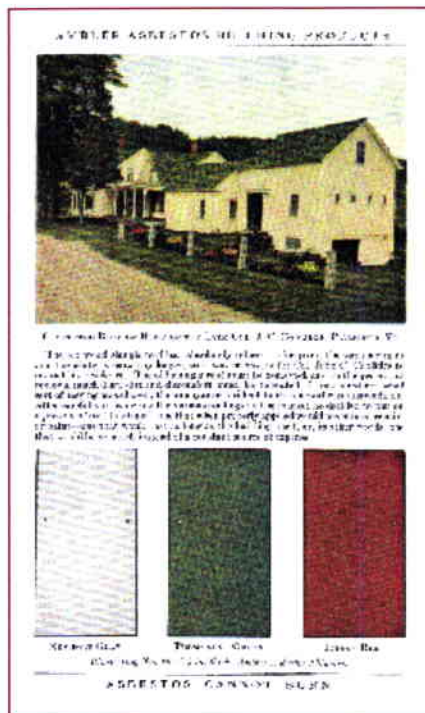
Johns-Manville promoted the direct application of their asbestos-cement shingles over worn roofing in this 1936 catalog. The Dutch Lap roof being applied here was easy to install and utilized a metal "clincher" to anchor exposed corners. (Home Owners' Catalogue, A Guide to the Selection of Building Materials Equipment and Furnishings, F. W. Dodge Corporation, 1936. Courtesy of The Sweet's Group-The McGraw-Hill Companies, Inc.) [click image for larger view]

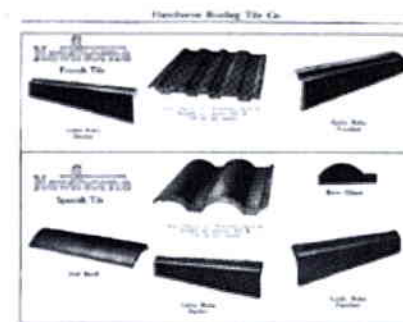
Chicago-based Hawthorne Roofing Tile Company originally manufactured its tile from slabs by a hand-process. These concrete roofing tiles depicted in the 1929 Sweet's Architectural Catalog imitated French and Spanish clay tiles. They were produced with automated power-driven equipment, and the colors were impregnated on the tile surface. (Sweet's Architectural Catalogue, 1939. Courtesy of the Sweet's Group, McGraw Hill Companies, Inc.) [click image for larger view]

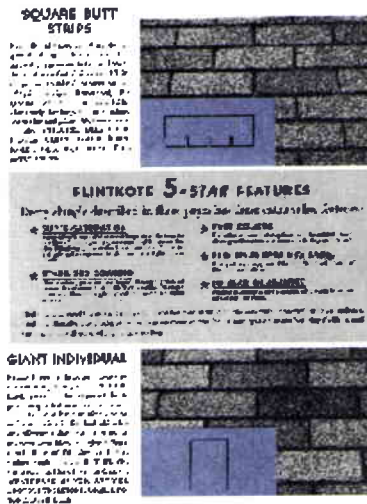
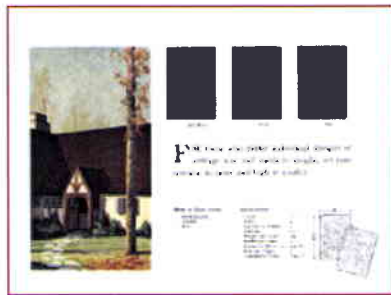
Slate used for the surface aggregate determined the colors of early shingles. [click image for larger view]

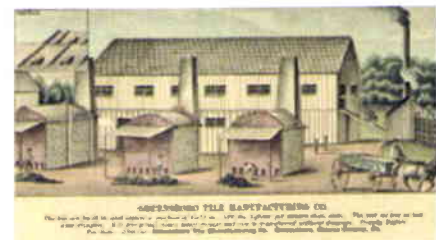
The kilns depicted in this drawing from an 1876 atlas have been loaded with tile and the open ends walled up with bricks. Fires for such kilns were lighted and kept slowly burning for the first five hours, and then progressively increased for the next thirty-three hours. Toward the end of the firing, the mouths of the kiln were stopped with ashes to prevent the flow of air from cooling the oven too quickly. A typical kiln consumed approximately four tons of coal per firing to produce hard fired tiles. (click image for larger view)

Roofing tile begins as raw clay that is processed by drying, pulverizing, mixing with water and kneading. It is then shaped into tiles, dried and fired. In the latter half of the 19th century mechanization was introduced incrementally to what was largely a manual operation. Even as steam power was applied to the rollers that pulverized the clay and the pug mill that mixed and kneaded it, clay continued to be pressed into molds by hand. In the 1870s machines were developed that delivered and mechanically pressed slices of clay into a mold. The installation of such presses at the Celadon plant in Alfred, New York, reportedly increased daily production tenfold. Other advances allowed shapes such as a shingle or barrel tile to be cut directly from extrusions, a process commonly used today.

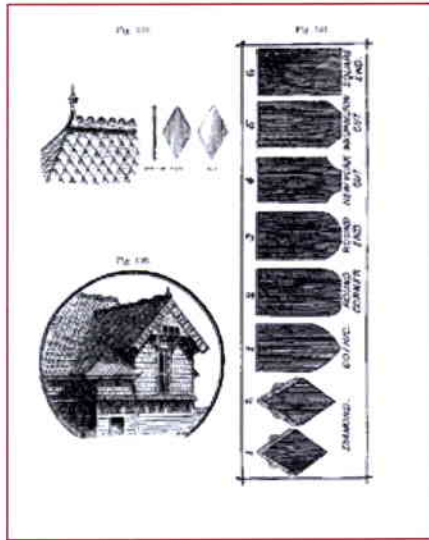
Outside of the Southwest, these tiles depicted in an 1884 publication are typical of what were in common use at that time. The diamond is an interlocking tile while the others are simply shingle tiles with shaped butts. [click image for larger view]

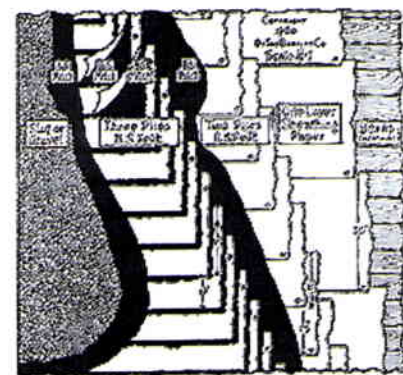
Diagram Showing Barrett Specification, Type "AA" Roof Over Boards
Revised for 20 years.

(Sweet's Architectural Catalogue, 1929. Courtesy of The Sweet's Group, The McGraw-Hill Companies, Inc.) [click image for larger view]

Samual Barrett, a Chicago roofing product manufacturer, made the first significant effort to set standards for the industry. "Barrett Specifications" were compiled in 1906, providing minimal guidelines for the materials and application of a gravel or slag roof. His generic

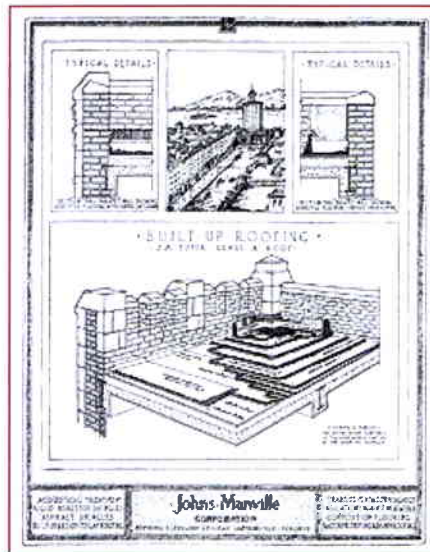
The specification for this built-up roof being advertised in 1929 called for it to be: "Applied only by the manufacturer or by approved roofing contractors." The materials consisted of asphalt-impregnated asbestos-based roofing felt and asphalt-based roofing cement. "No slag or gravel is ever used or needed on a Johns-Manville Roof." [click image for larger view]

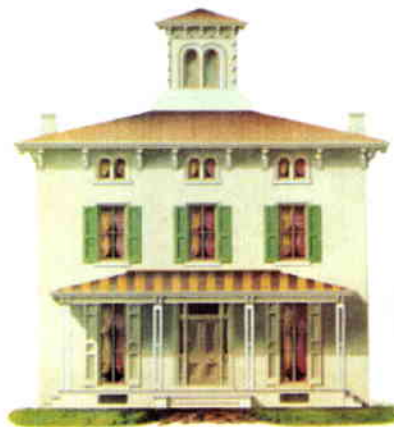
Painting the verandah roof in stripes following the seams in the metal was a fashionable treatment before the Civil War. Manufacturers and technical manuals recommended painting the underside of the metal as well as applying two or three coats to the top. Paints of iron oxide in linseed oil and white lead paint were variously recommended. Since the iron oxide produced a red or brown color, the stripes depicted would have required a tinted white lead paint. (Courtesy of The Athenaeum of Philadelphia) [click image for larger view]

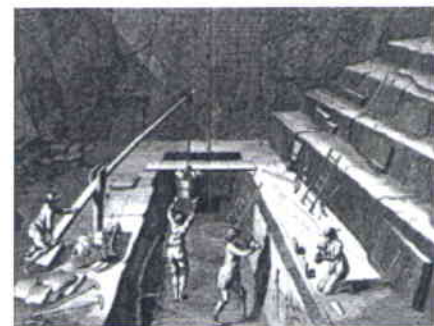
Mineralogie, Ardoises D'Anjou. Travail de la Carrière Ouverte et Outils. **Revuell de Planches, sue Les Sciences, Les Arts Liberaux, et Les Arts Mechaniques, Avec Explication**, Diderot-D'Alembert. (Courtesy of NewsBank, Inc.) [click image for larger view]

Until the 1870s the quarrying of slate changed little from what is illustrated by Diderot in the **Pictorial Encyclopedia of Science Art and Technology** of 1762. Blocks were separated from the floor of the quarry using picks, wedges, prybars and gunpowder, taking maximum advantage of the natural seams in the rock. Windlasses and simple cranes employed man or horse power to lift blocks of slate from the pit. With the Industrial Revolution came mechanical drills and steam-powered stone channeling machines and hoists. Waste associated with blasting was reduced and efficiency increased. Subsequent advances were marked by the introduction of the wire saw in 1926 and the diamond belt saw in 1988.

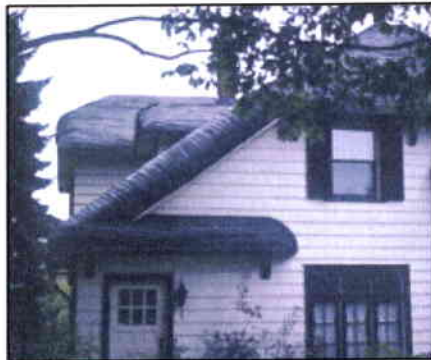
The wood shingles on the roof of this Tudor Revival house (left) were steamed and bent to resemble thatching. To aid architects and contractors to lay such special effects shingles properly, manufacturers like the Creco-Dipt Company, Inc. of North Tonawanda, New York, published roof details, like those in the 1923 **Sweet's Architectural Catalogue** (below). (Photograph courtesy of NPS; "Country Cottage Roof".) [click image for larger view]

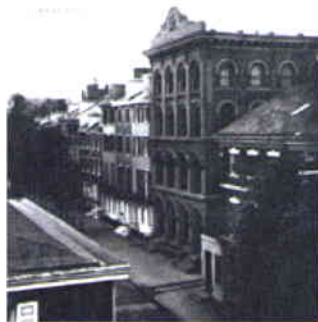
An 1871 photograph of the corner of 3rd Street, south of Walnut in Philadelphia shows a number of rain water conductor systems. In the lower left corner is a metal roof with a built-in gutter lined with metal; on the far right is a building with a wood shingle roof and a built-in gutter with exposed downspout; and in the center is a four story brick building with built-in gutters and internal downspouts. (Print & Picture Collection, The Free Library of Philadelphia) [click image for larger view]

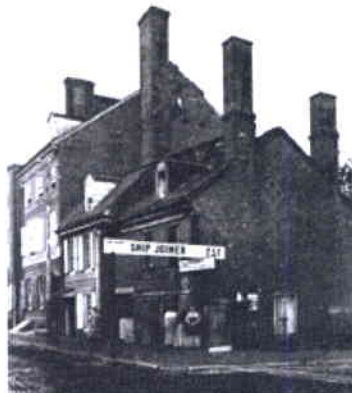
The pole gutters on the roof at 757 Swanson Street, Philadelphia in 1868 divert rainwater to a short cylindrical downspout. Moisture damage is evident on the wall of the building below the end of the pipe where there is no downspout extension. (Print & Picture Collection, The Free Library of Philadelphia) [click image for larger view]

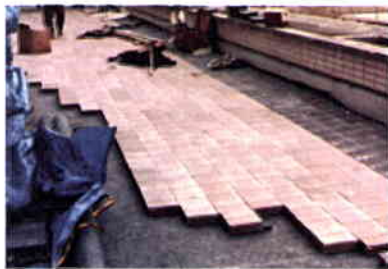
This single ply membrane with an isolation felt

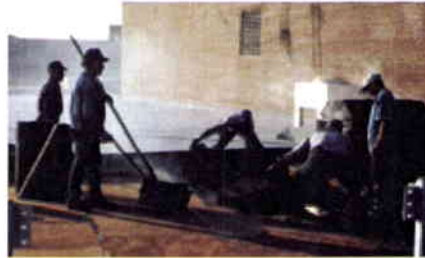
The first ply of hot applied, built-up roofing is installed over perlite insulation board. The system is carefully installed to accommodate locations of roof penetrations and rooftop mechanical equipment. (Photograph courtesy of Wiss, Janney Elstner and Associates)
