The Repair and Replacement of Historic Wooden Shingle Roofs

Sharon C. Park, AIA

September 1989

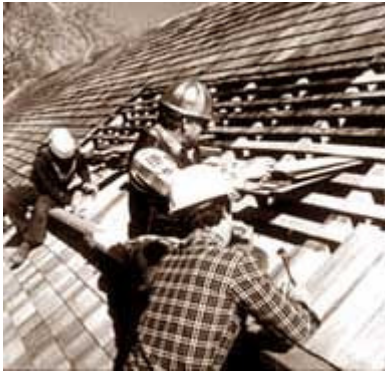
Appropriate re-roofing work in progress. Photo: NPS files.

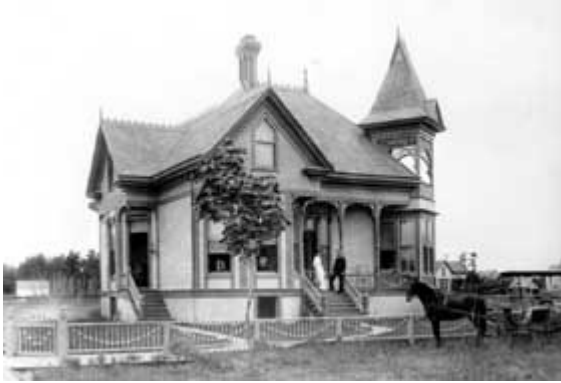
Readily available and inexpensive sawn shingles were used not only for roofs, but for gables and wall surfaces. Photo: Lane County Historical Society.

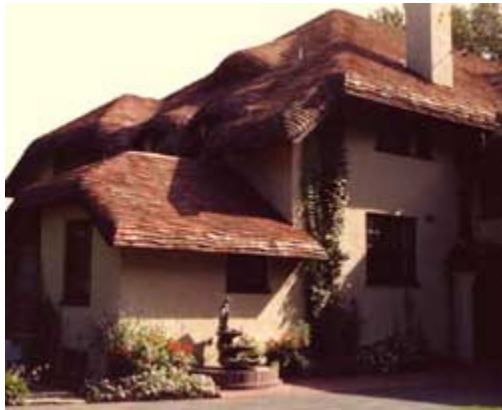
With the popularity of the revival of historic styles in the late 19th and early 20th centuries, a new technique was developed to imitate English thatch roofs. Photo: C.H. Roofing.

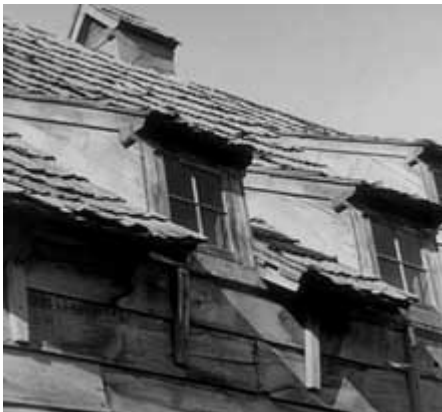
The long, biaxially tapered handsplit shingles are overlapped both vertically and horizontally. Photo: NPS files.

Not all shingles were laid in evenly spaced, overlapping, horizontal rows. In various regions of the country, there were distinct installation patterns; for example, the biaxially-tapered long shingles occasionally found in areas settled by the Germans. These long shingles were overlapped on the side as well as on top. This formed a ventilation channel under the shingles that aided drying. Because ventilation of the shingles can prolong their life, roofers paid attention to these details.

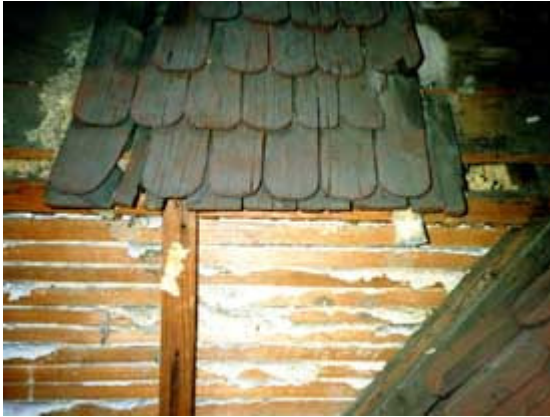
These weathered historic 19th-century handsplit and dressed shingles were found in place under a later altered roof. See also, below. Photo: John Ingle.

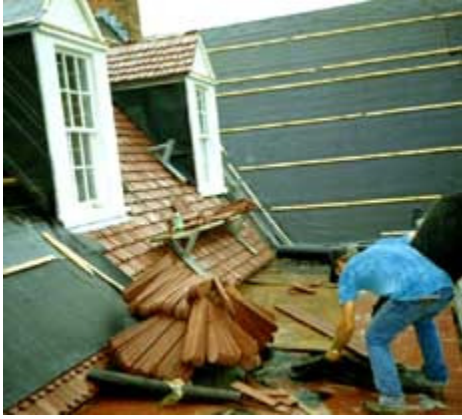
The replacement shingles matched the historic shingles and were of such high quality that little hand dressing was needed at the site.

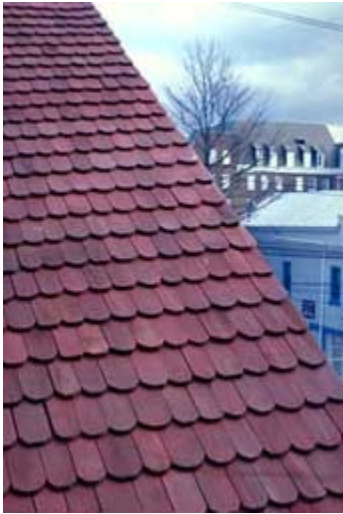
New rounded butt sawn shingles, with a smooth finish and red oxide stain, were used to replace the deteriorated shingles. The varying widths, between 4" and 7" will keep them from curling and cupping. Exposure length was determined from historic nail patterns on the historic spaced sheathing below. Photo: NPS files..

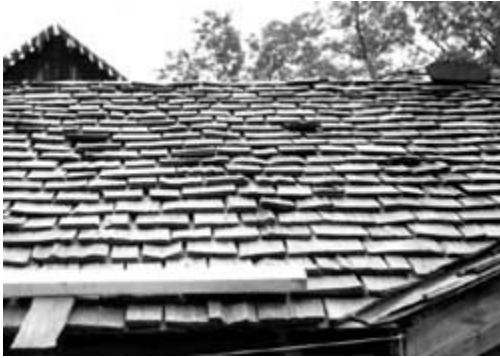
These commercially available roofing products with rustic split faces are not appropriate for historic preservation projects. Photo: NPS files.
